Rotary Wing (RW) Mishaps in DVE- Latest Statistics

William Albery, PhD
The Villages Florida
USA

ABSTRACT

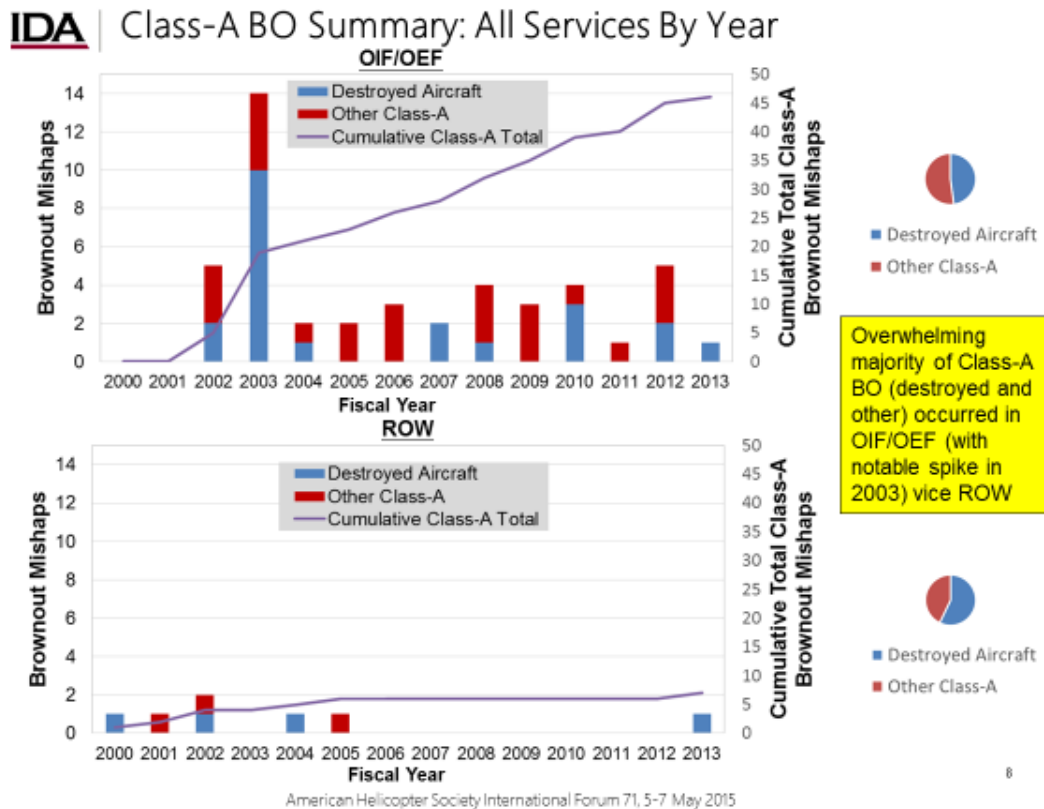
Figure 1. Class-A BO Summary: All US DoD Services by Year (Greer et al, 2015)

The numbers of Class-A mishaps attributed to BO by year across all the US services from 2000 to 2013 are illustrated in Figure 1 (Greer and Schwartz, 2013). The stacked bars use the scale on the left and are composed of destroyed aircraft and other (repairable) Class-A incidents. The cumulative total numbers of Class-A mishaps are also displayed with the overlaid lines using the scale on the right side. The top chart is for OIF (Operation Iraqi Freedom) /OEF (Operation Enduring Freedom) while the bottom chart is for the Rest of World (ROW), with the same scales. A spike in mishaps during the rapid ramp up of operations is clearly shown for 2003 in OIF/OEF. Although the BO phenomena was well understood dating back to at least the 1980's (with the infamous mishap during the failed attempt to rescue Iranian hostages), the US military's level of exposure to BO environments was not significant until 2002. Despite the significant reduction from 2003 to 2004, BO mishaps persisted through 2013 with smaller spikes over this time frame. For the ROW, by comparison, relatively very few BO mishaps occurred over this time period. Overall, 26 of the 53 Class-A BO mishaps (approximately 49%) resulted in an aircraft destroyed. Interestingly, this percentage is somewhat higher for ROW than for OIF/OEF.

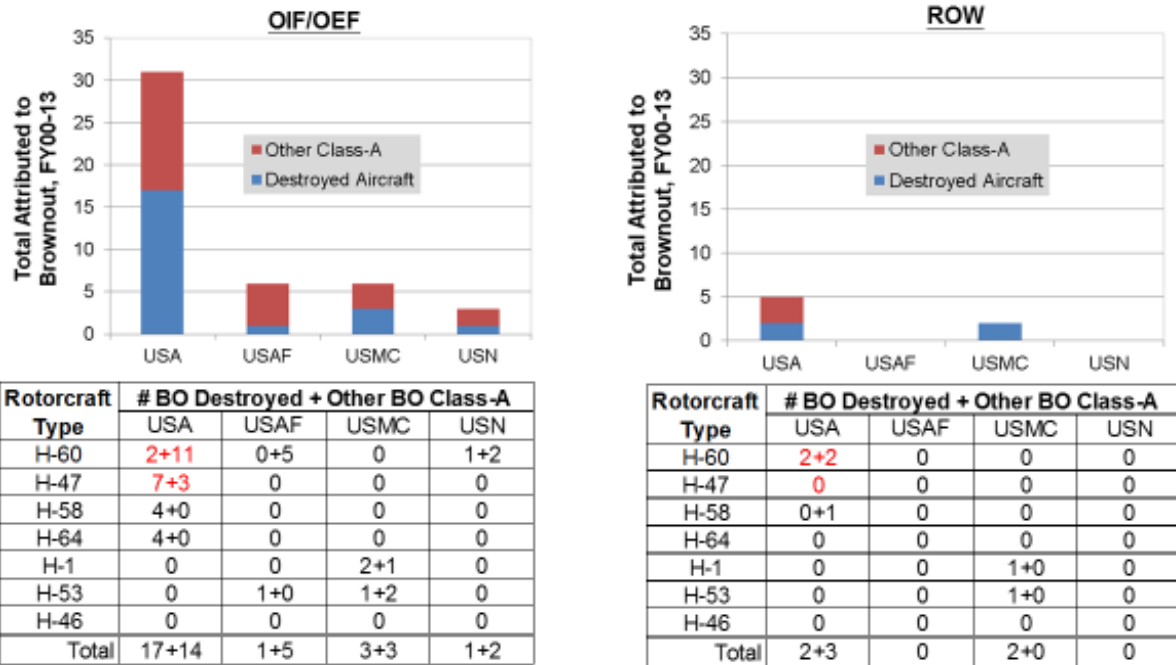
Figure 2. Class-A BO Summary: Total by Service and Rotorcraft (Greer et al, 2015)

The total number of US service specific Class-A mishaps attributed to BO across the 2000-13-time period is shown in Figure 2, again with the stacked bars composed of destroyed aircraft and other (repairable) Class-A incidents (Greer et al, 2015).

Vast majority of BO Class-A (destroyed and other) mishaps occurred in OIF/OEF vice ROW, with Army aircraft (particularly the H-60 and H-47) the primary ones

With the breakout of these mishaps between OIF/OEF and ROW operations, it is again clearly apparent that the overwhelming majority of BO Class-A mishaps occurred in OIF/OEF vice the ROW (Greer et al, 2015). The Army has by far the largest number of BO Class-A mishaps (roughly 68% of the overall total) mostly in support of Central Command (CENTCOM) operations over this time period. The USMC and the USAF have the next highest total combined number (approximately 15% and 11% respectively) followed by the USN (at about 6%). The table under each bar chart shows the type of rotorcraft that constitute each bar. Within each cell, the first number listed is the number of aircraft destroyed and the second number represents other Class-A mishaps. For the Army, the H-60 and H-47 are the predominant Class-A BO mishap contributors with the H-47 being the aircraft suffering the greatest number of losses due to BO. Within the Army, most of these mishaps were with aircraft in the Active force (versus Guard/Reserve forces). For the Air Force and Navy, the H-60 is the main aircraft type experiencing a Class-A mishap due to BO. For the Marine Corps, the H-53 and H-1 are the primary contributors to the BO Class-A mishaps. While not shown in the table, it is interesting to note that all four of the Army AH-64

attack aircraft were lost early in OIF/OEF, whereas the Army H-60 and H-47 transport aircraft Class-A mishaps due to BO were spread throughout this time period. A MV-22 aircraft experienced a hard landing in BO (2013) which was classified as a Class-A mishap. All four of the crew walked away.

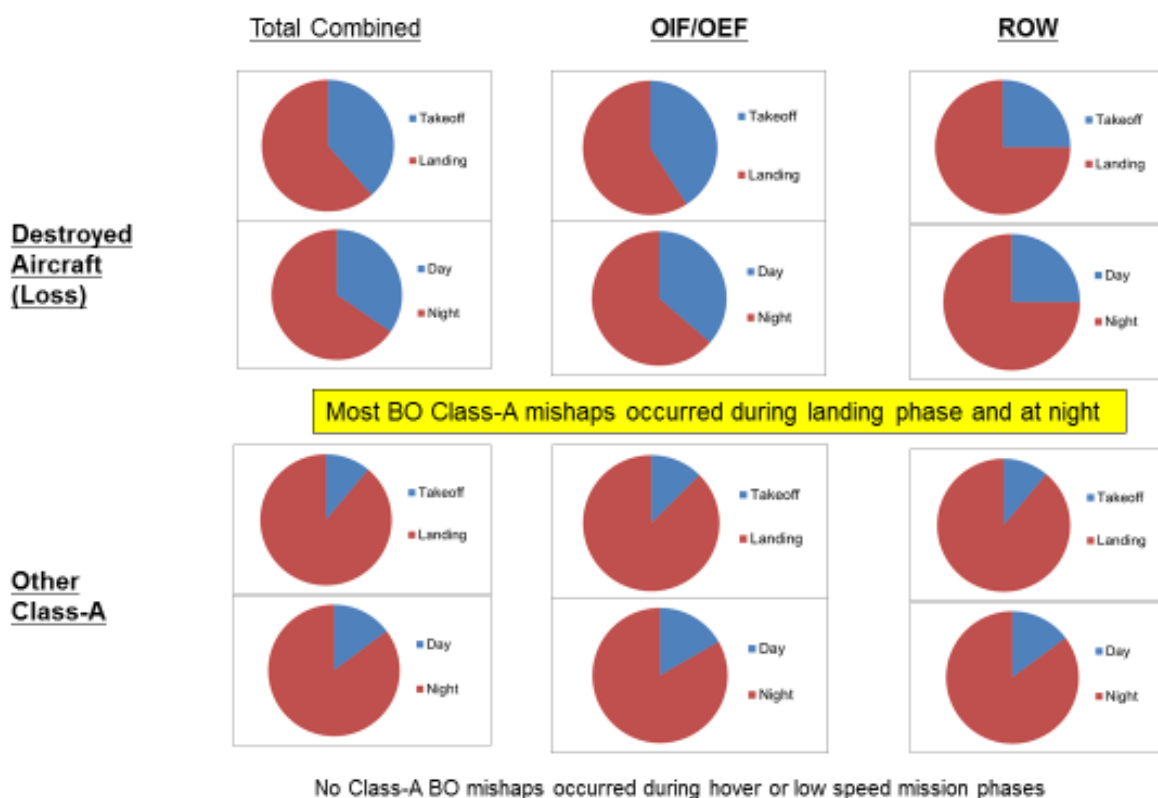
Figure 3. Class A BO Summary: All Services by Environment (Greer et al, 2015)

The number of Class-A mishaps attributed to BO by phase of flight and diurnal condition for all the US services is presented in Figure 3. The pie charts are partitioned by destroyed aircraft (loss) and other Class-A mishaps for OIF/OEF, the ROW, and total combined. The underlying data are for all the services across the 2000-13-time period. The primary takeaways are that the BO Class-A mishaps have occurred largely at night and during the landing phase over this time period. Secondary observations are that a slightly higher fraction of the takeoff and day conditions existed for the destroyed aircraft than the other Class-A BO mishaps. Similarly, a slightly higher fraction of the takeoff and day conditions existed for OIF/OEF versus the ROW Class-A BO mishaps.
