Canadian Forces Experience with Turbofan HCF – Case Study

Corey Kinart, P. Eng.
Magellan Aerospace Corporation
3160 Derry Road East
Mississauga, Ontario
Canada, L4T 1A9
ckinart@orenda.com

Maj. Pierre Theriault
National Defence Headquarters
101 Colonel By Drive
Ottawa, Ontario
Canada, K1A 0K2
theriault.pg@forces.gc.ca

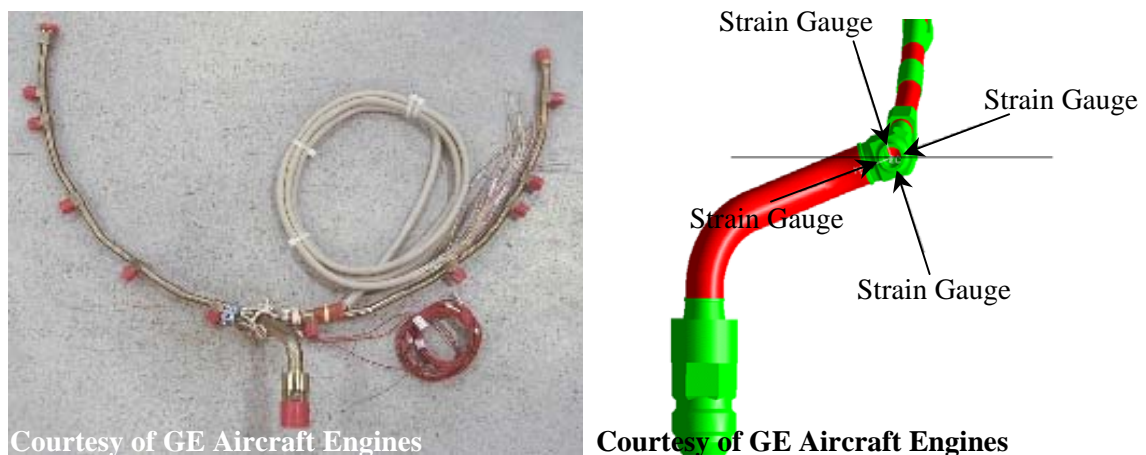
Figure 4: Instrumented Lower Fuel Manifold

An instrumented LFM was provided by GEAE for the engine test. The tube assembly was equipped with eight strain gauges, four on either side of the T-junction, at evenly spaced intervals around the tube circumference as shown in Figure 4.

Analysis of the AETE flight test data revealed several resonant frequencies during various engine operating regimes and aircraft manoeuvres. The maximum LFM strain measured over all test points occurred during the JP8 fuel portion of the tests under a high-g, high angle of attack, subsonic turn. During this manoeuvre, a low frequency input pushed the LFM strain to 100% of the design maximum allowable. Conversely, the strains measured during “straight and level” flight were significantly lower, and nearly negligible during ground testing. These flight test results suggested a clear correlation between aggressive aircraft manoeuvring and high LFM strains. This would help to explain why many LFMs in service were able to accumulate far greater flying hours than those that failed due to HCF without incident. It would also explain why F404 applications other than the F/A-18 had experienced no LFM failures.

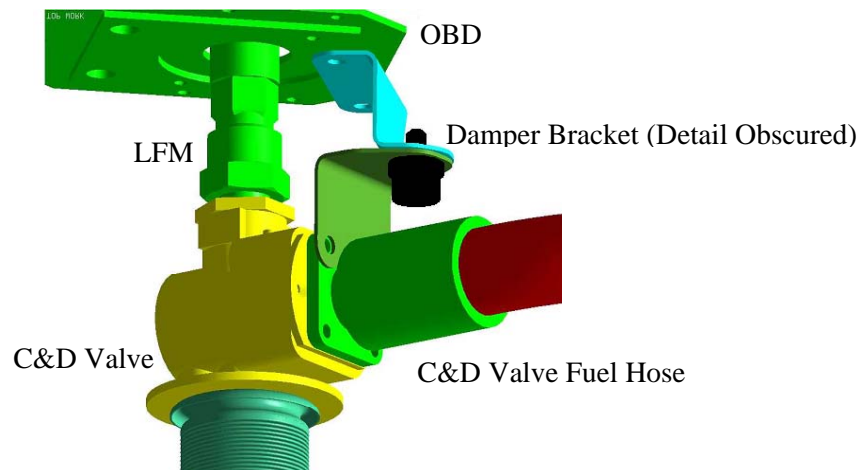
Figure 6: Prototype Damper Bracket Design

In November 2002, the prototype damper bracket was installed on the shake table test bed at GEAE with a new LFM to evaluate the ability of the bracket to reduce strains at the LFM T-junction induced by vibration inputs at the low frequency range of interest. With the shake table operating at the same frequency and amplitude as for the baseline test, the number of cycles accumulated was five times greater than that required to fail the LFM in the first test with no damper bracket installed, and the new LFM remained intact at the conclusion of this second test. The measured strain at the LFM T-junction was reduced by as much as 94% at the low frequency range of concern with the damper bracket installed versus the strains measured during the baseline shake table tests without the damper bracket. Although the bracket was not as effective at reducing higher frequency modes of vibration induced strains, some mitigation was afforded at these higher frequencies through both direct dampening, as well as by shifting several modal responses of the LFM/damper bracket system away from the damaging resonant frequencies of the installed, unmitigated LFM. Unfortunately, while these tests were being carried out, the CF operational fleet had its third LFM cracking event at CFB Cold Lake, which resulted in a fuel leak.

the F404 LFM issue since GEAE design experience would minimize development time and cost. The addition of the damper bracket to the LFM assembly would shift the first modal response of the system away from the low frequency input identified during flight tests. Therefore, existing low frequency vibration resulting from engine operation would no longer create a resonant response in the LFM assembly, thereby significantly reducing operational strain at the LFM T-junction. By September 2002, GEAE had developed a prototype damper bracket for the F404 that was installed on the laboratory calibrated shake table test bed to make an initial assessment of its ability to mitigate LFM strain. The prototype damper bracket consisted of three basic components. Two halves of the bracket spanned the distance between the C&D Valve (attached to the LFM inlet tube) and the Outer Bypass Duct (OBD). A spring and stud that provided the dampening feature of the bracket system joined the two bracket halves together. The bracket was designed to be bolted directly to the OBD using existing boltholes, and would interface with the C&D Valve Fuel Hose, which bolts directly to the C&D Valve and provides main fuel flow to the LFM. During engine operation, the bracket would restrict vibration of the LFM at the C&D Valve interface regardless of the source of vibration. Figure 6 depicts a rendering of the damper bracket installed on the F404 engine, showing how it is incorporated with existing hardware. Note that the damper bracket was designed to be installed on the outer shell of the F404 engine, and could therefore be installed without engine disassembly, and could even be installed on engines mounted in airframes. This greatly simplified the logistical planning for incorporation of damper brackets across the entire CF F404 fleet.

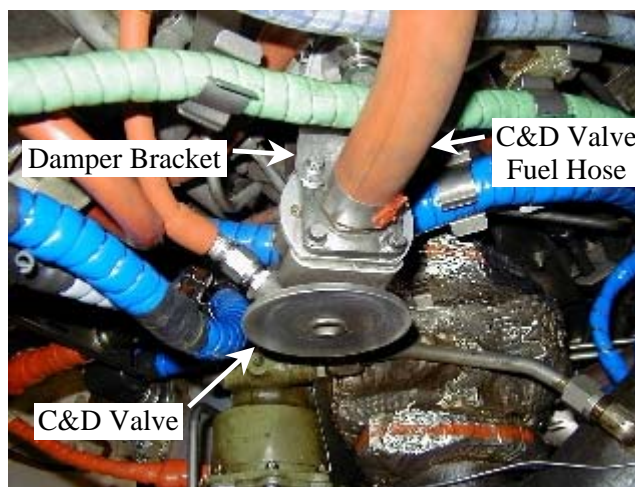
Figure 7: Second Damper Bracket Design

variability in the position of the C&D Valve with respect to the OBD meant that the mounting points for the two damper bracket halves could be of varying distances apart. This created a condition where the two bracket halves would become slightly separated, leaving a small gap between the two halves, and creating an undesirable possibility for abnormal wear of the damper bracket as well as the possibility of compromised dampening effect. This necessitated a redesign of the damper bracket in order to incorporate some adjustability that would allow the bracket to be adaptable to the varying installation conditions on all F404 engines. By May of 2003, a newly designed bracket had been produced by GEAE, which incorporated a feature that would allow the length of one half of the damper bracket to be adjusted in order to span the varying distance between the mounting points on the C&D Valve and the OBD. Figure 7 is a photo of an installed damper bracket, conveying the challenge of incorporating a new component within the complex network of existing engine hardware.

Analysis of the damper bracket flight test data was completed in September 2003 with the results indicating that with the damper bracket installed, overall strain levels at the LFM T-junction were reduced by approximately 48%, well below design maximum allowable levels. The damper bracket was found to be extremely effective in mitigating vibration input to the LFM in the low frequency range of concern that was identified during the 2002 flight tests. Based on these results, all parties involved in the development of the damper bracket agreed that the flight tested design was sufficient in its ability to mitigate undesired strain levels in the LFM T-junction and reduce the risk level associated with this issue to an acceptable level.

Trial installations were carried out on an F404 engine using the newly designed damper bracket with no further complications. The adjustable feature of the new bracket allowed the system to compensate for the variability of mounting point positions between engines and allowed proper installation of the bracket with little increase in complexity or effort. The new bracket was forwarded to CFB Cold Lake in July 2003 in preparation for flight tests at AETE during the following month. Before testing the new damper bracket, baseline flight tests were performed without the bracket installed in order to re-establish the measured strain levels experienced by the LFM in flight and to ensure that the results had not changed significantly from those recorded during the June 2002 flights. The same test matrix was flown as during the previous flight test phase, however this time only JP8 fuel was used. Upon completion of the baseline flight tests, the recorded data was analyzed and found to be very similar to that recorded during the June 2002 flight tests. The damper bracket was then installed and the flight test matrix was repeated.
