Non-Destructive Measurement Methods (Neutron-, X-ray Radiography, Vibration Diagnostics and Ultrasound) in the Inspection of Helicopter Rotor Blades

M. Balaskó¹, G. Endrőczy², Gy. Tarnai³, I. Veres⁴, Gy. Molnár⁴, E. Sváb⁵

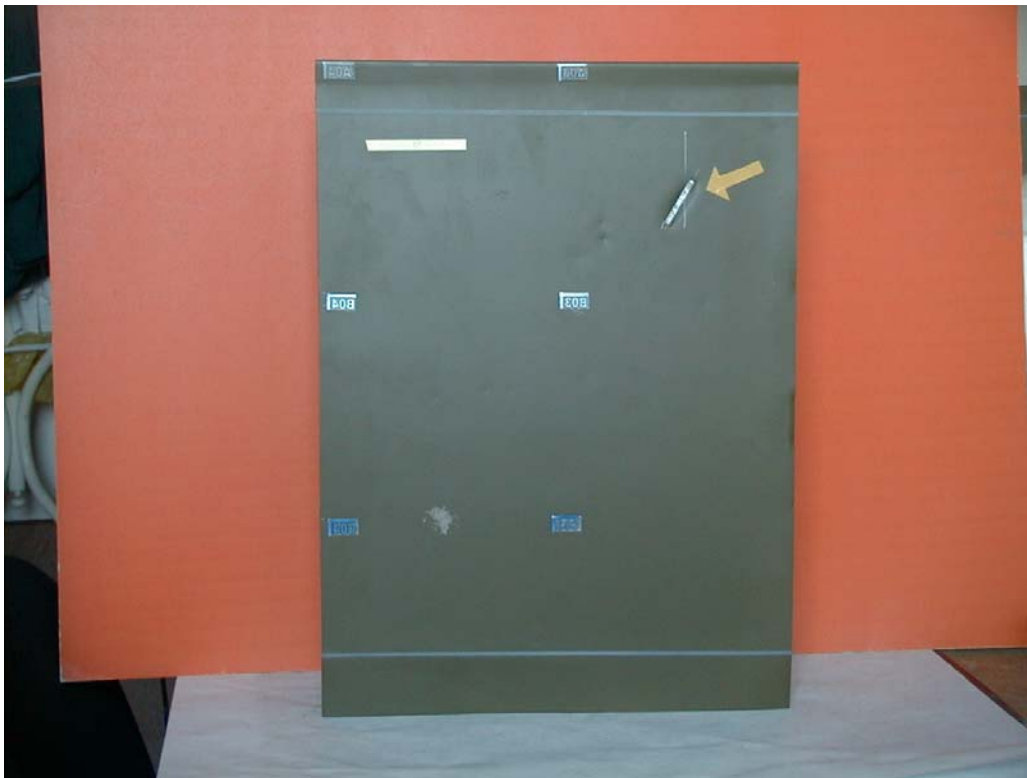
Figure 5: Metal inclusion (at the yellow arrow) in the reference object (original sector).

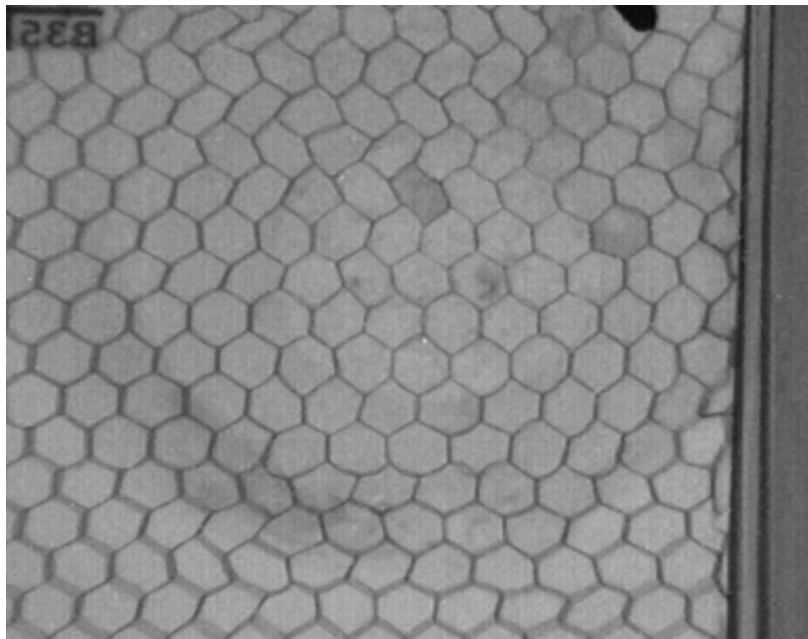
In this respect to monitor the result of the reparation in service seems to be prerequisite. Fig. 10 shows the repaired area of the honeycomb structure of the B35 exposed picture field. It is clear that the reparation surface and its inner structure can only be investigated by NR (Fig. 10/a), while that of metal inclusion by XR in Fig. 10/b. The whole repaired area, as determined by NR imaging, was measured to be 27770 mm².

Figure 10/b: XR picture B35 exposed picture field with the repair area. The resin rich area hardly see but the metal inclusion is visible on the right-up corner.

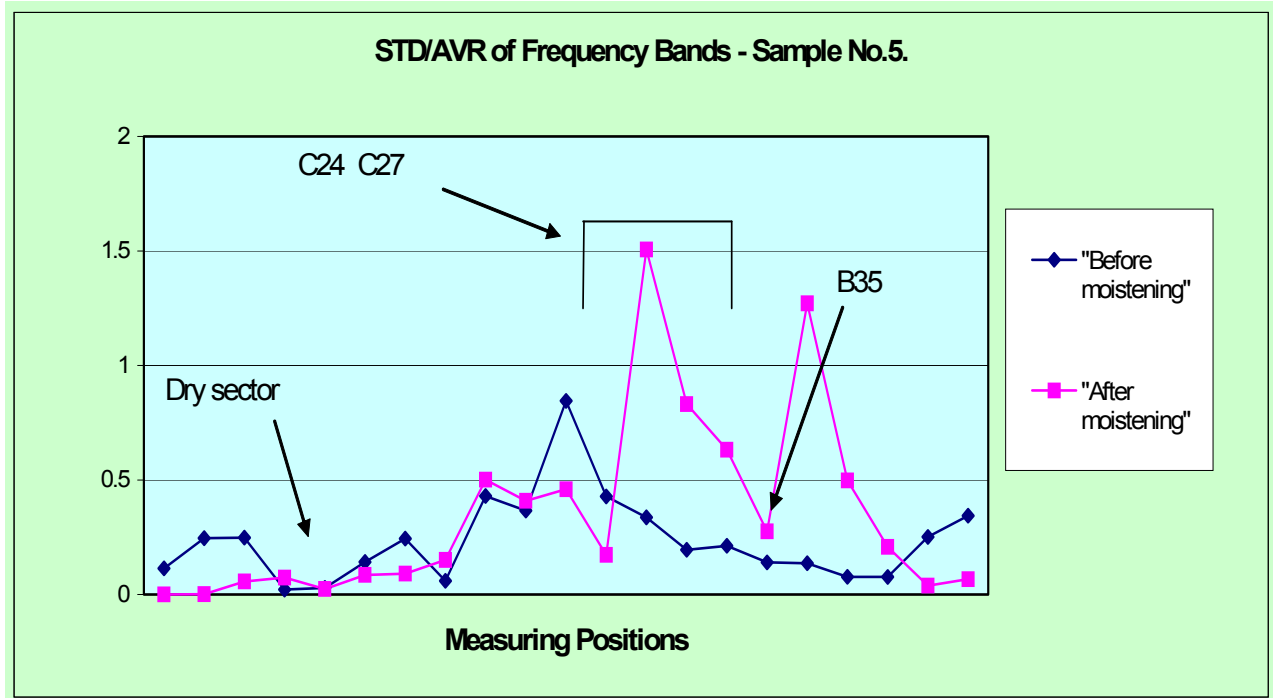
depending on the position of rotor blade. The STD is the standard deviation and the AVR is the average. The VD measurement is able to detect the rough errors in the rotor blade. Both the water percolation (C27) and place of the reparation (B35) are distinguishable.

Figure 11: The STD/AVR of frequency band depending on the position of the rotor blade.

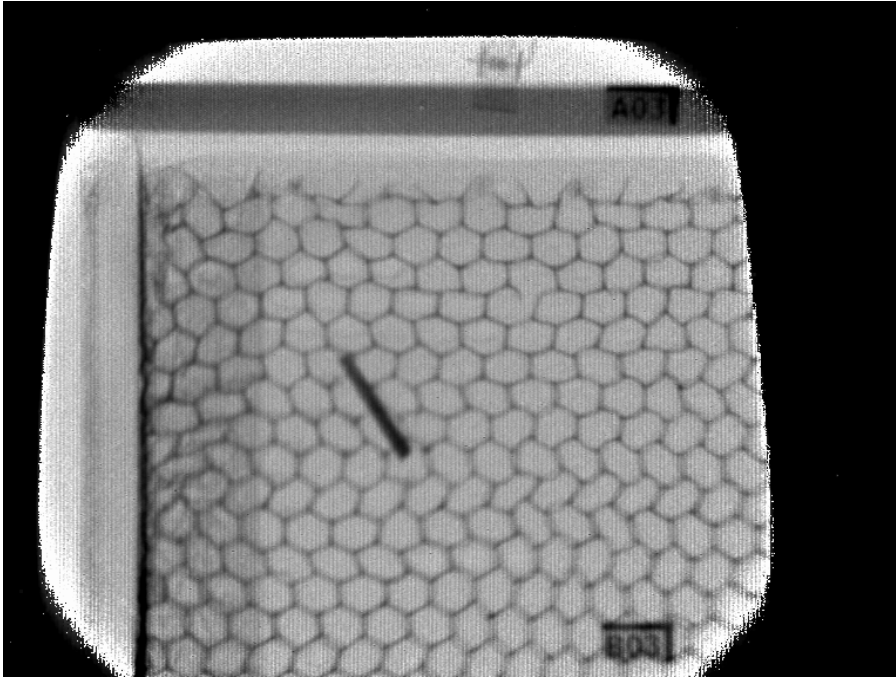
Figure12: NR picture of the A03 exposed picture field on the Reference-2 object with a metal inclusion in the middle of the field.

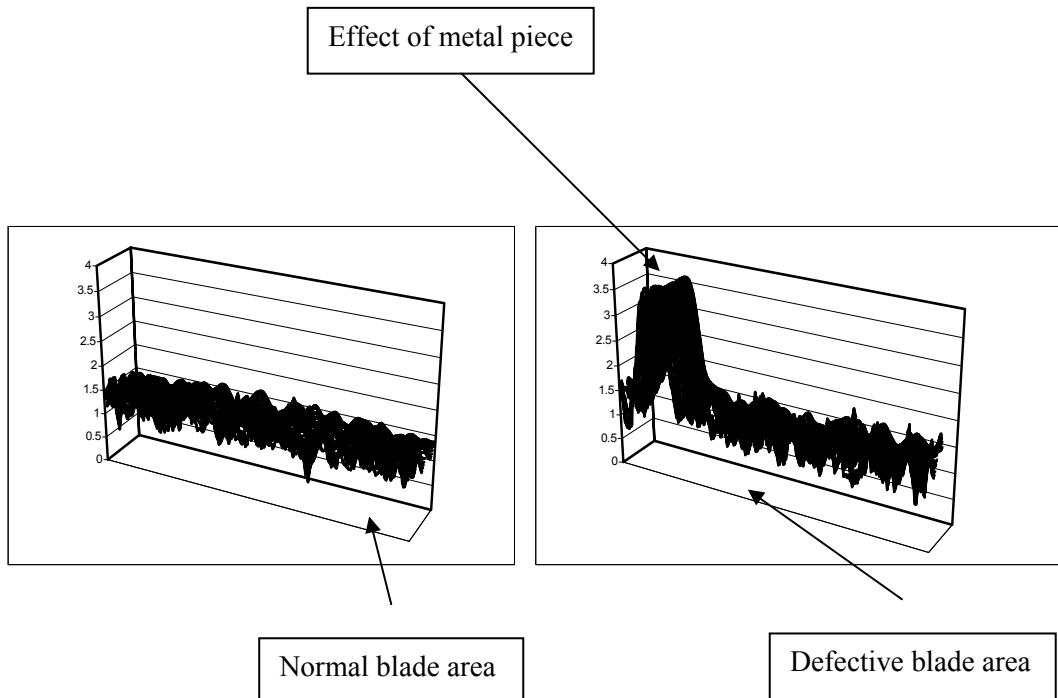
During the experiments of the defected Reference-2 object was scanned and analyzed in different frequency bands. Fig.13. shows the scanned vibration pattern of a defective blade part around 80kHz. The picture demonstrates that the small metal piece integrated in blade changes the local acoustical stiffness of the blade.

Figure13: Scanned acoustical pattern of metal piece defected blade.

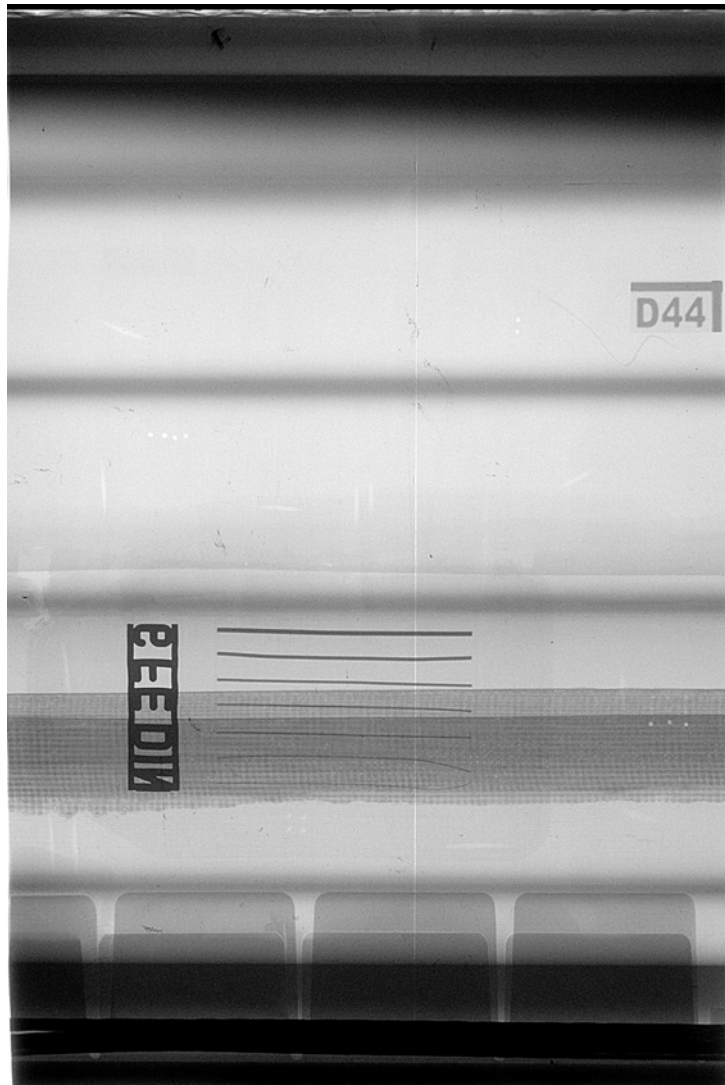
For the UT measurements a special object was produced (see Fig. 6.). Its XR picture (40 kV;2,5 mA) is shown in the Fig.14. It contains of some holes (diameter is 0,4mm) and some crack imitation (0,4 X 10 mm²) in the material of aluminum alloy spa with the 6FE type wire picture quality indicator on the D44 exposed picture field. In the tests to detect the cracks of main spar's section we used the principle of ultrasonic physics that the significant part of energy, using the appropriate inspection technology, rebounds in echo form from the cracks. The test would be successful when the echoes descending from the cracks simulation in sections, clearly, are detected and can be located.

Figure 14: XR picture of the special object (D44 exposed picture field) for UT measurement contains of holes and imitation of cracks with 6FE type picture quality indicator.
