Technical Findings, Lessons Learned, and Recommendations Resulting from the Helios Prototype Vehicle Mishap

ABSTRACT

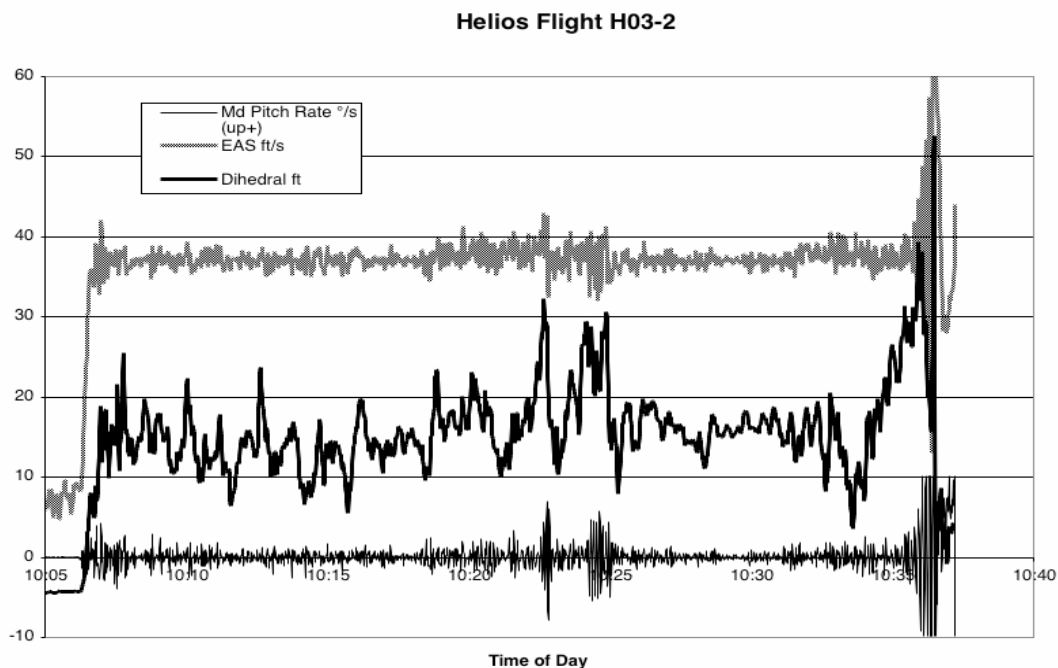
Figure 7: Wing dihedral, pitch rate, and airspeed history during mishap

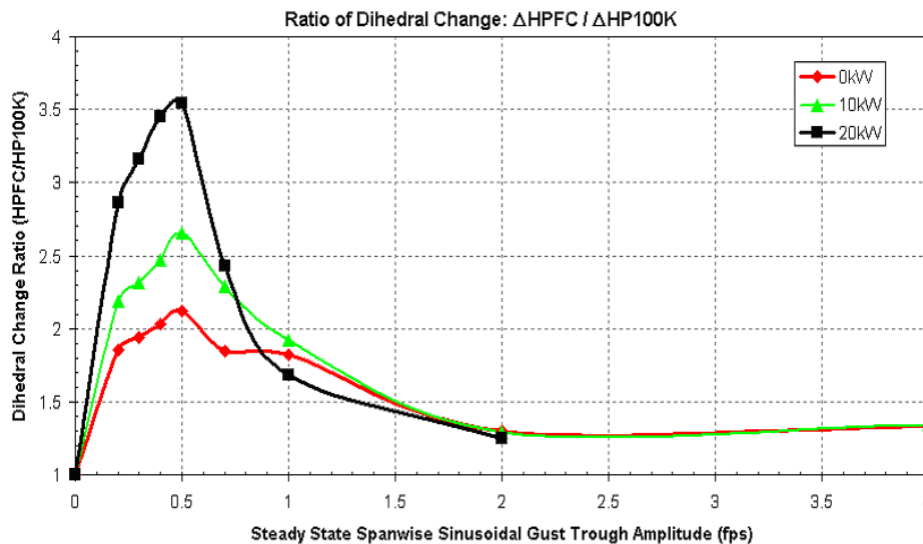
Turbulence Effects: In terms of the environmental effects, turbulence was determined to have initiated the high wing dihedral, however it was also determined the turbulence was not necessary to maintain it. Post mishap analysis revealed that spanwise lift redistribution (from the center of the aircraft to the outboard wing panels) was very sensitive to small amplitude gusts (Figure 10). It had been the experience of the Helios type aircraft that its dihedral varied as local airflow varied along the wingspan. Figure 11 provides a comparison of the wing spanwise lift distribution for the HP01 and HP03-2 aircraft configurations with a superimposed 0.5 ft/sec gust. For this study, it was assumed that the aircraft encountered a gust exhibiting a 0.5 ft/sec downward flow at the centerline and 0.5 ft/sec upward flow at the wing tips. Although the probability of the aircraft encountering such a gust is very low, the intent of the analysis was to show the sensitivity of the aircraft to gusts, even small gusts. The HP03-2 configuration has noticeably more lift outboard and less lift inboard. The increased lift outboard would be expected to lead to considerably increased dihedral. It is important to remember that the modeled sensitivity to local variations in sectional airflow is primarily a consequence of the aircraft's reactions to increasing dihedral, trailing edge up elevator, and wing tip leading edge twisting up, not the first-order effects of airflow change. The airflow variation is only the transitory force. It was determined that elevator response and the change in wing twist contributed to the wing's slow return to nominal dihedral conditions. In the absence of a gust that flattens the wing (for example, a momentary gust having relative downward air motion on the tips and upward near the airplane centerline), these aerodynamic effects slowed the return to nominal dihedral.

Figure 10: HP03-2 increased sensitivity to small gusts

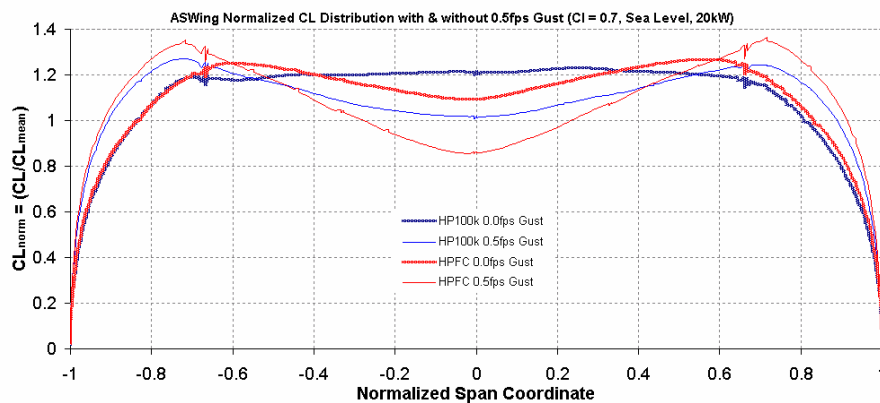
Figure 11: Variation of spanwise lift distribution with gust velocity
