Repair and Substantiation of the NH90 Sandwich Composite Bottom Shell

Airbus Helicopters Deutschland (AHD)
Industriestrasse 4
86609 Donauwörth
GERMANY

ABSTRACT

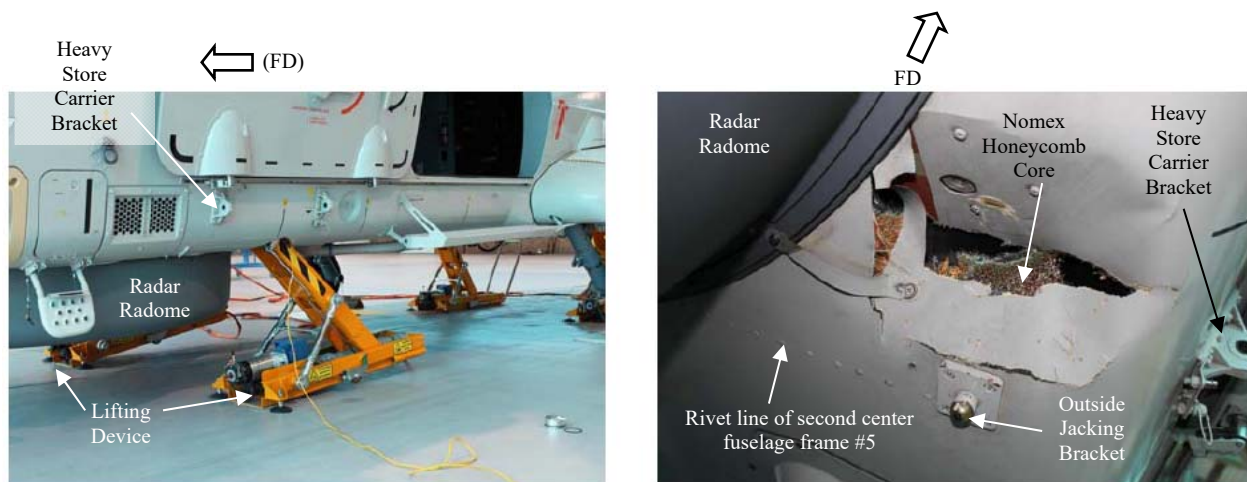
Figure 2-1: Damaged Bottom Shell Sandwich Composite Structure

As a result, the two front lifting devices slipped to the front and penetrated the CFRP sandwich composite structure of the bottom shell in the area of the front tank bladder in front of the second center fuselage frame #5.

Figure 2-1 (left hand side) shows the lifting device (orange) penetrating the bottom shell structure between the first and second center fuselage frames (frame #4 and frame #5).

Figure 2-1 (right hand side) shows the damaged composite structure on the left hand side after removal of the lifting device. Looking through the cracks, the ripped and broken Nomex honeycomb core of the sandwich composite structure can be seen.

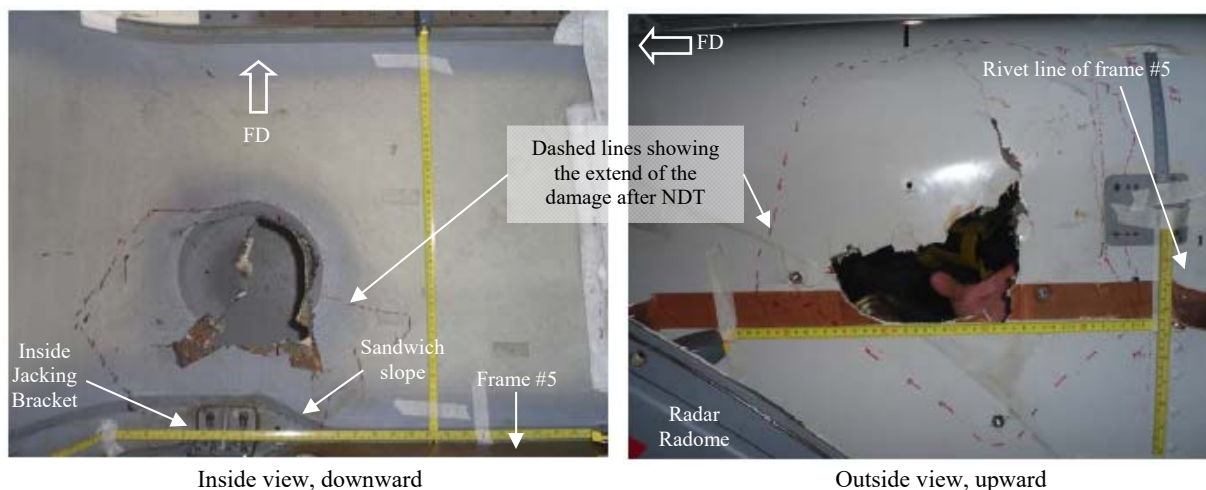
Figure 2-2: Damages on Bottom Shell (only left hand side shown)

The penetration of the jacking device caused cracks in the laminate parallel to the sandwich slope with further cracks reaching widely forward into the sandwich region. The bending inwards of the structure caused also a shear failure of the laminate at the sandwich slope directly in front of the jacking bracket which is installed in front of frame #5.

The extent of the damage on the bottom shell, after NDT was completed, is shown in Figure 2-2 by the dashed lines. The frame #5 showed no defects.

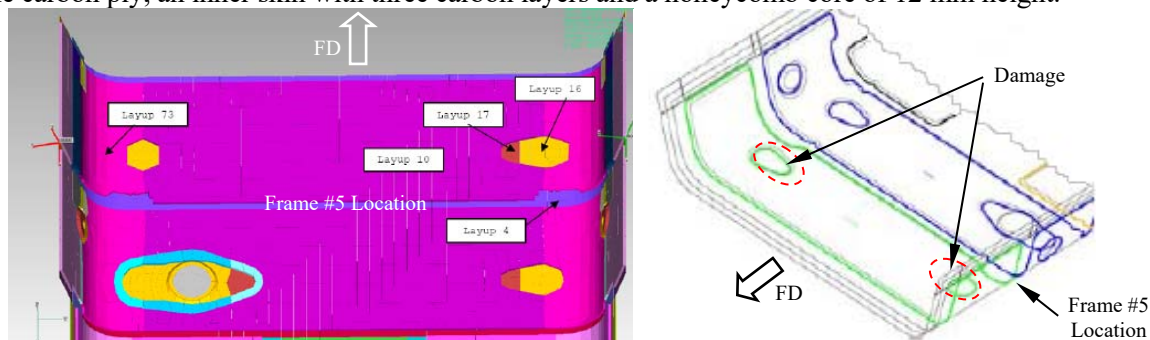
Figure 4-1: Design Environment

Figure 4-1 shows on the left hand side a finite element model (FEM) plot of the front bottom shell where the different properties are shown in different colours. The mainly affected properties are sandwich layup no. 10&73 and laminate layup no. 16&17. The illustration on the right hand side gives the borders of the sandwich areas in the front bottom shell with the damaged areas marked in red.
