# Interpretation of Complex Fatigue Fractures in the Defence Aerospace Industry Using Quantitative Fractography Techniques

**Tamara P Chapman, Edward A Saunders**

Rolls-Royce plc., Failure Investigation, Defence Aerospace Operations Facility, Bristol, BS34 7QE  
UNITED KINGDOM

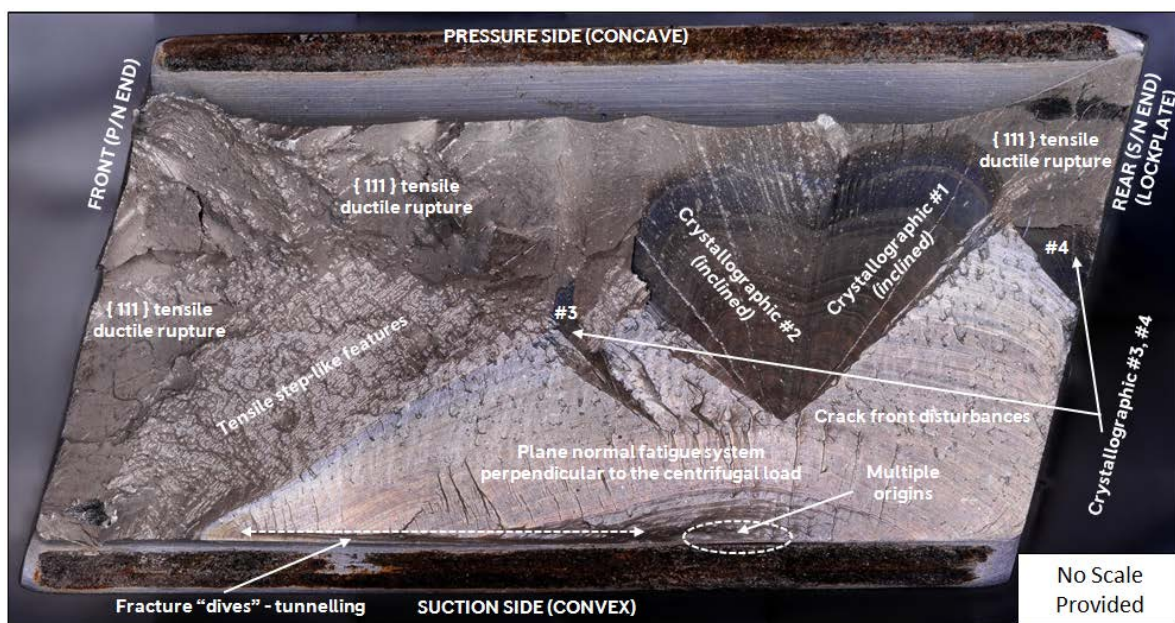
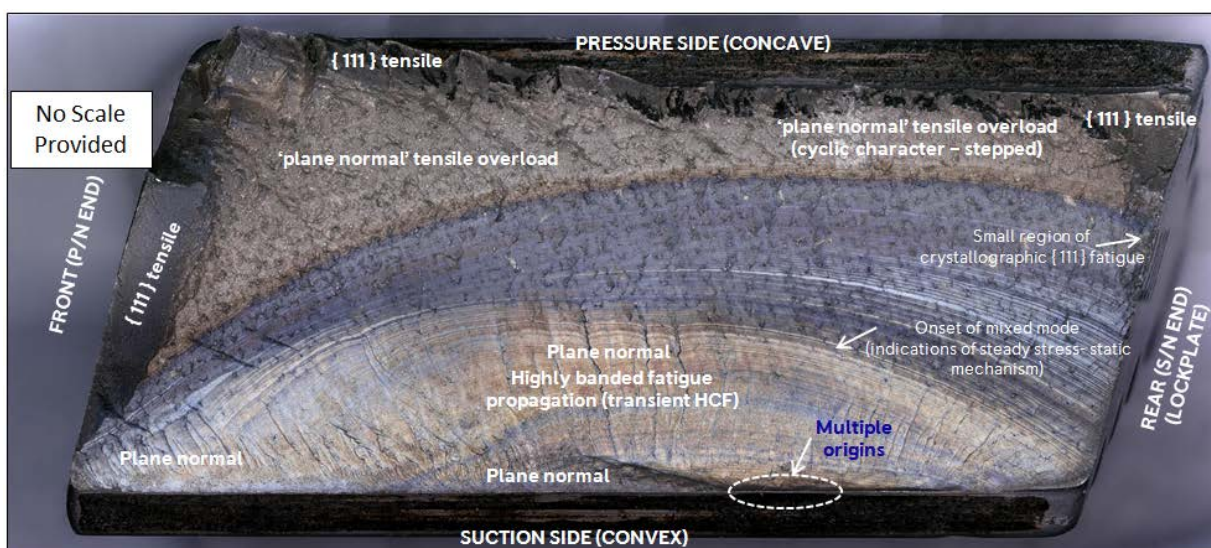
In recent years there were three similar significant events involving the same military aircraft from two different operators. The events were ultimately shown to have resulted from a single turbine blade release in each case. These turbine blades had a root with a firtree form and were manufactured from a single crystal nickel alloy, SRR99. In all cases the blades had failed between the two outermost serrations, below the platform. Fracture of the released blades was due to fatigue development, specifically via a transient HCF mechanism. A characteristic array of macro and micro banding was therefore observed on the fracture surfaces (Figure 3).

Figure 3 – Two examples showing the colour banding on the released blade fracture surfaces

The fatigue cracks had propagated via passage through certain engine speeds at which particular vibration modes were excited. Although the LCF contribution provided a significant proportion of the overall stress intensity range ( $\Delta K$ ), it was the HCF stress intensity range ( $\Delta K_{HCF}$ ) that was driving crack growth by local progression at the crack tip by providing an increase to the  $0-K_{max}$  cycle to drive the crack forward.

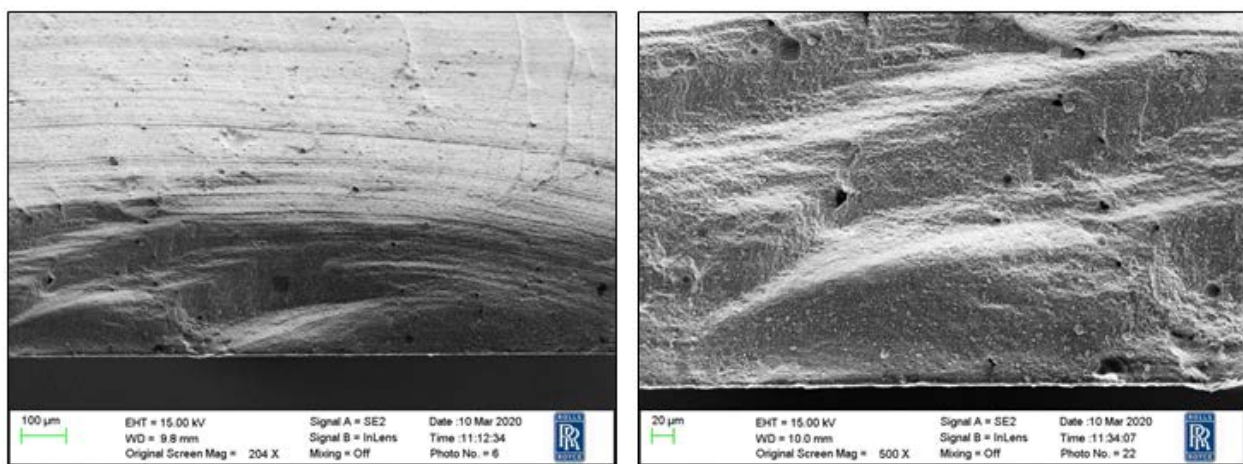
In all three cases the macroscopic crack trajectory of the primary failed blades was across the blade root to failure, i.e. perpendicular to the blades' principle stress axis. In each event, several other blades were also observed to contain one or more cracks in the firtree serrations. However, in the vast majority of cases the macroscopic crack trajectory of these cracked blades was inboard down through the serration lobe, i.e. approximately parallel to the principle stress axis (and opposite to the centrifugal load). Even if these cracks had grown to failure only minor material loss to serration tips would have occurred. Microscopically, the released blade fracture surfaces showed evidence of an alternating crack trajectory. The crack trajectory was observed to alternate in a step-like manner between perpendicular and parallel to the principle stress axis of the blade (Figure 4).

Figure 4 – Crack trajectory alternating in a step-like manner

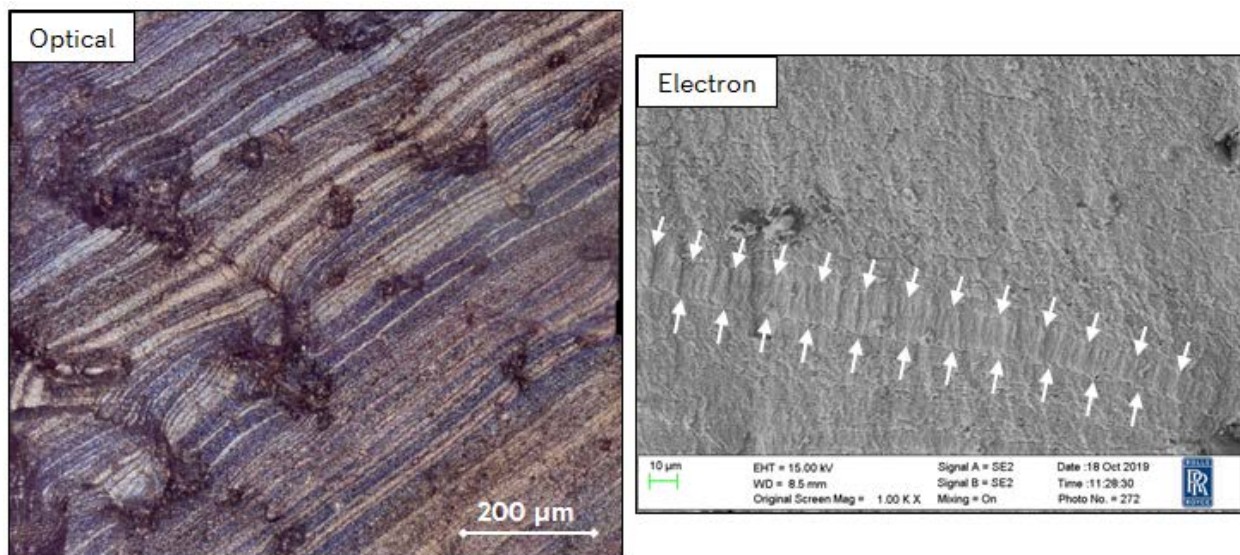
1. Type 1 – generally dark purple/ dark blue in colour1 (optical), lighter delineated appearance (electron): delineations lie ~perpendicular to crack growth direction (Figure 5)
2. Type 2 – generally white/yellow/light blue in colour2 (optical), darker ratcheted appearance (electron): ratchet lines lie in a direction ~parallel to crack growth direction (Figure 5)

Figure 5 – Type 1 and type 2 fractography

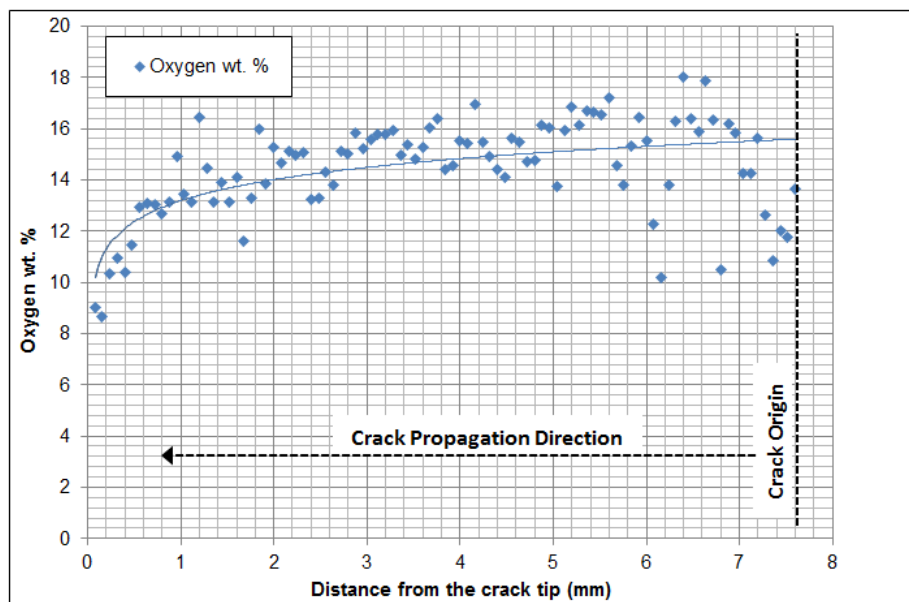
Figure 6 was generated following oxygen profiling across a single crack path on the fracture surface. The oxygen profile showed a fairly consistent plateau region from the origin until ~1mm from the crack tip; average oxygen content in the plateau region was ~15 wt. %. Oxide growth rates are generally logarithmic and will plateau after long durations at temperature, thus the inference of the nominally consistent oxygen

content in a plateau region over the majority of the fracture surface, showed that it had spent a considerable time at the ambient engine running. For instance, it indicated that the crack did not grow so rapidly such that only the early part of the crack was exposed to the environment long enough to develop any significant oxide layer. With reference to (Hernandez, Saunders and Madariaga, 2018) it was possible to gauge a rough order of magnitude age for the primary blade crack. It should be noted that the data provided in (Hernandez, Saunders and Madariaga, 2018) is for an iron containing nickel alloy, which was exposed as open tensile fracture surfaces to temperatures of 700-750°C and at one atmosphere. At these conditions the logarithmic trend of the data indicated 15 wt. % oxygen would be measured after ~500 hours at temperature. Recognising that the difference in alloy composition and exposure temperature of the gauge data would promote increased oxidation compared with this single crystal turbine blade material at ~550°C, there was considered to be sufficient inference to suggest that the primary failed blade crack had been growing in the order of hundreds of hours. This data therefore further substantiated the band counting findings and also corroborating the idea that the L2 bands were very likely to relate to flights.

Figure 6 – Oxygen profile demonstrating oxygen content with distance from the crack tip at 15kV

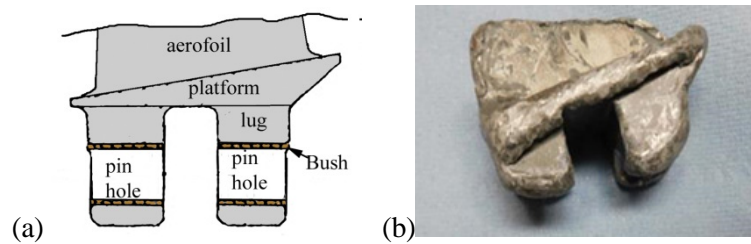
Recently, there have been two military aircraft accidents that were ultimately shown to have resulted from a compressor blade release, from the same aircraft type. These blades are the kind that include bushed pin hole fixings in the root with two lugs (front and rear), as depicted by the schematic in Figure 7. The blades are fitted to the disc via pins located between the disc and blade fixings. The blade release was due to fatigue development that had initiated from the pinhole bore occurred at the 3-9 o'clock line of the rear lug. The blades were manufactured from aluminium alloy 2618a (RR58).

Figure 7 – (a) Schematic representation of the compressor blade root fixing form, not to scale; (b) Shows processed portion of blade root following release (*no scale provided*)

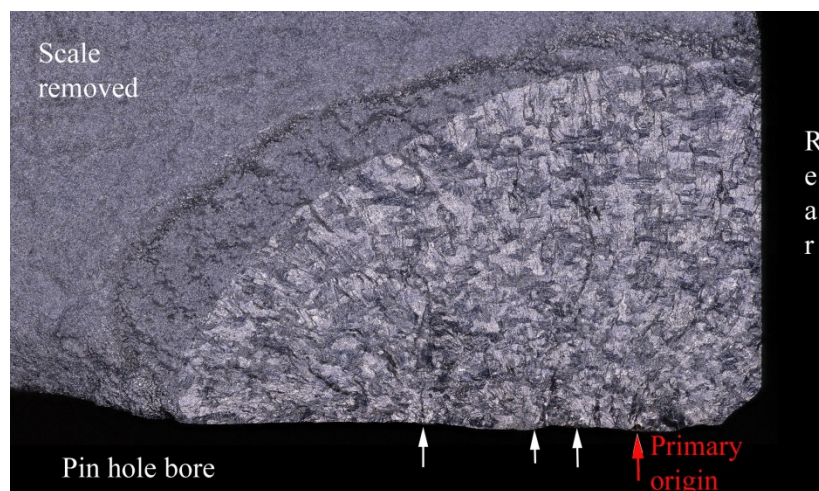
Since these incidents, a few other blades from other engines were identified with cracking at the same location in the rear lug pinhole. These were from the same engine type with two different operators. In each case of blade release and cracking, fatigue initiation had occurred at a position close to the rear lug rear face around the 3 o'clock position (viewed from the rear). One typical opened fatigue crack surface is as shown in Figure 8.

Figure 8 – Showing a typical opened fatigue crack surface. Fatigue origins are arrowed, with the primary in red. The origins are also co-located with dark spots of transferred copper material on the pin hole bore, with migrated copper locally on the open crack surface

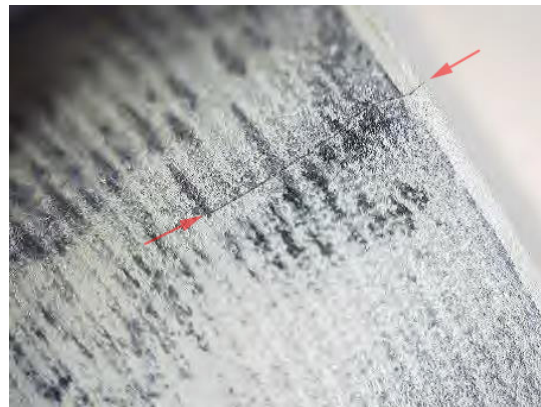
A number of metallurgical and stress factors, co-located at the primary origin locations, were assessed to be the underlying cause for fatigue initiation. Metallurgically, these included fretting and metal transfer (copper) between the inserted aluminium bronze bush and pin hole. These appeared as a series of dark spots on the pinhole surface, aligned with original machining lines with higher than drawing tolerance surface roughness (Figure 9). Fretting was consequential of a combination of vibrational resonances and an undersized interference fit between bush and pin, allowing more freedom of movement than normal.

Figure 9 – (a) Showing dark spots from fretting and metal transfer from the bush on the pin hole surface, following bush removal – aligned with original machining lines. The crack is identified between the two red arrows, and runs at the apex of the dark spots. After crack opening, these were shown to be co-incident with fatigue origins

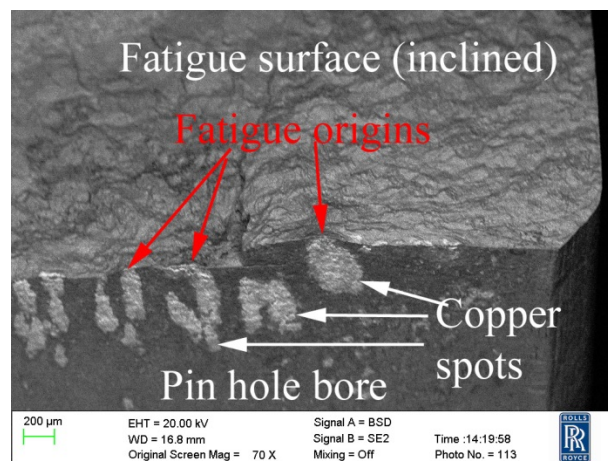
Fatigue initiated at the apex of a number of these spots, which were positions of balancing tensile stress; Figure 10. There was also evidence local overheating and consequent effect to the immediate underlying parent material; Figure 11. The material structure of the blades was otherwise metallurgically satisfactory.

Figure 10 – Backscattered electron image of one of the opened cracks (different from figure 8 and 9) showing fatigue initiation occurring at the apex of transferred copper material from the bush. The image is inclined at ~45° to show both pin hole and open crack surfaces. In electron backscatter imagery the copper appears light against the darker aluminium alloy background.

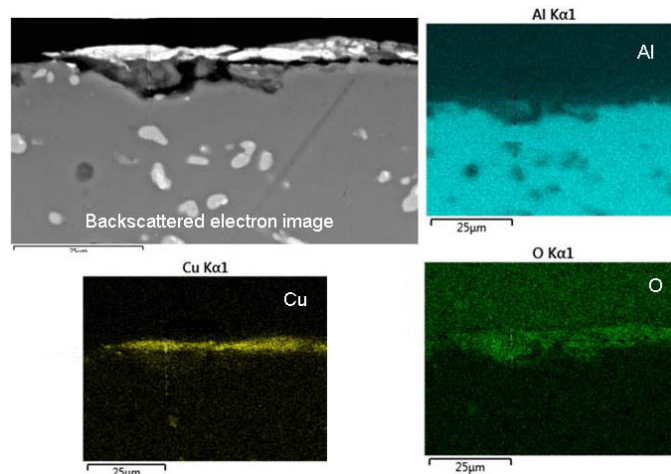
**Figure 11 – Section through dark spot at a fatigue origin at the pin hole, observed in backscattered electron and equivalent EDX x-ray maps for aluminium (Al), copper (Cu) and oxygen (O). The copper material transferred from the bush can be seen, and a slight overheated zone beneath (mapped in oxygen), effecting the underlying parent material**

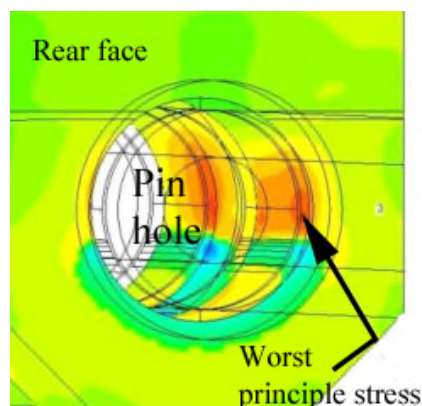
Finite element stress analysis, with interrogation of former strain gauge testing, identified a predicted critical location due to a combined peak LCF (worst principal) stress (Figure 12) and peak alternating (vibratory/ resonance) stress. The primary fatigue origins were situated very close to this location. Under certain flight conditions, 2-off chief resonant modes can be excited over a particular, high, compressor spool speed.

**Figure 12 – Showing worst principle stress from finite element model on zoomed in area around pin hole showing peak at ~3 o'clock position (scaling/values removed)**

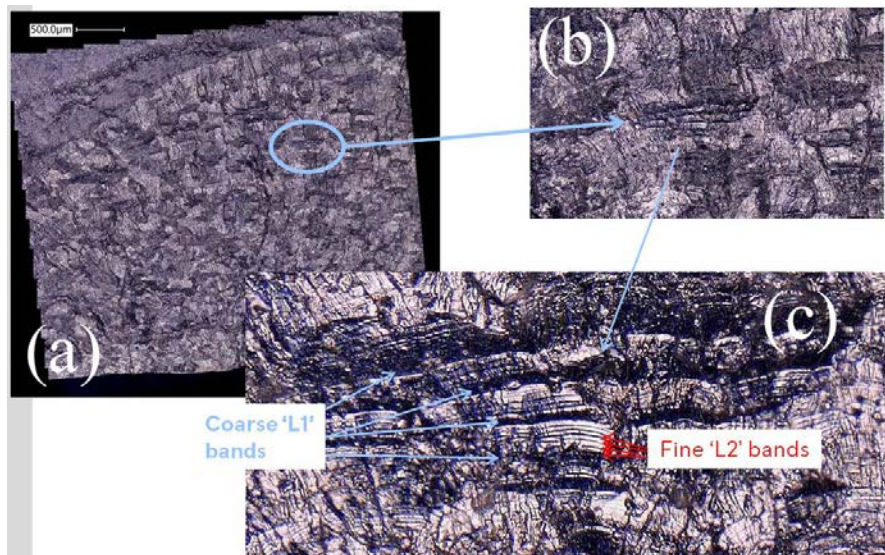
The fracture surfaces were characterised by banding at three different magnification ranges or levels (L1, L2, L3). Due to variant band width, the fatigue propagates locally at the crack tip under transient HCF, whilst the bands act as event markers indicating the underlying flights, minor LCF cycles and throttle movements. Examples of the banding may be seen in Figure 13 and 14.

Figure 13 – Optical images of one of the opened fracture surfaces to show the banding observed at an optical level. (a) Shows a segment of an overall opened crack surface where some L1 bands may be seen with close scrutiny (example ringed in blue); (b) Shows the L1 bands more clearly, and (c) shows an example area of L2 bands seen within the L1 bands with increased magnification

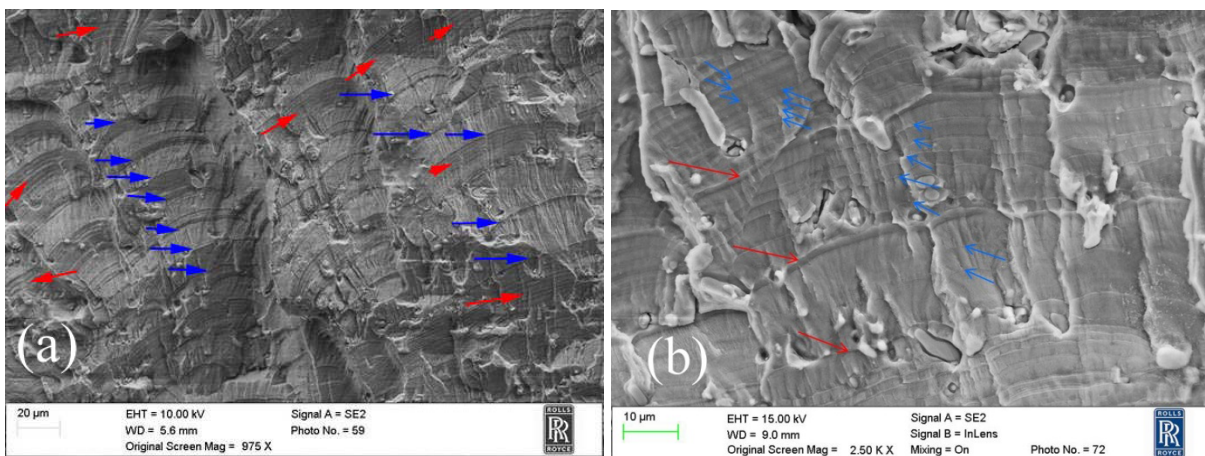
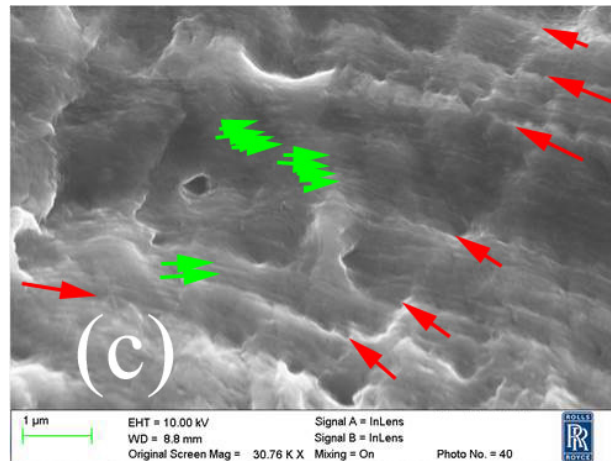
Band counting was performed at each of the three different levels. This was done both optically (L1 and L2) and in the SEM (L2 and L3) through assessment of average spacings at a number of crack depths across the full fatigue system surface then integrating to give a total. The typical ratios between those numbers (e.g. number of L2's per L1) were also calculated. Figure 14 shows examples of L2 within L1, and L3 within L2 bands as viewed in electron optics.

**Figure 14 – Secondary electron images of typical examples of the banding: (a) Shows a low magnification image of L1 bands, examples of which are arrowed blue with example groups of L2 bands arrowed red; (b) Example area of L2 bands (arrowed blue) within L1 bands (arrowed red), and (c) higher magnification image of fine L3 bands (examples arrowed green) within L2 bands (arrowed red)**

Fracture mechanics analysis, using only LCF loadings (inclusive of minor cycles), found the predicted growth rate to be much slower than that suggested by the band counting work. However, when HCF cycles were supplemented into the calculations the modelled growth rates were much more comparable. This supported the mechanistic understanding developed from the fractography of a transient HCF/ combined cycle fatigue system where the L1 bands were established as flights. Hence, an estimated crack growth rate for these cracks was obtained, and thereby a suitable inspection interval has been put in place through off-wing and on-wing NDE inspections, which allows the aircraft to operate safely going forward.
