Implementation of a New Inlet Protection System into HEMS¹ Fleet

EC-135P2+ helicopters operated by the LPR are highly exposed to environmental particles entering the engine during HEMS missions. The organisation adopted a comprehensive set of measures to predict and limit the impact of dust ingestion including gas path analysis, health and usage monitoring, and visual inspections. Finally, helicopters had modified inlets to install air filtration system which minimises the number of particles ingested by the engine. CFD simulation has been performed to check whether the upgrade has an impact on helicopter aerodynamics. The consequence of using filters is to extend the lifetime of engines, reduce operating costs and the number of maintenance tasks.

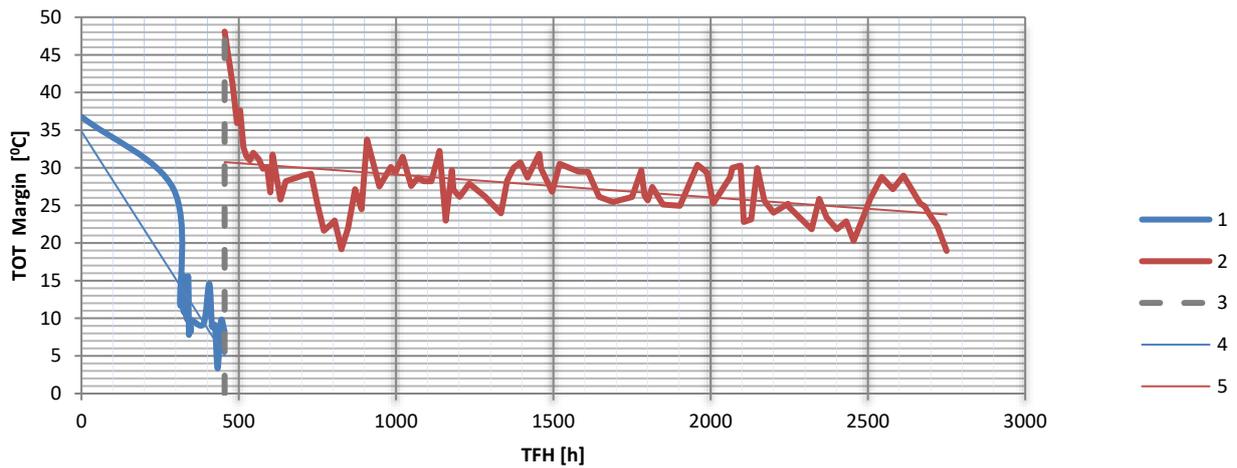
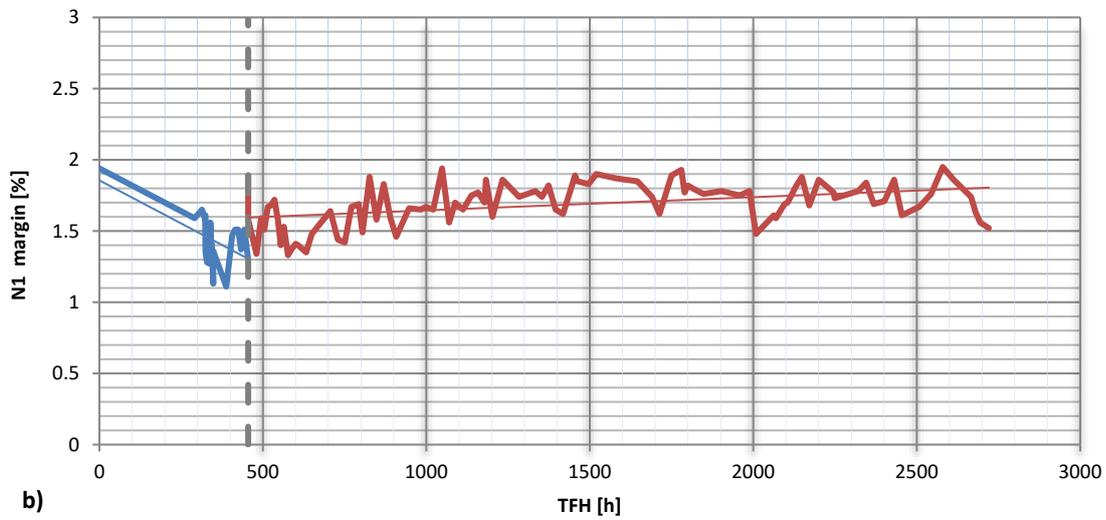
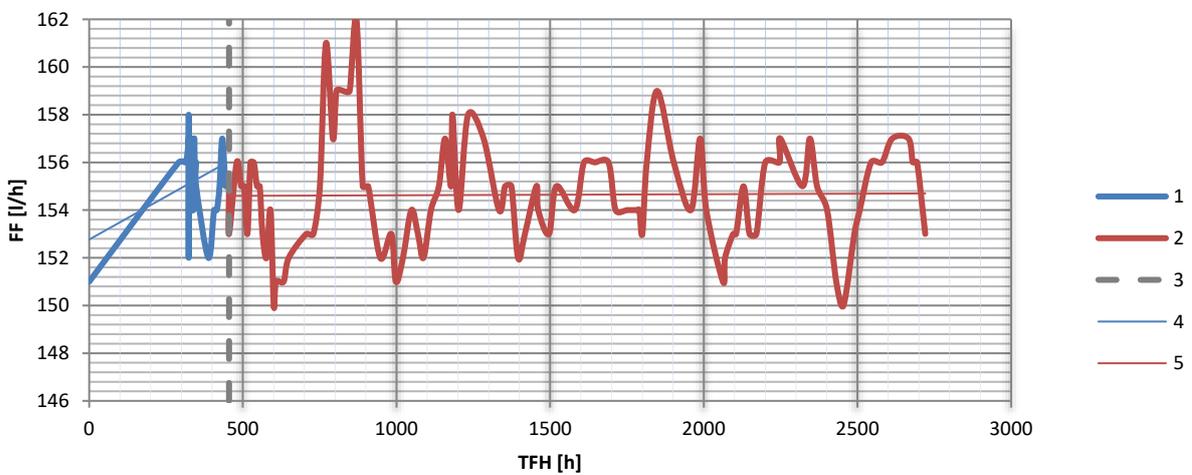
Figure 5. TOT margin, N1 margin and fuel flow FF as the function of flight hours TFH: 1- before the overhaul and IBF installation, 2 - after the overhaul, 3 – time of the overhaul, 4,5 - trend lines

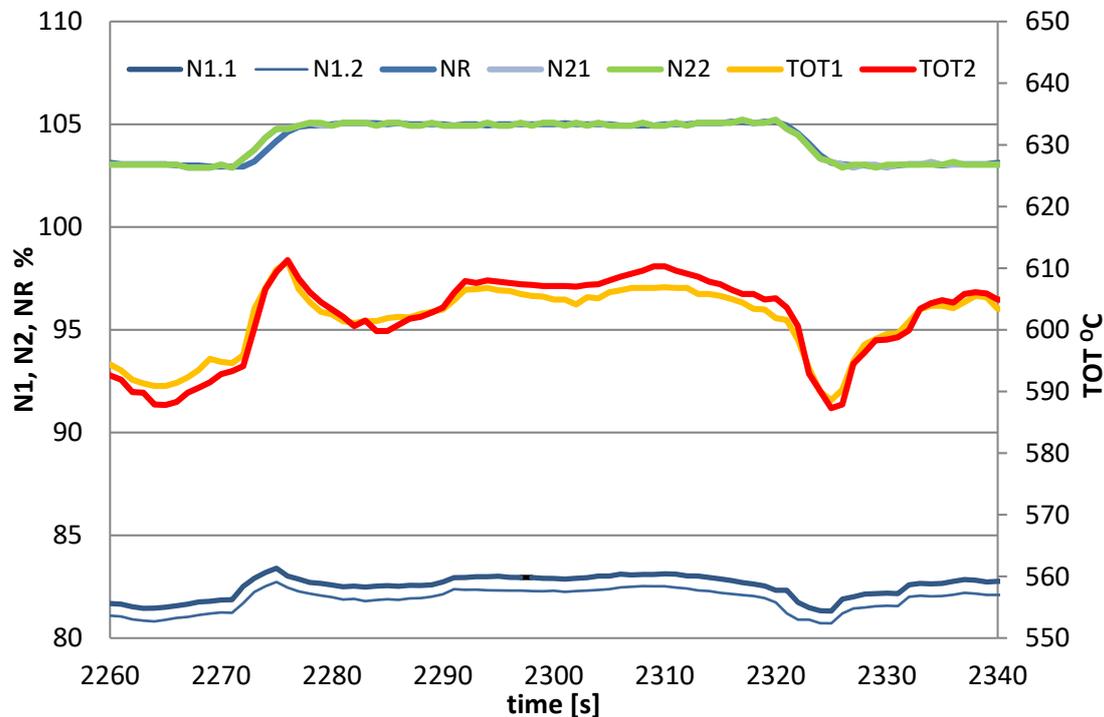
Figure 6. Results of a GPC; N2 threshold exceeded for both engines: N2 > 104°C

Knowing the parameter values and the duration period of the potential exceedance it can be determined whether it is necessary to conduct additional maintenance works as, e.g. the inspection of the main rotor blades or, e.g. engine replacement due to exceeding the N2 threshold. The manufacturers in helicopter maintenance manual (AMM) [8] and engine maintenance manual (EMM) [25] defined the allowable values of parameters, what and when shall be done in case of an exceedance. For example, if N2 speed has gone above the threshold of 104%, it is not always associated with the engine replacement. In such a case, data are sent directly to the engine manufacturer and they, based on their models, decide whether the engine can be operated further or should be overhauled.

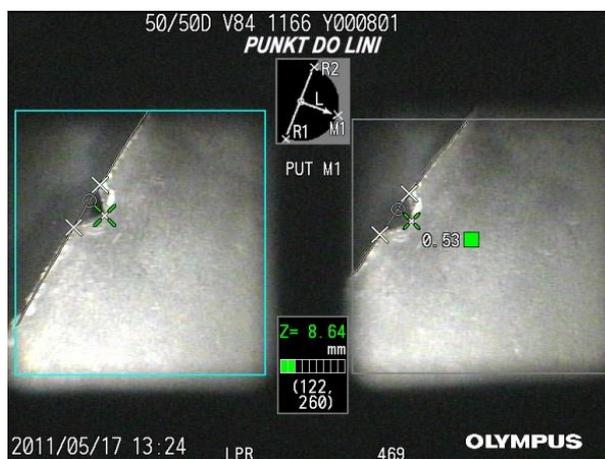
The visual inspection of the gas path consists in inserting the borescope through the engine inlet, checking the compressor impeller, measurement of potential failures (figure 7) and the comparison of results with permissible values defined by the manufacturer.

Figure 7. Flaw in the compressor aerofoil measured with the use of a calibrated borescope (photo J. Haliniak)

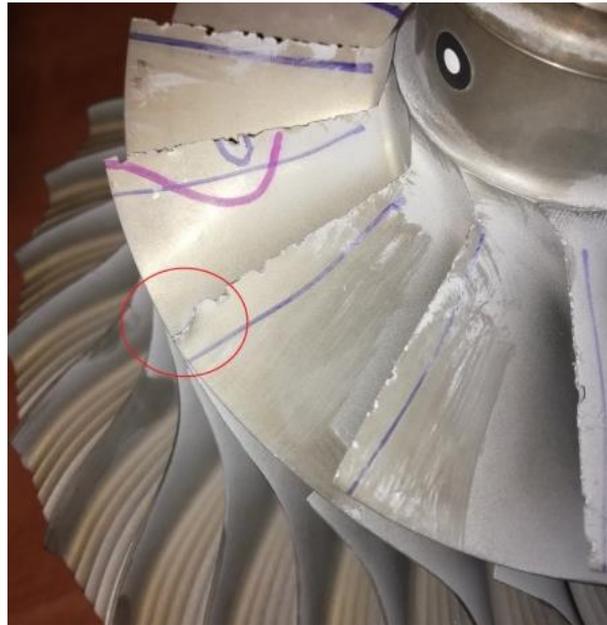
In the case of the lack of inlet protection or high exposure to environmental factors, various types of FOD as well as the erosion of the compressor impeller, inlet guide vanes, diffuser behind the compressor and some aircraft structures are observed. The most common failures of the compressor observed in engines operated by LPR include:

Figure 8. Nicks in compressor aerofoils (photo B. Przybyła).

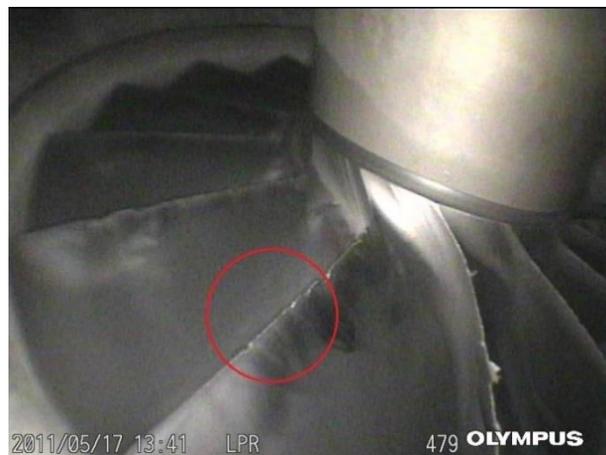
Figure 9. Dents of a compressor aerofoil (photo J. Haliniak).

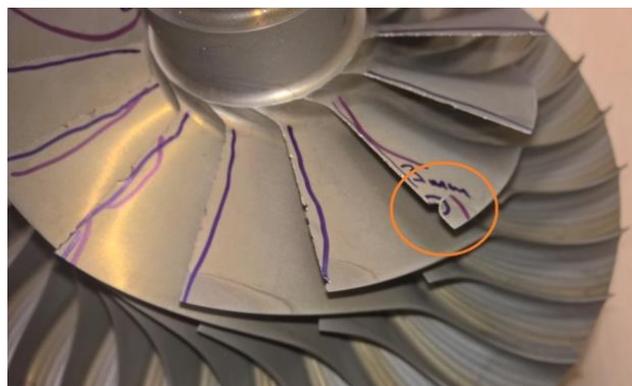
Figure 10. Tears of a compressor aerofoil (photo B. Przybyła)

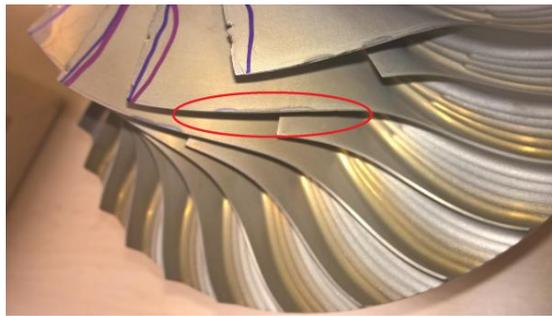
Figure 11. Erosion wear of the edges of the impeller (photo B.Przybyla)

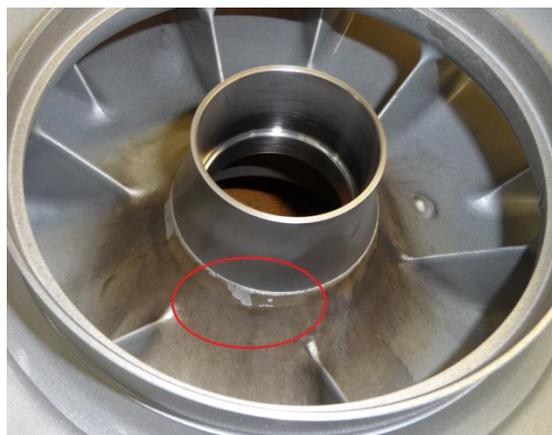
Figure 12. Erosion of the compressor stator (photo P. Rutkowski)

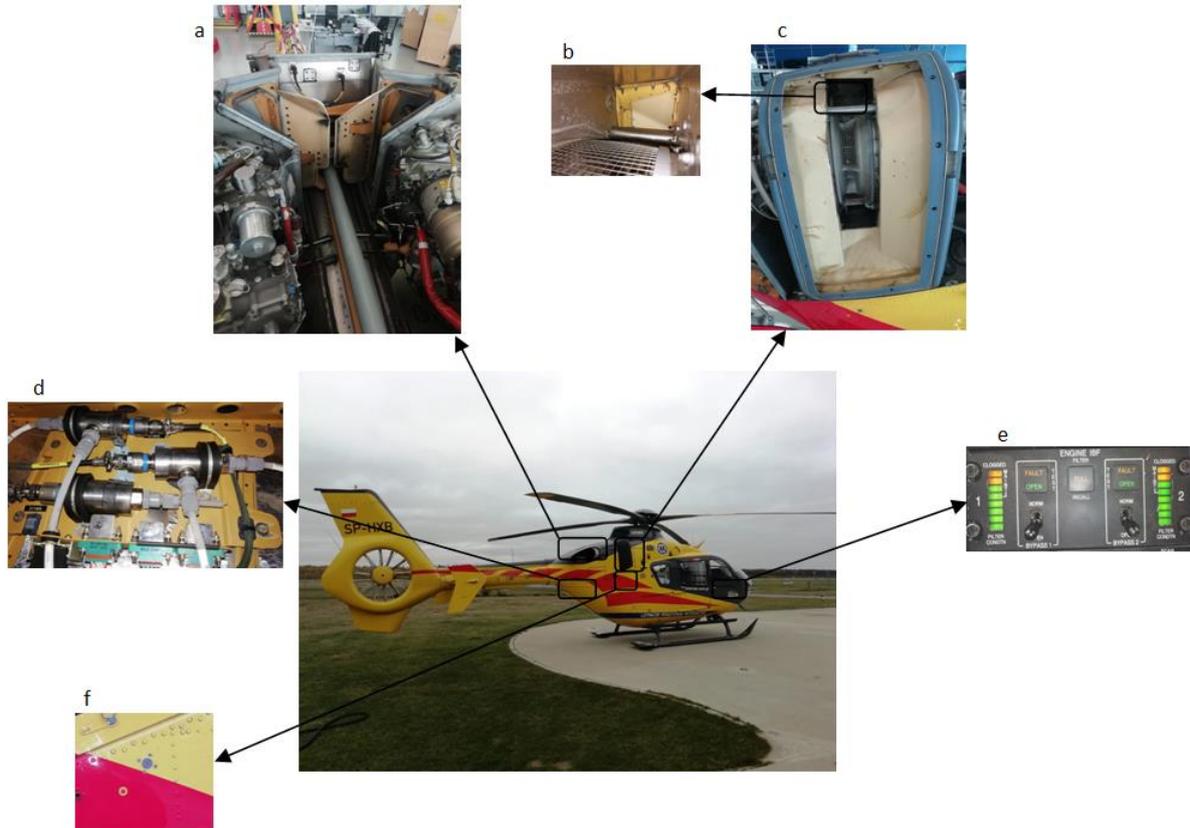
Figure 16. AHD IBF system installed on EC135: a) bypass door, b) internal port of static pressure c) intake - filter box, d) differential pressure sensor, e) IBF control panel, f) external port of static pressure

In the years 2013-2014, LPR equipped all 23 operated EC-135P2+ helicopters with the AHD IBF system. The air filtration minimises the possibility of foreign particles being ingested into the engine. The overall weight of the installed system amounts to 26.5 kg [1]. Its implementation involved substantial modification of the airframe related to the reconstruction of the inlet system (figure 16).

The new side inlets c) created for both engines replaced the existing central inlet which has been dedicated for emergency use only since then. Currently, it hosts bypasses a), which open automatically in the event of excessive accumulation of particles in the filter. In the cockpit, the IBF control panel (e) is installed. Static pressure ports inside the engine inlet (b) and on the fuselage (f) transfer the signal to the IBF control panel through the appropriate differential pressure sensor (d). There, the signals are compared with each other, processed by the computer and depending on the degree of filter clogging; the information is displayed in the form of switching diodes (figure 17). The control panel (figure 17) consists of:
