Structural Out-of-Autoclave Repair of Aircraft Fuselages via Adhesive Bonding

Dr. Patryk Burka, Frank Fischbach

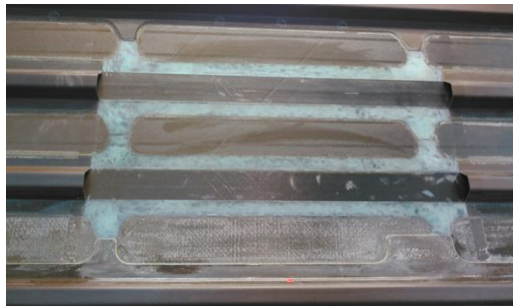
The area that was cut out from the panel to demonstrate a penetration was sized 120 mm in circumferential and 150 mm in flight direction. To be able to conduct the repair two stringers had to be removed from the panel's inside surface which is conducted by cutting out and manual grinding. The grinding operation is conducted until reaching the bond line which is shown in Figure 3-2.

Figure 3-2. Inside of a fuselage side shell showing the partly removed stringers.

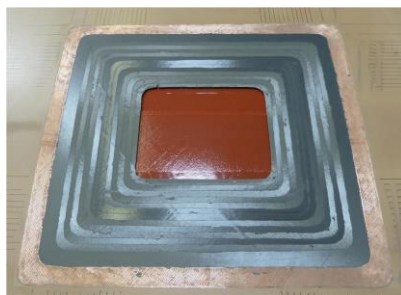
Figure 3-4. Penetrated fuselage structure with prepared bonding surface and mounting area before repair process.

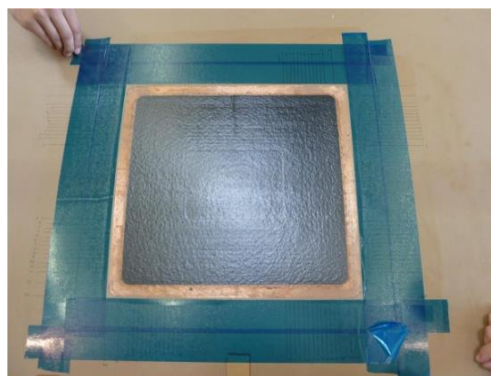
A photograph of the cured repair patch laid up on the penetrated fuselage substrate is illustrated in Figure 3-6. The patch is visible in the middle, the edges around it showing the lightning strike protection.

Figure 3-6. Fully laid up repair patch on fuselage structure.

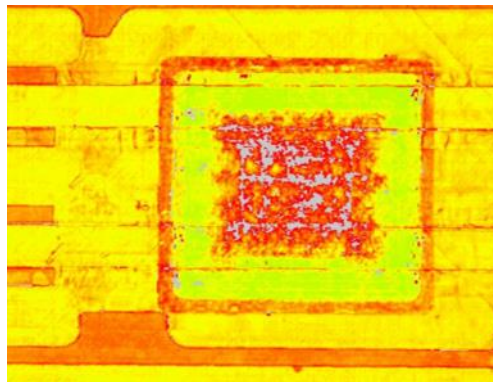
Figure 3-7. C-scan of repair patch on perforated fuselage structure showing some quality issues in the middle of the repair area.

The C-scan illustrates the amplitude drop after being reflected from the back wall and compared to a reference limit. Subtracting a defined allowed drop results in a C-picture that displays all weakenings below that limit in grey colour. This is evident in some areas of the shear repair patch. The area where the repair patch overlaps the substrate as well as the shear substrate area show no grey areas and thus can be interpreted as intact. The repair patch, however, might include some porous parts. To validate this assumption, microcuts of these parts and microscopic analysis must be conducted, which is planned for the future, after mechanical testings have been performed. A second explanation is that the reference amplitude level which was applied is not suitable for the shear repair material. This may result from the material, although being a repair prepreg, not being cured under elevated pressure and therefore not being as compacted as a comparable prepreg that was autoclave-cured. Further investigations must be performed to understand whether a new reference amplitude level may be required.
