## **AVT-339 Research Workshop on Robotics and laser/plasma – paint interaction in paint removal**

# **Nd:YAG laser de-painting and its effects on military aircraft surfaces**

**Henning Baron  
Airbus Defence and Space GmbH  
Germany**

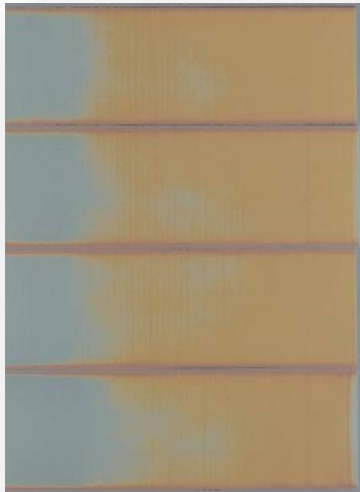
2 overruns:

PUR top-coat with areas of EP primer coming through

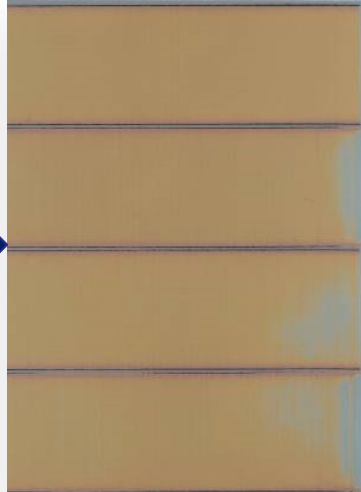
3 overruns:

EP primer with residues of PUR top-coat

- 50 µm of PUR top-coat is mostly removed after 3 de-painting overruns.
- 25 µm of epoxy primer are still intact after the same energy intake.

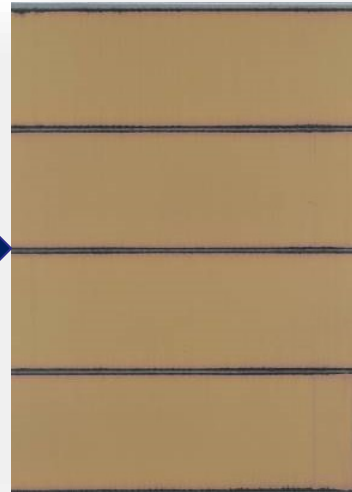
4 overruns:

EP-primer, edges show fully de-painted substrate

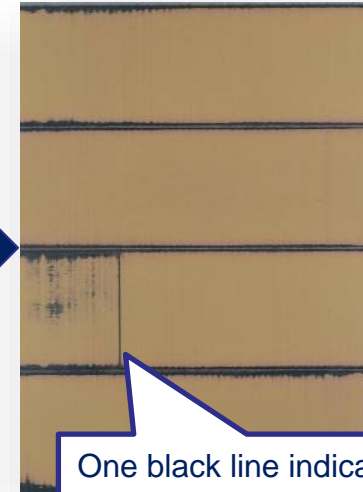
5 overruns:

One black line indicates full de-painting, which caused aborting of de-painting procedure.

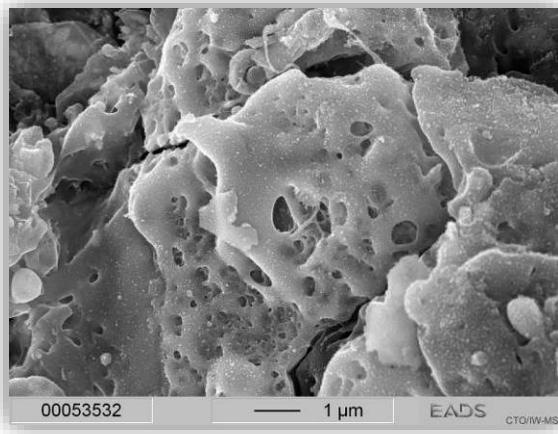
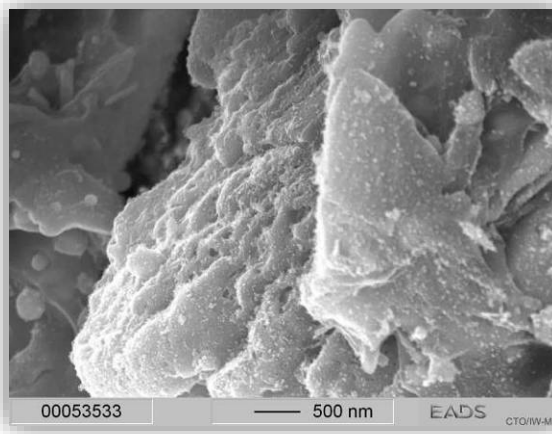
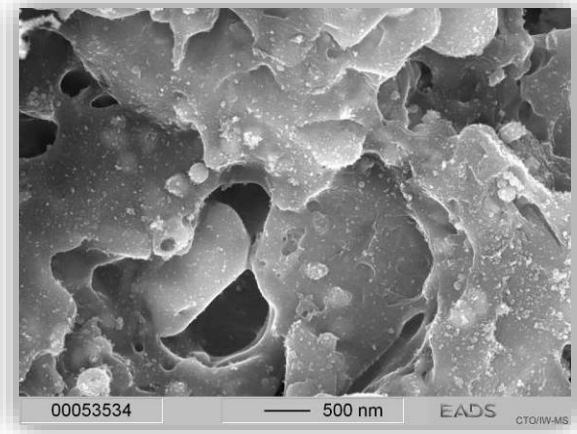
- The examined CFRP specimen shows a very rough surface, some parts of which apparently being molten.

- Laser-treatment generates a very rough CFRP surface with partly molten areas.
- Laser-treatment destroys anodic films and generates a dense oxide layer of 10 to 100 nm in thickness on Al surfaces.

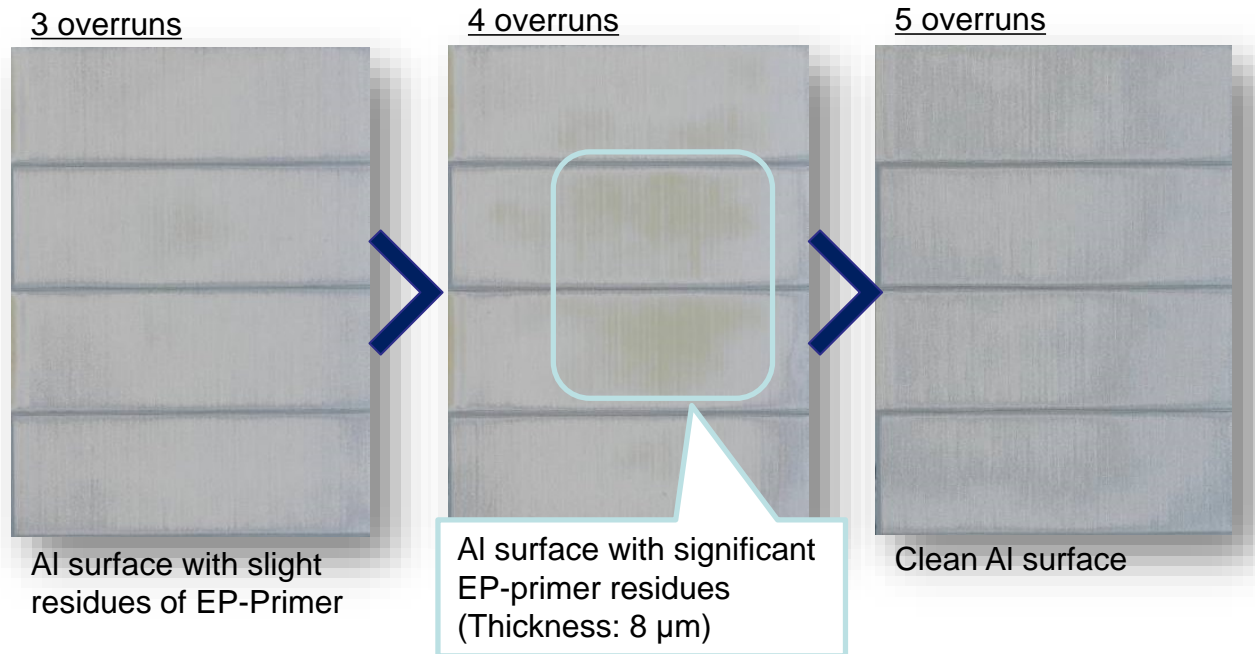
Amount of paint residues is clearly depending on the paint layer thickness:  
While there were only little residues on the 3 de-painting overrun specimen, on the 4-overrun-specimen up to 8 µm of primer remain.

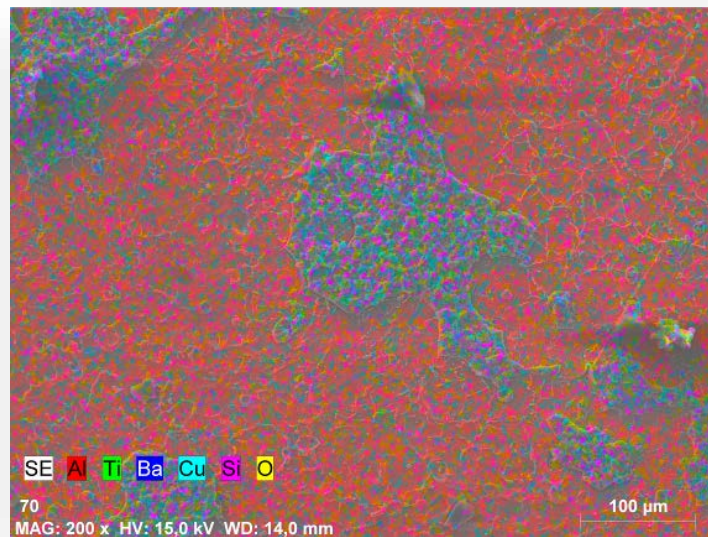
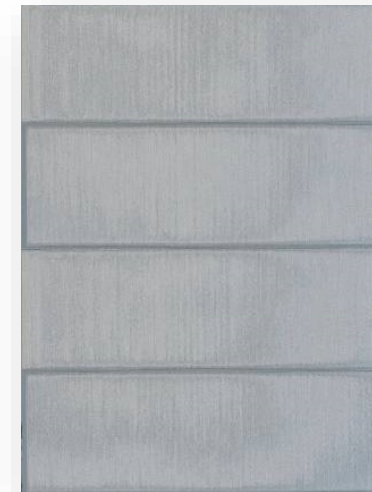
5 overruns

Clean Al surface

- The shows traces of Barium (blue colour area), which originates from paint residues
- The coating material has not been entirely removed without residues.
- EDX shows an even distribution of oxygen compounds, which indicates the formation of an even oxide layer.

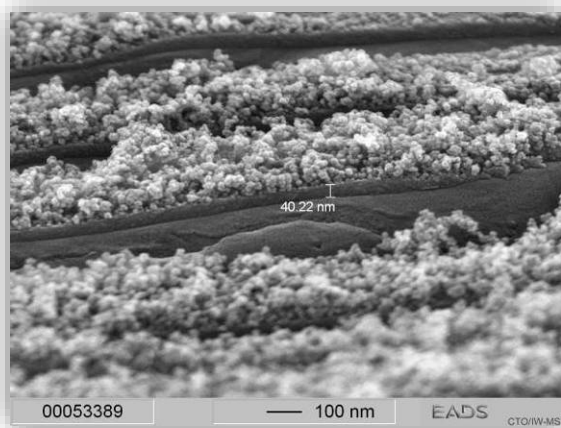
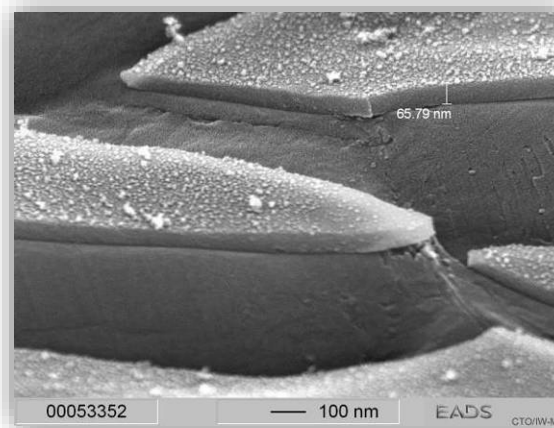
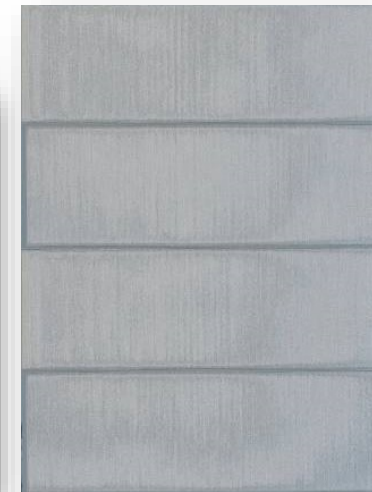
5 overruns

Clean Al surface

- Both CAA substrates (pictures b and c) show the removal of the anodizing layer. Instead there is found an apparently compact oxide layer of 40 to 60 nm in thickness that shows molten areas.
- In addition the oxide layer of both specimens is covered with small agglomerated particles.
- On the left SEM picture paint residues are clearly visible.

- ➔ In case of full de-painting the oxide layer has to be removed, e.g. by abrading.

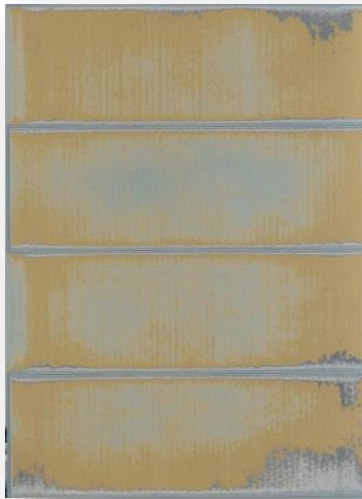
3 overruns:

"Boiled-up" wash primer residues

- Laser treatment damages the adhesion of the EP primer on the wash primer.
- PUR top-coat and EP primer are removed easily after the 3<sup>rd</sup> overrun.
- Selective de-painting of top-coat is not possible.
- Wash primer residues remain on the surface for a very long time.

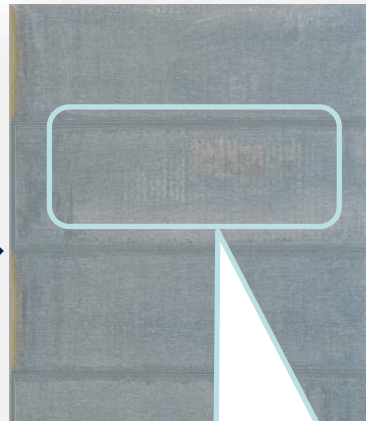
5 overruns:

Clean Al-surface with wash primer residues  
(Thickness: 2  $\mu\text{m}$ )

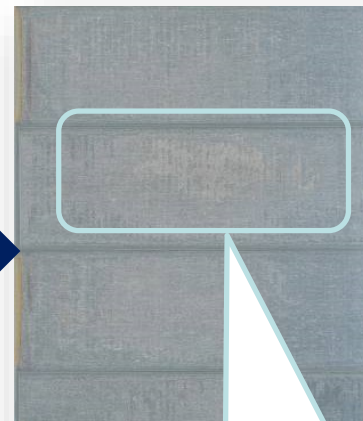
6 overruns:

Clean Al-surface with wash primer residues  
(Thickness: < 1  $\mu\text{m}$ )

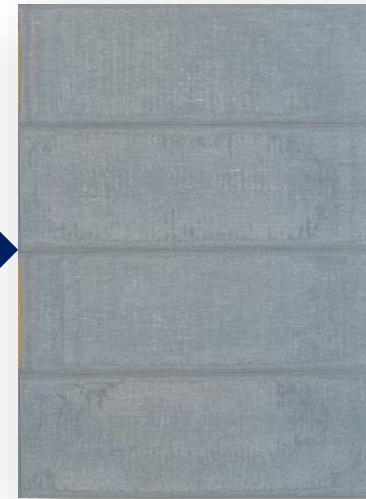
7 overruns:

Clean Al-surface

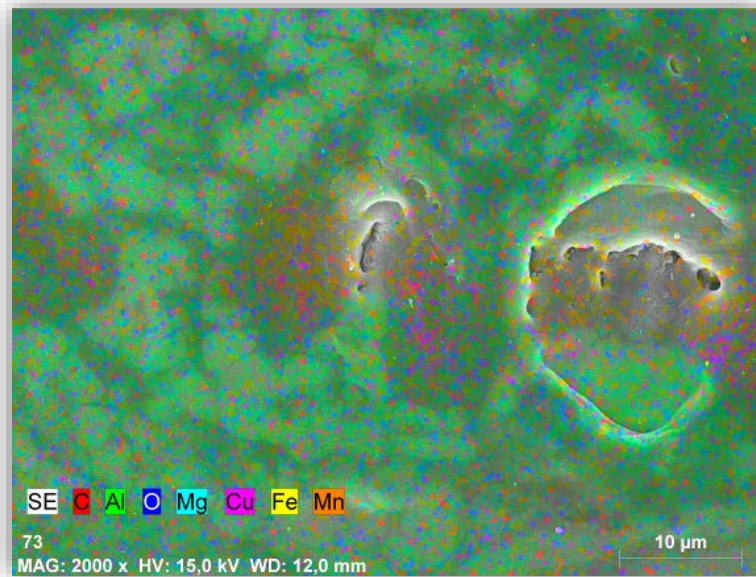
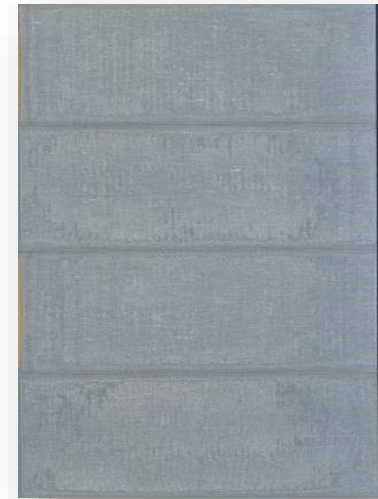
7 overruns:

- The EDX picture shows an even oxide layer.
- In addition, the picture still shows remnants of carbon, indicating an incomplete removal of the coating material.

Clean Al-surface

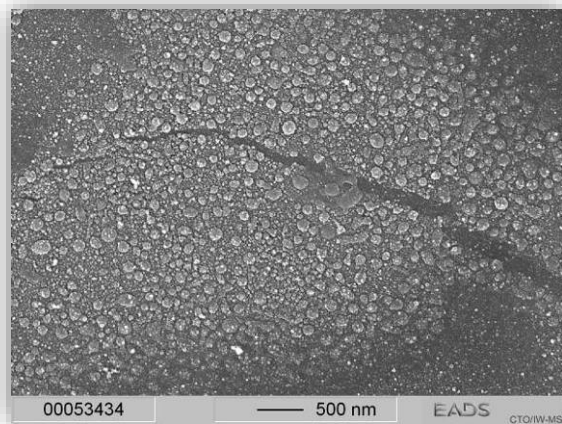
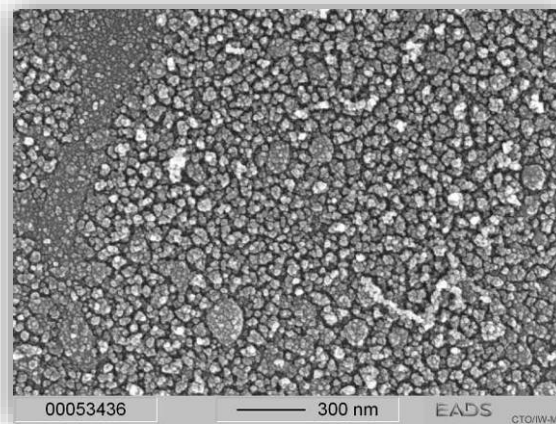
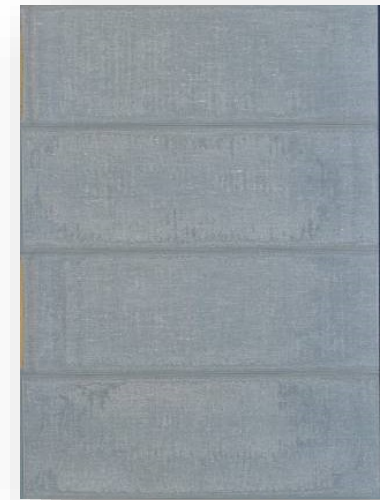
7 overruns:

Clean Al-surface

- The SEM pictures show a compact oxide layer with thicknesses between 50 to 100 nm.
- The surface shows a grainy structure. The paint apparently has been completely removed.
- Smooth areas as well as molten areas are visible.

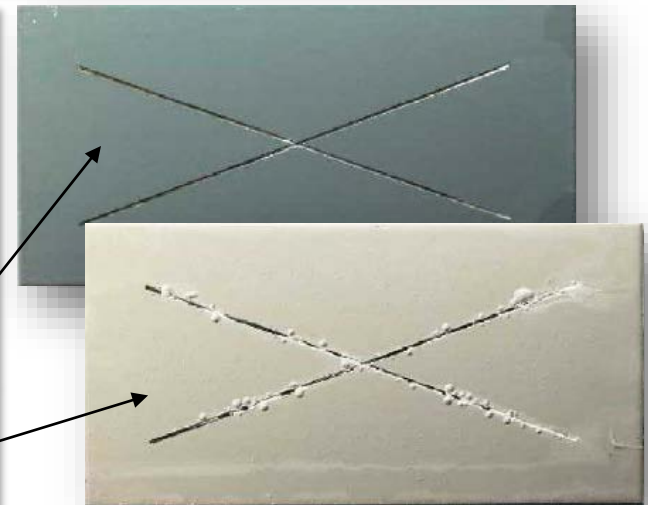
Salt spray exposure 1000 hours acc. to ISO9227 Painted and scribed	TSA Reference	Laser-treated bare Al-sheets	Laser-treated anodized Al-sheets	Laser de-painted Al-sheets
	Aerowave 2001 + Aerowave 5001			
	Aerodur 2100 MgRP + Aerodur 5000		Paint Creepage	Paint Creepage & Blisters

- Examinations of these oxide layers showed detrimental behavior with regard to adhesion of subsequent paint layers and corrosion protection.
- ➔ Therefore Airbus Defence and Space took the decision that the laser de-painting process may not be applied for the removal of an entire coating system from an aluminium surface. Instead, the top-coat on an Al component shall be selectively de-painted until the primer surface is reached.
