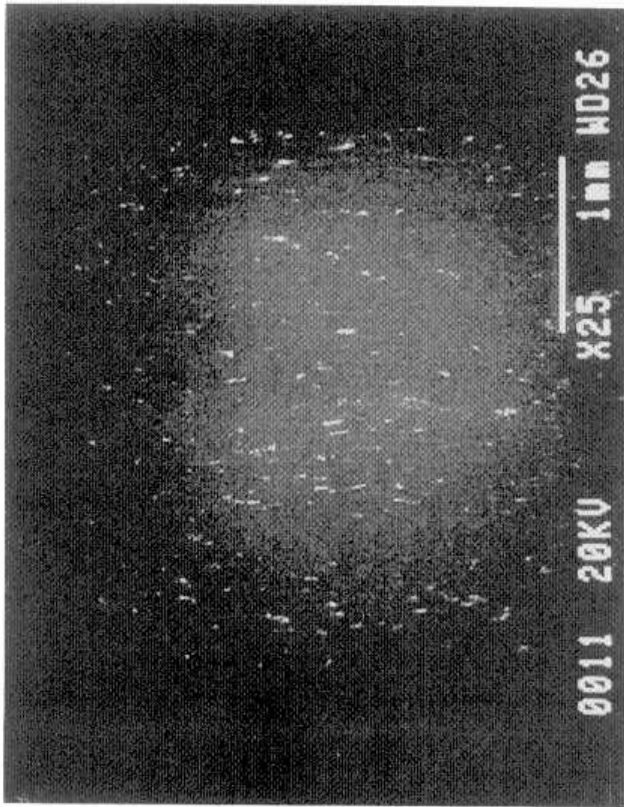
1990 pedigree plate

Figure 9: Backscattered SEM images of constituent particles located in the hole bore of open hole fatigue specimens from the 1990 and low porosity 7050-T7451 thick plate variants.
