**Figure 19: Microporosity is sometimes found to be the failure-initiating microfeature in tests of smooth fatigue specimens taken from thick hand forgings.**

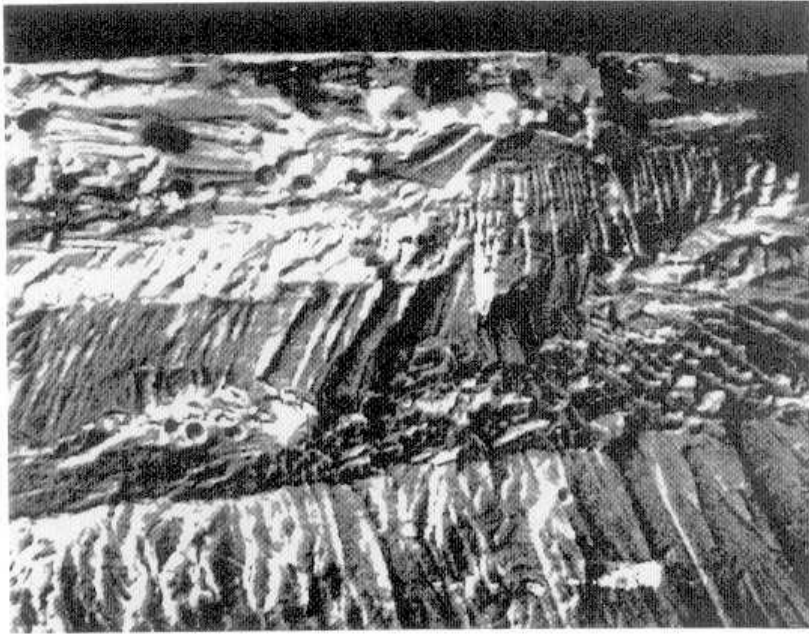
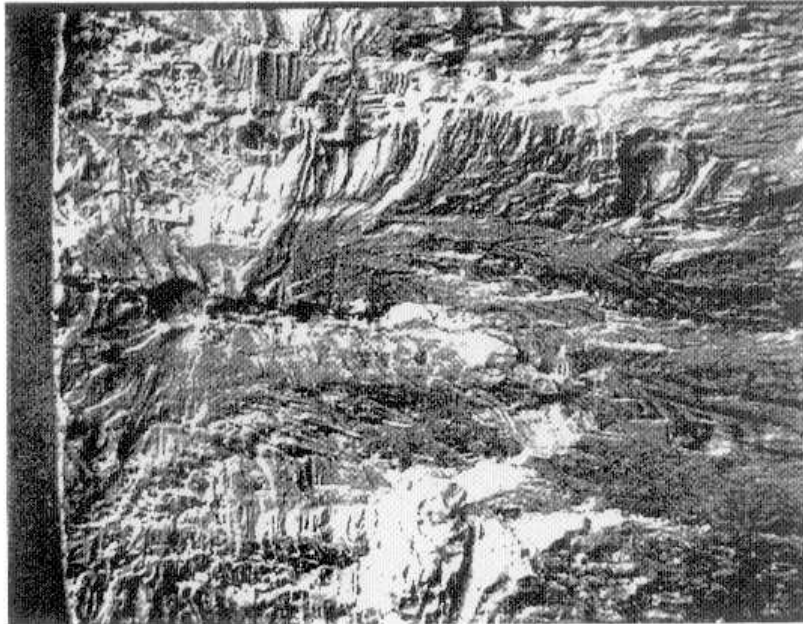
The figures show partially healed micropores found on fracture faces of short-lived specimens taken from a 6 in. thick 7050-T7452 hand forging.
