Degraded Visual Environment Mitigation (DVE-M) Program, Yuma 2016 Flight Trials

ABSTRACT

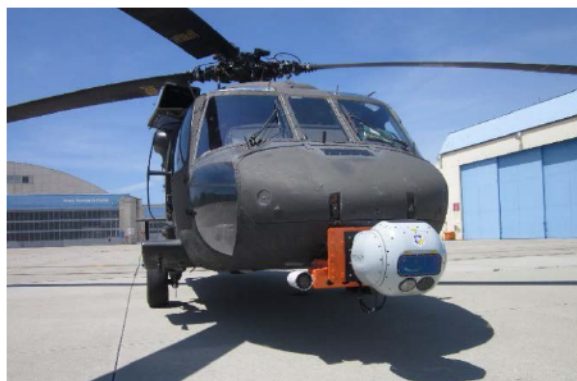
Figure 2: 3D-LZ sensor and test aircraft.

AFRL executed a program to develop a technical solution for brownout landings with flight tests conducted from 2009 through 2016. The 3D-LZ program included a LADAR see-and-remember sensor (Figure 2) developed for AFRL (Burns Technologies LLC, Orlando, FL), and the BrownOut Symbology System (BOSS) developed by the Army ADD as detailed in References 2-7. Much of the symbology for the test that is the subject of this paper, was first developed under the 3D-LZ program.

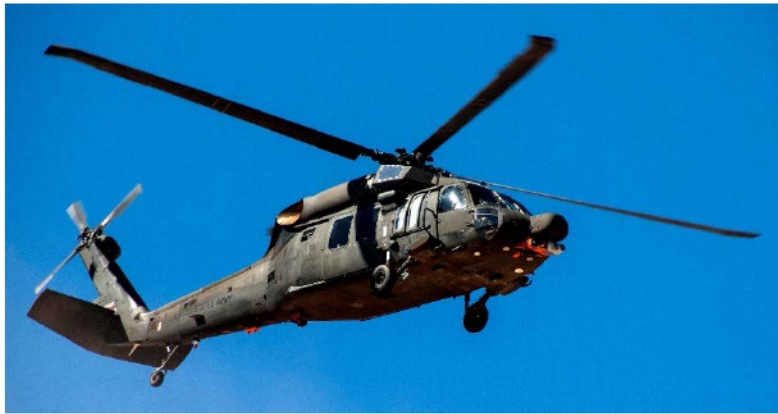
Figure 3: EH-60L Black Hawk test aircraft.

The test aircraft shown in Figure 3 is an EH-60L Advanced QuickFix helicopter, Army Serial Number 87-24657. Most of the original QuickFix equipment was removed and replaced with research equipment to support the new sensors, flight control, and pilot cueing systems. Equipment installed for DVE research included engine inlet barrier filters, an inertial measurement unit (Honeywell H-764GU EGI), a digital output version of the Army APN-209 radar altimeter, a GPS antenna mounted on the tail (with the signal split to various systems), two terrain imaging sets of sensors, a programmable flight control augmentation system, a programmable graphics generator, a video distribution system, video recorders, a voice synthesizer system, a tactile cueing system, and aircraft instrumentation for data recording. All symbology was driven from the EGI, radar altimeter, and the torque sensors.

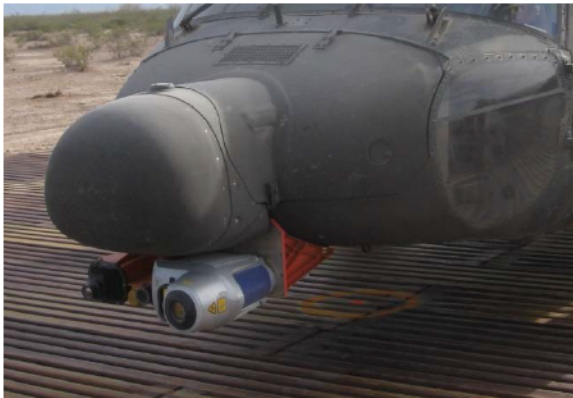
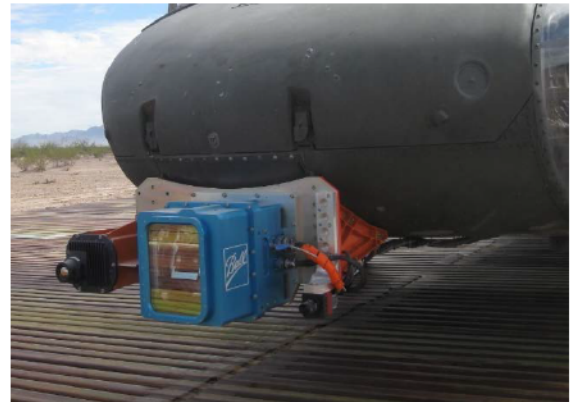
Figure 4: SNC sensor system and terrain image.

One sensor system was developed by Sierra Nevada Corporation (SNC). As shown in Figure 4, the SNC sensor system included a radar (SNC, Sparks Nevada), a LADAR (Neptec Opal 120, Kanata Ontario Canada), an infrared camera (DRS 720p, Arlington Virginia), and pre-stored (a priori) terrain elevation data. The infrared camera input to the fusion algorithm was paused automatically once the brownout formed, to prevent the high

contrast swirling dust cloud structure from being displayed and providing false-motion cues.

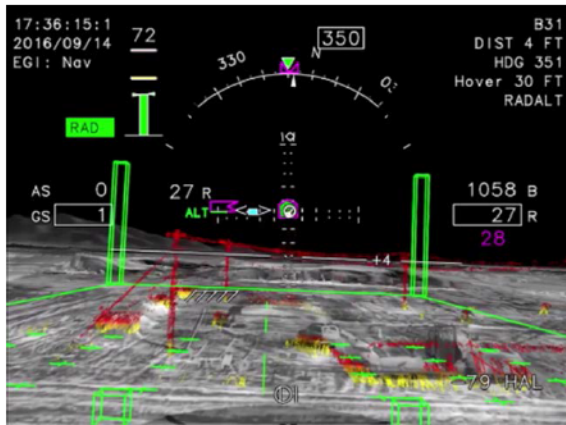
Figure 5: Areté sensor system and terrain image.

The second sensor system was developed by Areté, as shown in Figure 5. It included a LADAR (Areté, Colorado), an infrared camera (DRS 720p, Arlington Virginia), and pre-stored terrain elevation database. The infrared camera input to the image fusion algorithm was manually reduced in contrast by the sensor system operator once the dust cloud started to develop in order to diminish the image of the cloud on the display. Obstacles at the landing area were also artificially colored yellow or red if their height above the local ground plane exceeded thresholds, as shown in Figure 5.

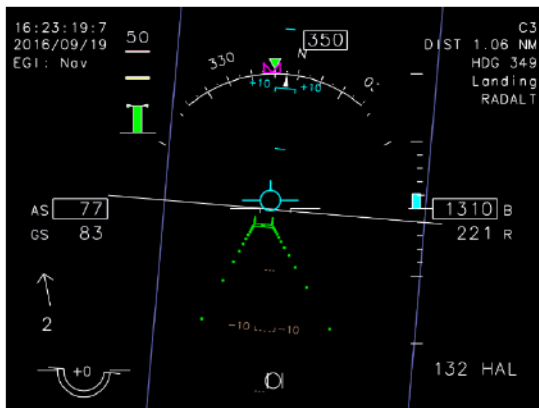
Figure 7: Enroute (Cruise) page shown with artificial landing pad.

There were two symbology pages with ICE, the enroute page (Figure 7) and the Hover/Approach/Takeoff (HAT) page (Figure 8). The enroute page was shown above 60 knots whenever the guidance to hover or landing was off. The HAT page was displayed at all speeds when guidance to hover or landing was active. The HAT page was also displayed whenever the aircraft was below 60 knots. The entire approach was flown on the HAT page from 1.0 NM to the hover/landing point. The most important distinguishing elements of ICE symbology are listed below:

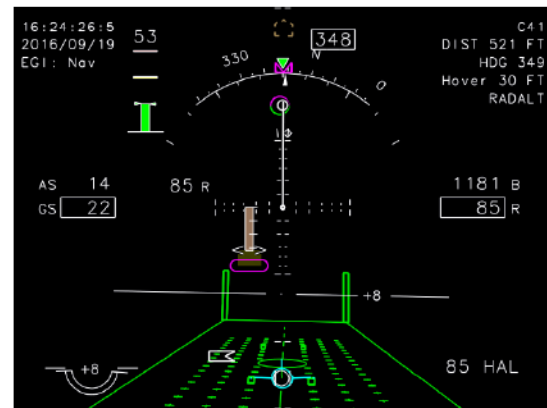
Figure 8: Hover/Approach/Takeoff (HAT) page shown with artificial landing pad.

- a) Horizontal and vertical speed guidance were explicitly shown, in plan view, for approaches to hover or landing. Simultaneously, the current horizontal and vertical speed of the aircraft were also shown. Thus the pilot could close the control loop between the desired speeds and actual speeds.

- b) The velocity indicators did not change scales during the approach. Using a blended linear and logarithmic scale, the velocity and position scales provided plenty of range (up to 160 knots to the top of the screen), while they also provided enough resolution at touchdown (indices are 1, 2, 4, 6, 8, and 10 knots).

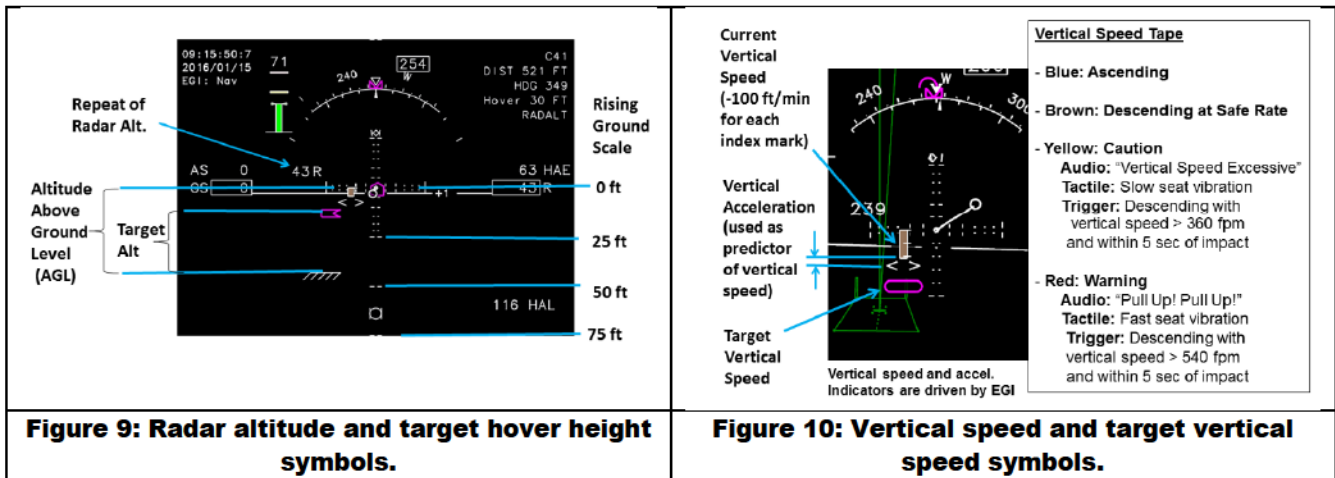
Figure 9 shows the radar altimeter indicator in the form of a rising ground, and the corresponding target altitude symbol used during hover. Figure 10 shows the vertical speed tape, and the predictor for the vertical speed tape, driven by vertical acceleration. The figure also shows the target vertical speed symbol. All these vertical symbols are clustered together and are meant to work together. Their placement left-of-center was intentional so that the symbols map well with the placement of the cyclic and collective control sticks.

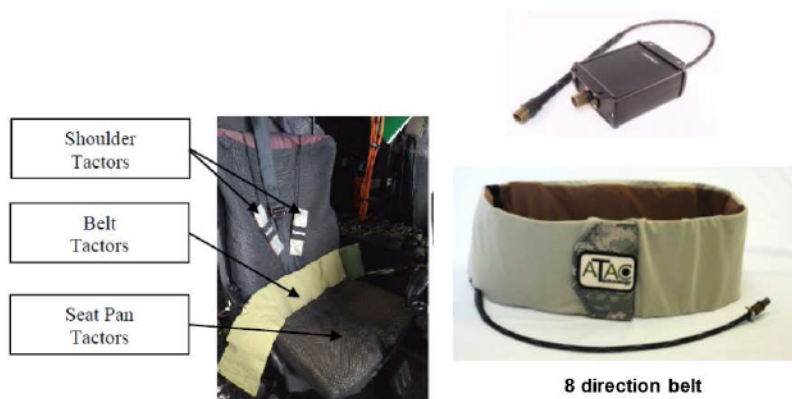
Figure 11: Tactile system.

Figure 11 shows the tactile system manufactured by Engineering Acoustics Inc. (Casselberry, Florida). The shoulder tactors were built into a sleeve that attached to the shoulder harness belt. Multiple tactors were built into the seat cushion which vibrated in unison. Pilots also wore a belt, with eight different directions of vibrations around the waist. The system is detailed in References 10 - 12.

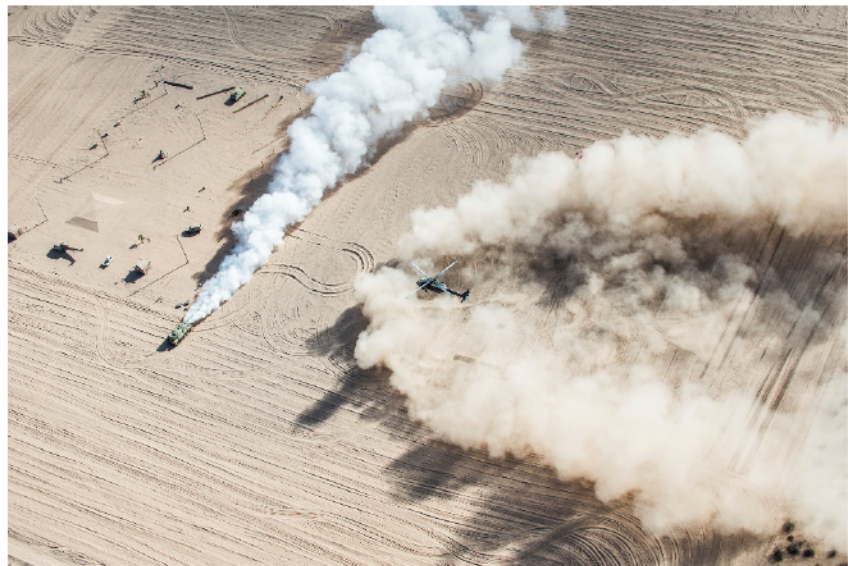
Figure 12: Test site.

Figure 12 shows the test site at Yuma Proving Ground. The ground was composed of sandy soil, with a range of particle sizes including very fine. The top soil was tilled regularly, to reduce adhesion between particles, enabling large dust clouds to be formed. A smoke generator was also used on some of the approaches as shown in the figure. Obstacles were purposefully set up in defined areas including small buildings, poles, wires, palm trees, short posts, ground vehicles, helicopter airframes, dirt mounds, and ditches.

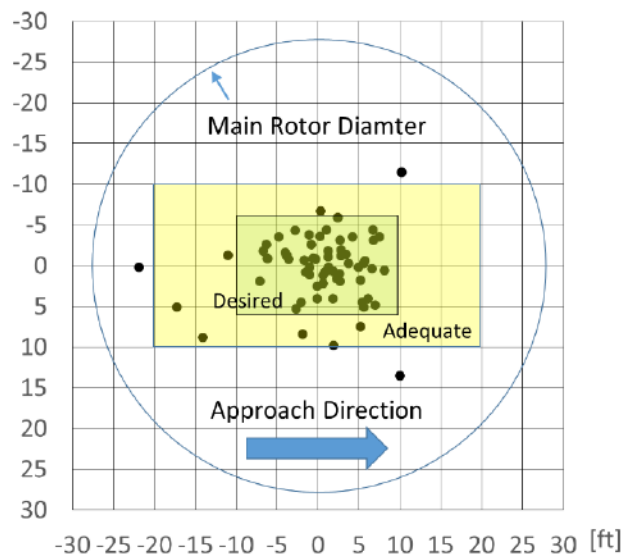
Figure 14: Touchdown footprint (64 landings shown).

Figure 14 shows the distribution of touchdown position data for 64 brownout landings, as measured by the EGI. The same EGI drove the guidance equations, and symbology, so the data indicates how far off the pilots were compared to where they were being guided to. Therefore, in the data analysis, pilots were not penalized for any EGI position errors. As can be seen in the figure, the majority of the landings were within the desired region, and only three landings were outside of the adequate region. All landings were within the main rotor diameter of the aircraft, as measured with the EGI.

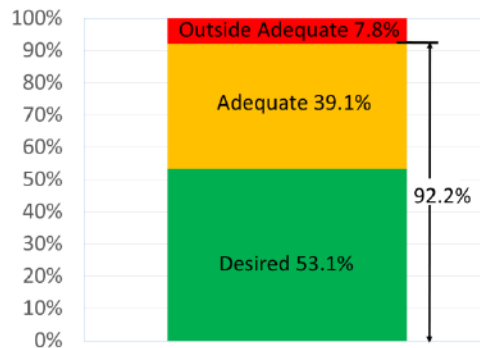
Figure 15: Percentage of 64 landings meeting all 6 performance criteria.

Figure 15 indicates (in green) the percentage of landings that met all six desired criteria (53.1%). The yellow region (39.1%) indicates the percentage of landings that had at least one parameter in the adequate criteria and no parameters outside of adequate. The red region (7.8%) indicates the percentage of landings that had at least one parameter in the outside adequate criteria. As shown in the figure 92.2% of landings simultaneously met at least the six adequate criteria. One landing was outside adequate for longitudinal distance (21.9 ft). Two landings were outside adequate for lateral distance (max = 13.5 ft). Four landings were outside adequate for lateral speed at touchdown (max = 1.5 knots).

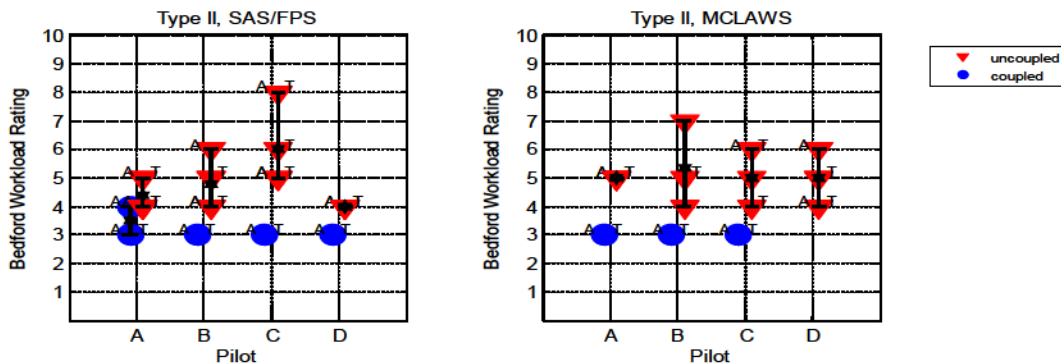
Figure 17: Bedford workload ratings for unobstructed approaches.

As a part of the pilot questionnaire completed after each approach, Bedford workload ratings were collected. A total of 47 approaches were analyzed which included both unobstructed and obstructed approaches using both MCLAWS and SAS/FPS flight control systems. These ratings are plotted in Figures 17 and 18. Red triangles indicate uncoupled collective conditions while blue circles indicate coupled collective conditions. The star (*) indicates the mean score for a particular pilot, while the bars indicate min and maximum ratings for a particular pilot. An “A” indicates that audio was ON. A “T” indicates that tactile was ON.

During the unobstructed approaches, those approaches conducted with the coupled collective received Bedford Workload ratings of predominantly 3 while uncoupled approaches received 4 or greater as shown in Figure 17. Due to the way the Bedford scale is structured via the questions the pilot must answer, a change in rating from 4 to 3 is a significant improvement indicating that the workload is satisfactory without reduction and that the pilot still has spare capacity to conduct additional tasks. Note that there is little difference in the workload rating for flight control response type (SAS/FPS vs. MCLAWS).

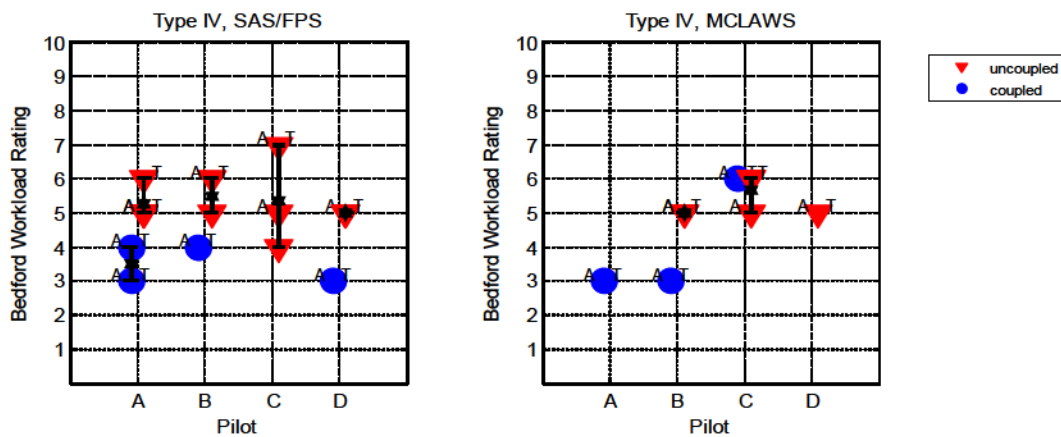
Figure 18: Bedford workload ratings for obstructed approaches.

For the obstructed approaches, the coupled approaches received Bedford Workload ratings of 3 and 4 while uncoupled approaches received ratings of predominantly 5 or greater, again indicating a sizeable reduction in workload with coupled collective, as shown in Figure 18. Again, there is little difference in the workload rating for flight control response type (SAS/FPS vs. MCLAWS).
