**RTO MEETING PROCEEDINGS 18**

# **Fatigue in the Presence of Corrosion**

*Papers presented at the Workshop of the RTO Applied Vehicle Technology (AVT) Panel (organised by the former AGARD Structures and Materials Panel) held in Corfu, Greece, 7-9 October 1998.*

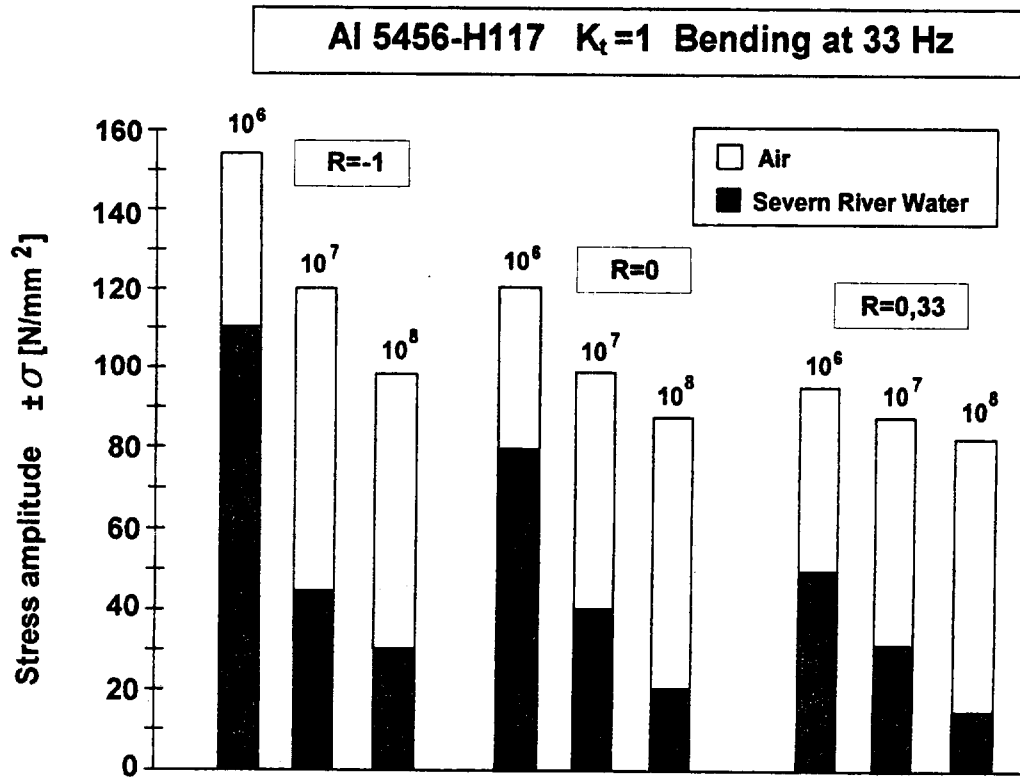
Fig 1. Effect of Corrosion on Fatigue Strength

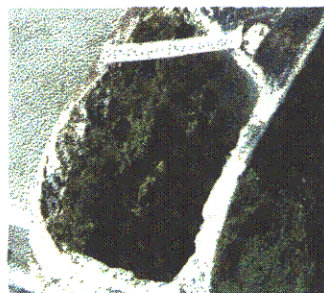
Fig.1

After de-skinning, the external spacers, in magnesium alloy AZ91 C, were found severely corroded, as visible in Figg. 1-2.

The corrosion distribution was not symmetrical and appeared concentrated on the lower part more than on the upper one, both cases especially on the rear surface.

Metallographic inspection revealed the galvanic nature of the corrosive attack (Fig. 3) produced by the moisture penetrated between the spacers and the steel beams. Geometrical shape explains the corrosion pattern.
