***High Energy Processes on Aircraft – Structural Integrity Considerations and Lessons Learned  
AVT-302 Research Workshop on Paint Removal Technologies for Military Vehicles***

**Presented by  
Dr. Paul N. Clark**

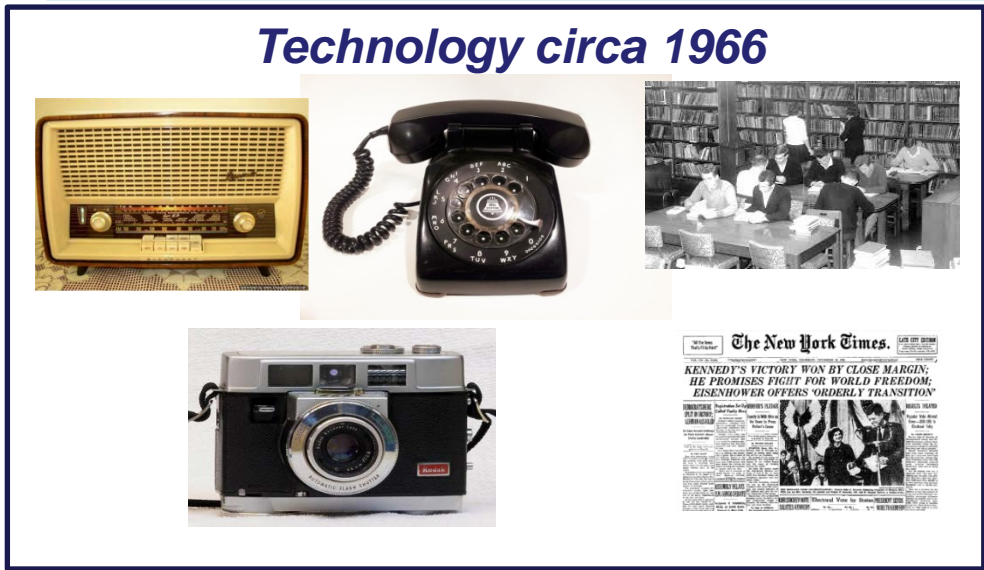
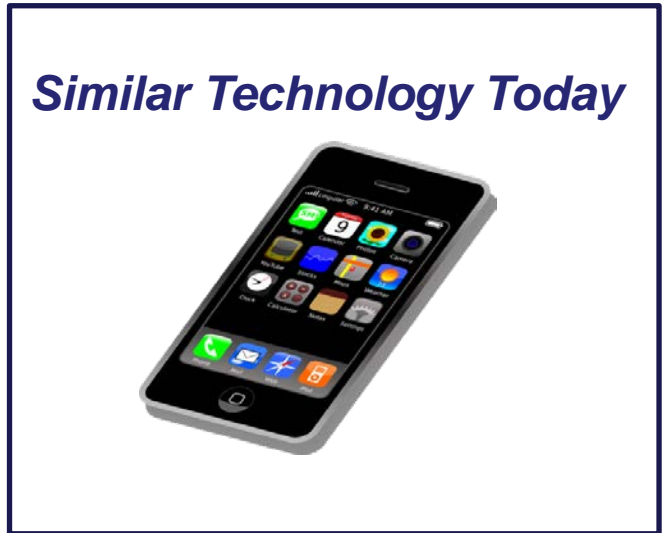
| | Aircraft | | | | | | |
| | A-10 | T-38 | F-16 | KC-135 | B-52 | B-1 | F-22A |
| 2005 | 1977 | 1961 | 1978 | 1957 | 1955 | 1986 | 2005 |
| Original Count | 716 | 1146 | 2230 | 803 | 744 | 104 | 187 |
| Projected Retirement Age* | 60 | 70 | 36 | 83 | 80 | 52 | ? |

- **27 years old: Average age of USAF aircraft in 2015** *Reference: 1*

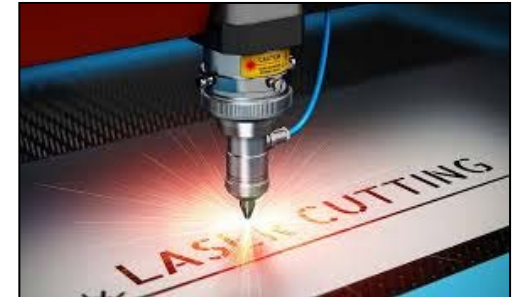
- **Change to microstructure**

- Durability
- Widespread fatigue damage (WFD)
- Multiple site damage (MSD)
- Multiple element damage (MED)
- Damage tolerance potentially altered
- Fail safety potentially compromised
- Surface integrity
  - Any change or compromise to the structure surface or protection system

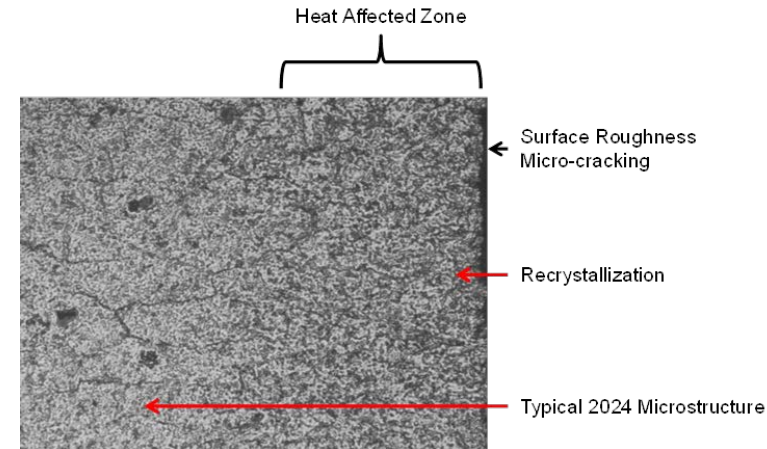
- **Laser Cutting (USAF 2007) Reference: 3**

- Microstructure changed
- H.A.Z. & recast layer
- Micro-cracking
- Surface integrity/durability degraded
- 94% durability downgrade for 2024-T3
- AA-07-02 (*Airworthiness Advisory, Oct. 10, 2007*)

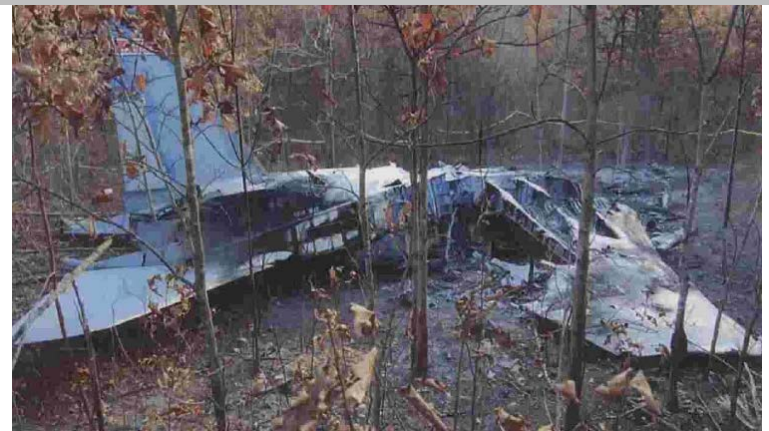
Reference: 7

Example: Secondary Crack – surface as machined  
(Cracking from accident aircraft)

Based on Pilot Testimony

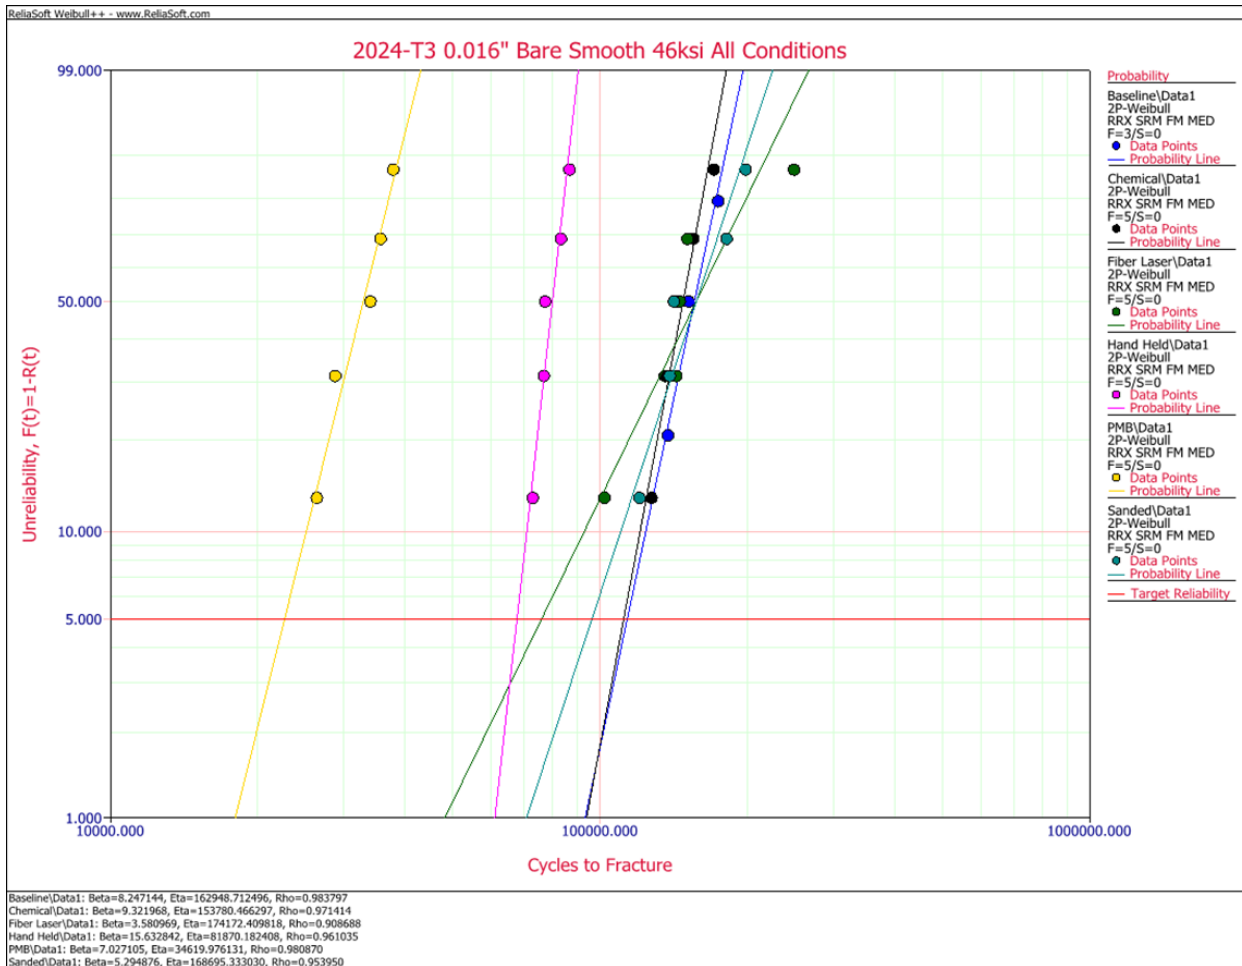
# Difficult to Utilize

- Compatible Betas (5.29-9.32) *except...*
- Fiber Laser  $\beta \sim 3.58$
- Hand Held Laser  $\beta \sim 15.3$
- Relatively comparable for  $N_{95/95}$
- $FMF_{Chem}$  is positive
