A Trade-off Based Assessment Study on Possible Coating Alternatives for Armored Combat Vehicles

FNSS Savunma Sistemleri A.Ş.

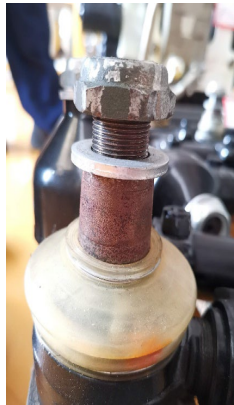
Figure 1: Corroded component from an underbody system of an armored combat vehicle.

In terms of environmental and economic aspects or degradation of mechanical properties, corrosion has to be overcome or at least prevented for complete engineering component (see Figure 1). In addition to the potential problems in service life, corrosion can also cause extra maintenance or repair costs of nearly 3% of the total worldwide GDP (Urbahs et al., 2018). In defense industry, where a reasonable number of parts may have mission-critical functional applications, any premature failure due to corrosion and/or hydrogen embrittlement could lead to catastrophic failure/dramatic results (see Figure 2). In most cases, corrosion itself can be a source of free hydrogen, and the coatings used to prevent corrosion can trigger hydrogen embrittlement (HE) (Kamoutsi et al., 2006, Ibrahim, 2017, Sriraman et al., 2013). Particularly in some mechanical components such as transmission gear systems or compression connections, applying paint is nearly impossible due to the desired mechanical tolerances and clearances. In such cases, coating and/or electroplating processes come into play.

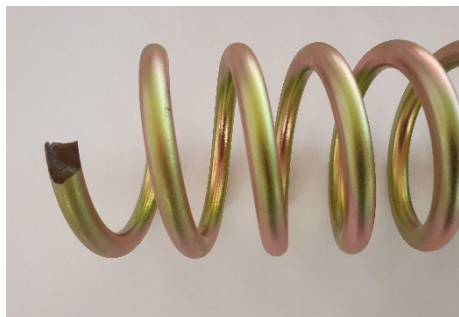
Figure 2: A fractured spring of a component due to hydrogen embrittlement.

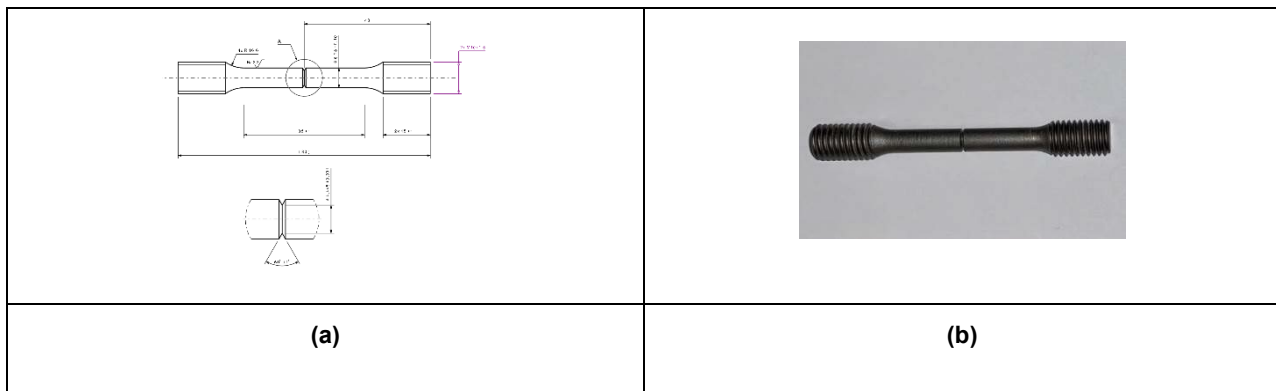
Figure 3: The specimen geometry in ASTM F519: a) Designed in the metric system, b) Test specimen.

The substrate specimens described by ASTM F519 were used in this study: Coated and uncoated tensile notch bar AISI 4340 steel specimens with the composition given in Table 1 were used to examine the susceptibility to HE. The samples with the dimension given in Figure 3 were heat treated to 51-53 Rockwell C (HRC).

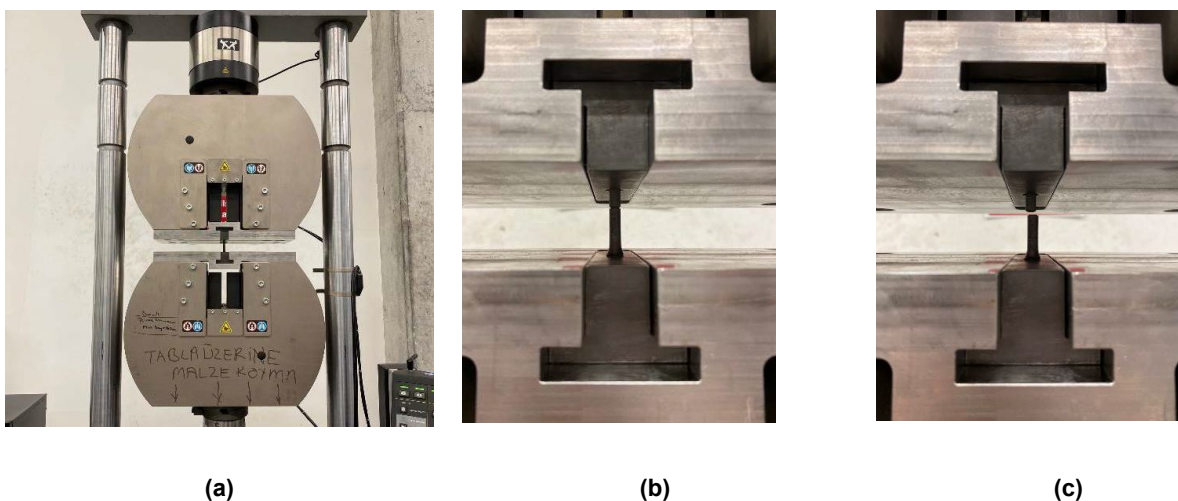
Figure 4: Tensile test: (a) Machine set-up, (b) Before fracture, (c) Fractured specimen of uni-axial tensile test.

The tests designed for the experimental studies started after the properties of the samples belonging to the tests were verified. Before starting the mechanical tests, the spacers of the tensile test (TT) set-up specially designed in compliance with ASTM F519 were produced to be compatible with the Instron 600LX (England) machine. Thanks to this design, both tensile tests and sustained loading tests (SLT) were performed with the same device and design tools. As the first step of ASTM F519 tests, a simple tensile test was performed with uncoated notch bars to calculate the loading described in the standard. In addition, the tensile test was also performed with coated samples to observe the direct effect of the coating on the mechanical response, although ASTM F519 does not provide a directive in this regard. As stated in the standard, 75% of the tensile test results obtained from the uncoated samples were preloaded for 200 hours on the apparatus shown in Figure 4.

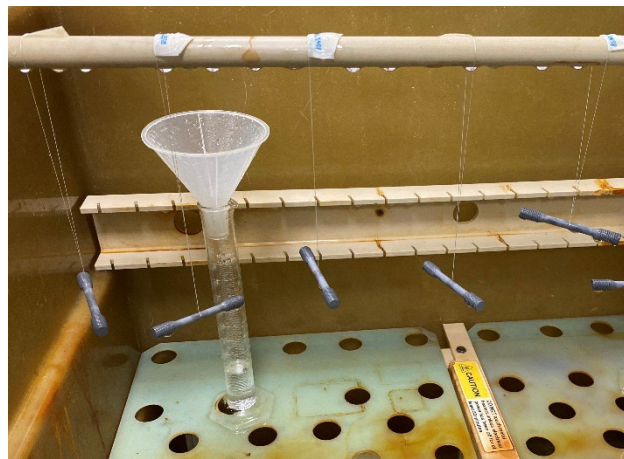
Figure 5: Specimens at the salt spray test set-up.

Then the samples were tested on the Q-Fog SSP-1100 (USA) machine conforming to the ASTM B117 standard for salt spray test (SST). As stated in the standard, the environment during SST consists of 5% (± 0.50) NaCl and 95% water, and the ambient temperature is 35 °C. Figure 5 shows how the test specimens are positioned inside the SST apparatus during the test, and Table 3 indicates the specified test durations in the coating standards for ASTM B117 Salt Spray Test.

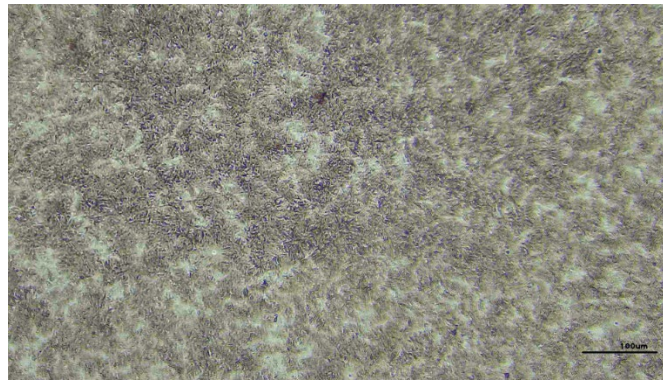
Figure 7: OM examination of the Zn-phosphate coated specimen without baking, where fracture was observed.

(Brahimi, 2014). This phenomenon is substantiated when evaluating the fracture resistance of specimens in the context of ASTM F519 sustained load tests. Hence the study showed that the baking process at 160°C for 23 hours after Zn-Ni and Zn-Phosphate coating reduced the HE effect. Furthermore, several metallographic inspections are carried out on the fractured samples to observe the microstructure and possible fracture mechanism. As a first attempt, after completing the metallographic sample preparation process, optical microscope (OM) images are taken at distinct magnifications. In Figure 7, a sample image is given for x100 magnification where the tempered martensite and retained austenite-dominated microstructure could be observed. In addition, scanning electron microscope (SEM) analysis on the fractured surface possessed a mixed-type fractographic character which consists of both ductile, brittle, and intergranular type fracture modes to some extent. In Figure 8, some voids (evidence of some ductility in the material, even it is insubstantial and intergranular character are detected.

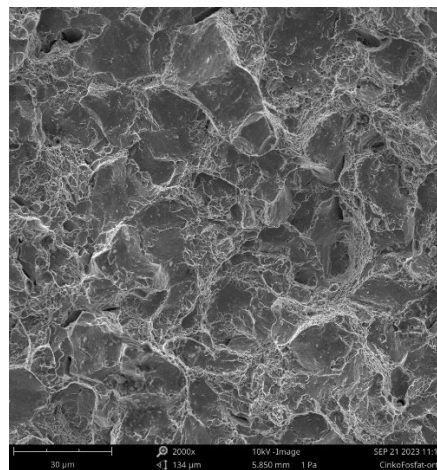
Figure 8: SEM examination of the Zn-phosphate coated specimen without baking, where fracture was observed.

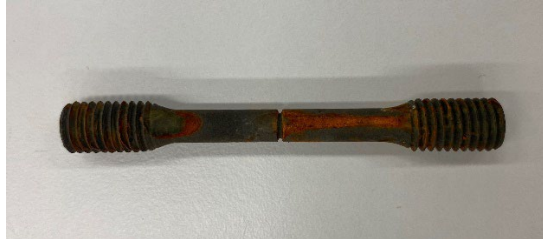
Figure 9: Zinc-phosphate coated AISI 4340 specimen after 24 hour salt spray test.

in the literature that environmentally sourced hydrogen input occurs more slowly compared to internal hydrogen input. Hence, in order to understand environmental effect, salt spray tests according to ASTM B117 standard were conducted to Zn-phosphate coated and baked specimens (160°C, 23 hours). After the salt spray test, 5 samples were tested according to ASTM F519 sustained load tests. Similar to the Zn-phosphate coated and baked samples, no fracture has been observed in the salt sprayed test samples given in Figure 9.
