## **IDEaS Corrosion Detection in Ships Sandbox: Technologies Demonstrated and Next Steps**

*In the spring of 2022, the Canadian Department of National Defence's (DND) Innovation for Defence Excellence and Security (IDEaS) Program held a month-long Sandbox event for a Corrosion Detection in Ships challenge. The challenge to the Non-Destructive Examination (NDE) and Innovation communities was to demonstrate technologies of varying maturities that could detect and assess corrosion behind surface coatings such as paint, insulation, tiles, and seamless decking onboard Royal Canadian Navy (RCN) platforms. Participating Innovators were given the opportunity to demonstrate their solutions in two modalities: i) under ideal conditions on large test panels representing various elements of the ship such as hull, decking, and piping, and ii) under real-world conditions on an operational RCN vessel. Department of National Defence and the Canadian Armed Forces (DND/CAF) subject matter experts provided feedback on each solution. The broader aim of the Sandbox was to inform DND and the RCN of currently available and mature as well as emerging and unconventional NDE technologies that would enable

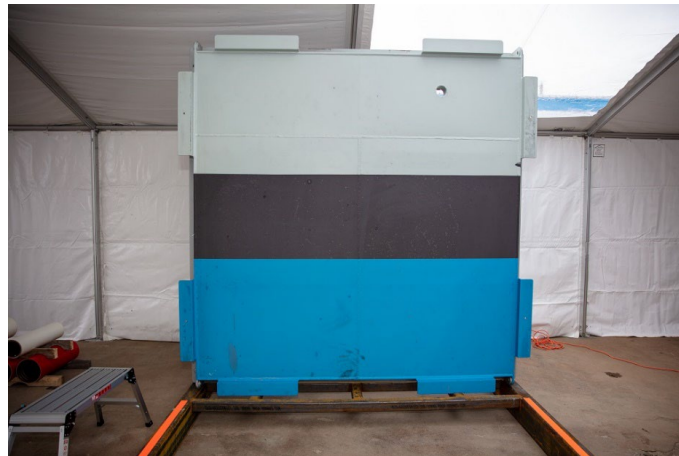
**Figure 1: Dry hull test panel<sup>(1)</sup>. Large circular defects representing general corrosion and small blind holes representing pitting corrosion were machined into the back side of the plate at depths ranging from 10 to 50% of the material thickness, and covered with insulation so they were not visible to the Innovators.**

- Dry Hull with the underwater and above water paint scheme used on RCN vessels (Figure 1)
- Wet Hull with the underwater paint scheme used on RCN vessels (Figure 2)
- Deck with seamless decking, quarry tile, and machine mounts (Figure 3)
- Deck with non-skid coating, machine mounts, bolts, and kick pipes (Figure 4)
- Fuel Oil Transport Piping (Steel), with flanges, valves, and elbows, painted (Figure 5)
- Seawater Piping (CuNi) with flanges, valves, and elbows, painted and wrapped in 1” thick insulation (Figure 6)

Flaws representing the three types of corrosion in the challenge were introduced into the hull and deck panels and the pipes by machining areas of thinning. These areas were on the back side of the hull panels, so that they were not visible under the paint, the front/top surface of the decking panels where they were covered by seamless or non-skid coatings, or quarry tiles, and on the inner surfaces of the pipes.

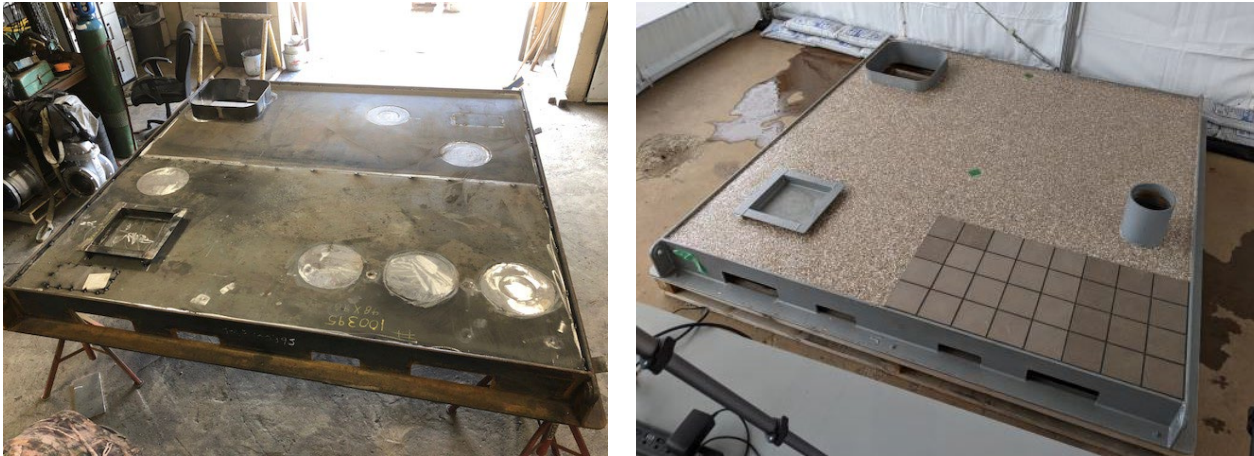
Figure 3: Seamless decking test panel before (left) and after (right) coating. Large circular defects representing general corrosion and small blind holes representing pitting corrosion were machined into the front side of the plate at depths ranging from 10 to 70% of the material thickness, and covered by seamless decking or quarry tile.

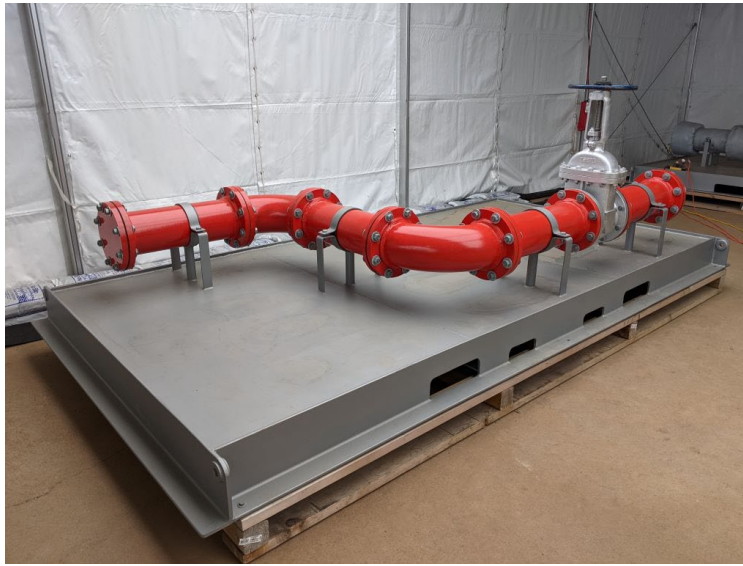
Figure 5: Steel fuel oil transport pipe test panel. Large circular defects representing general corrosion and small blind holes representing pitting corrosion were machined into the inner surfaces of the pipe at depths ranging from 10 to 50% of the pipe wall thickness.

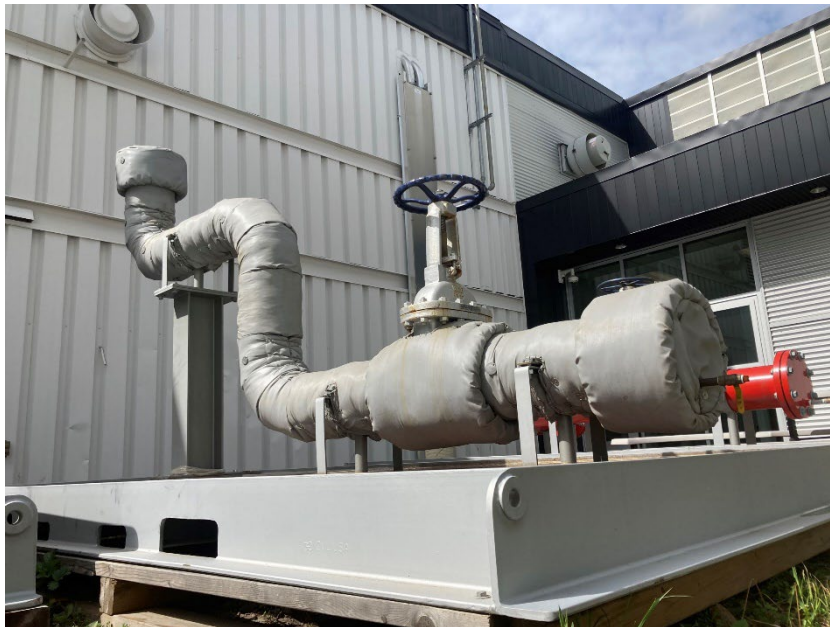
Figure 6: Copper-nickel seawater cooling pipe test panel. Large circular defects representing general corrosion and small blind holes representing pitting corrosion were machined into the inner surfaces of the pipe at depths ranging from 10 to 50% of the pipe wall thickness. The entire pipe was wrapped in 1" thick insulation which could not be removed for inspections. Photo credit: Centre de Métallurgie du Québec.
