Corrosion Repair Using Cold Spray Technology

Matthew Chu, Luc Doan, Stonet Middleton and Conrad Macy
Fleet Readiness Center SouthWest (FRCSW)
Naval Air Station (NAS) North Island, Materials Engineering Laboratory
Door 1, BLDG. 469 North Utgoff Ave., San Diego, CA 92135
UNITED STATES

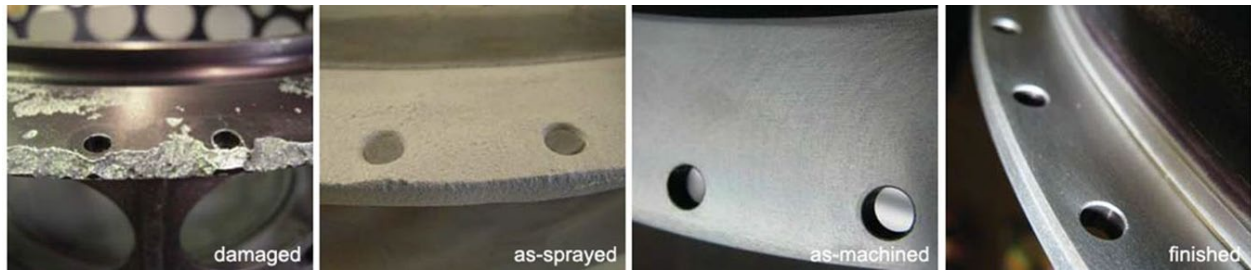
Robotic application is more appropriate and expedient when applying the same amount of Cold Spray on the same area of the component because there is a pre-machining step. This pre-machining step sets the dimensionally restoration needed to be the same every time. Therefore, a robotic program can reapply the Cold Spray coating the same every time without human error (see Figure 4).

Figure 4. Consistent corrosion on the flange.

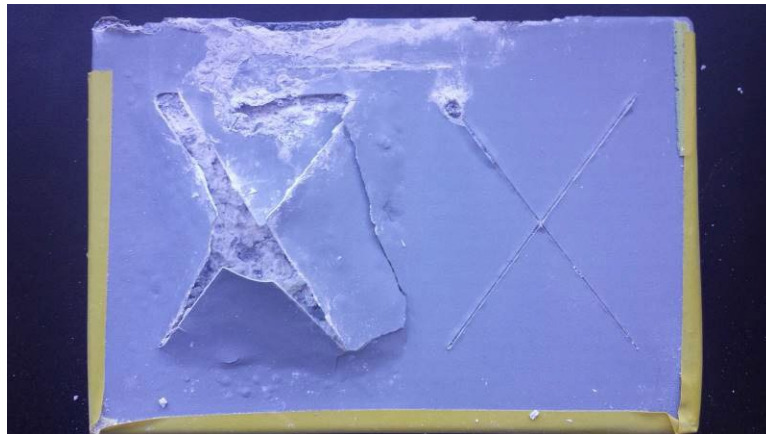
The testing was thorough as this was the first application of cold spray for NAVAIR aluminum. Test panels were coated and placed in ASTM B117 neutral salt fog, ASTM G85 method 4 acidified salt fog, and beach exposure at the Kennedy Space Center corrosion site. Figure 9 shows a panel coated with 6061 aluminum that underwent acidified salt fog testing. All of the panels were from the same lot of AZ41 cast magnesium and were cut to 3 inches' x 4 inches' x 0.25 inches thick, then half of the panel was left bare and the other half coated with 6061 CS aluminum to a thickness of 0.012-.0.015 inches (0.30mm-0.39mm). The entire panel was then pretreated, Rockhard® coating applied, primed and topcoated and scribed.

Figure 9: Corrosion panel after 500hrs acidified salt fog, (left) magnesium prime/paint only, (right) magnesium 6061 CS, prime/paint.

The resulting 6061 CS aluminum test panel side after 500 hours shows the beginning of undercutting. As compared to the current coating system which showed total failure at the scribe line with extreme exfoliation of the substrate. The modified coating stack-up in contrast performed extremely well and subsequent fleet trials also affirmed this anodic protection.

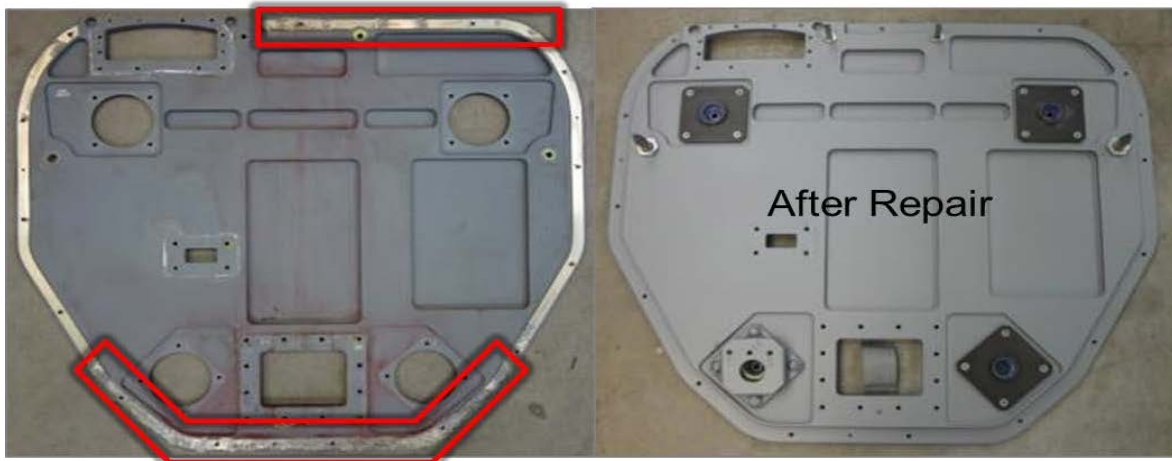
Figure 11: Avionics rack repair.

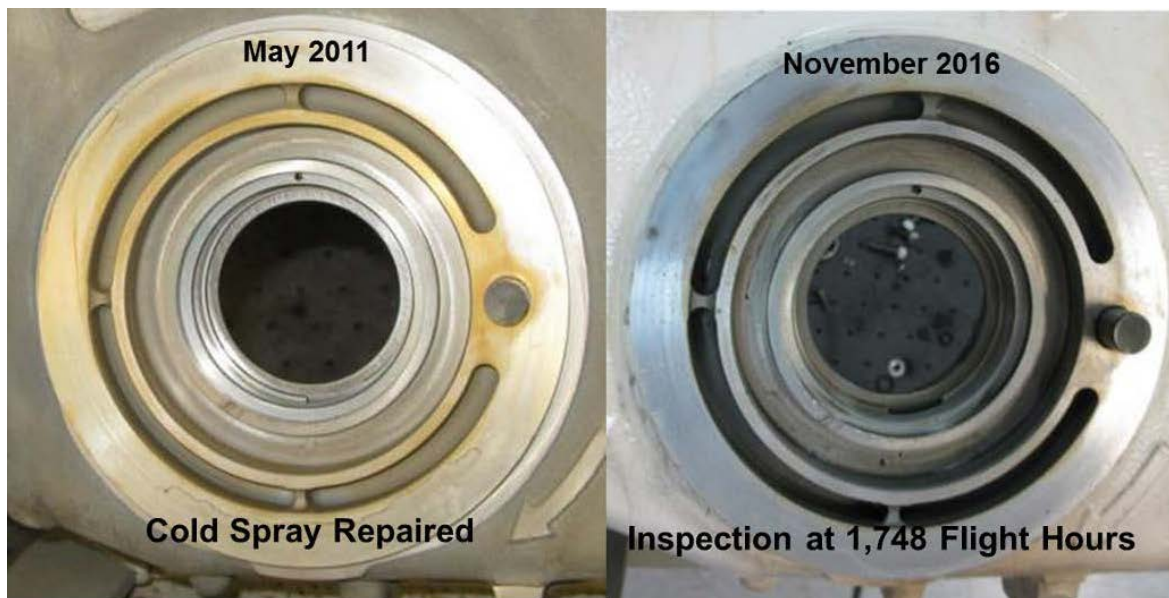
Figure 13: Aluminum housing inspection after 1,748 flight hours.

One of the original gearboxes was removed for a general inspection after 1,748 flight hours and no fretting damage to the repaired hydraulic pad was observed as show in Figure 13. This gearbox was sprayed with 4047 aluminum using a high pressure system and showed that the new alloy applied was not susceptible to the fretting condition.

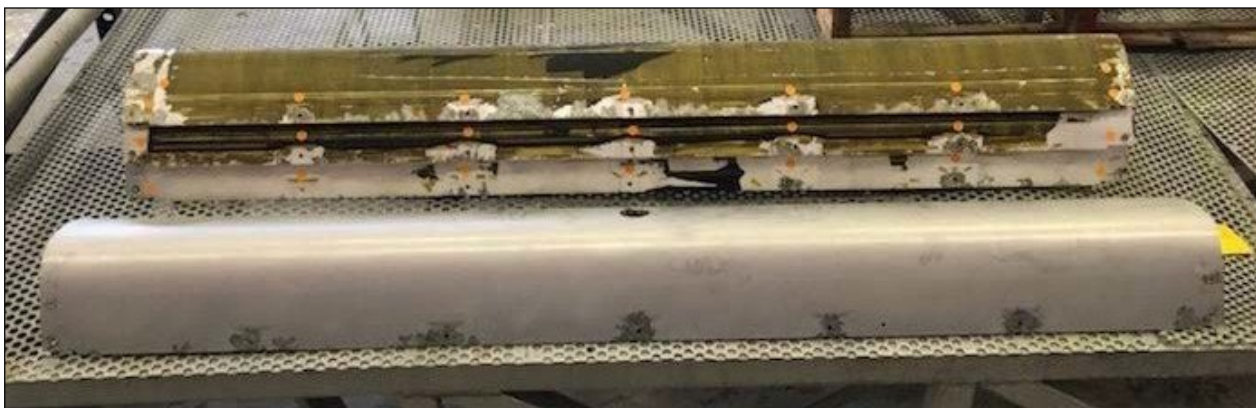
This repair was developed to for a leading edge cover that also has a deicing boot attached to it. The panel is curved and constructed of 7075 aluminum with a honeycomb sandwiched core in the middle of the panel, where the edges are flat. Corrosion was found on the lower nine fastener holes where moisture collects at the lowest point. The configuration of this leading edge did not have a corrosion inhibited primer coating in the coating stack-up and only consisted of a pre-treatment bonded boot and then a topcoat. This created the conditions for pitting corrosion around the fastener heads, in an area susceptible to corrosion.

Figure 14: Corroded areas on leading edge around lower fasteners.

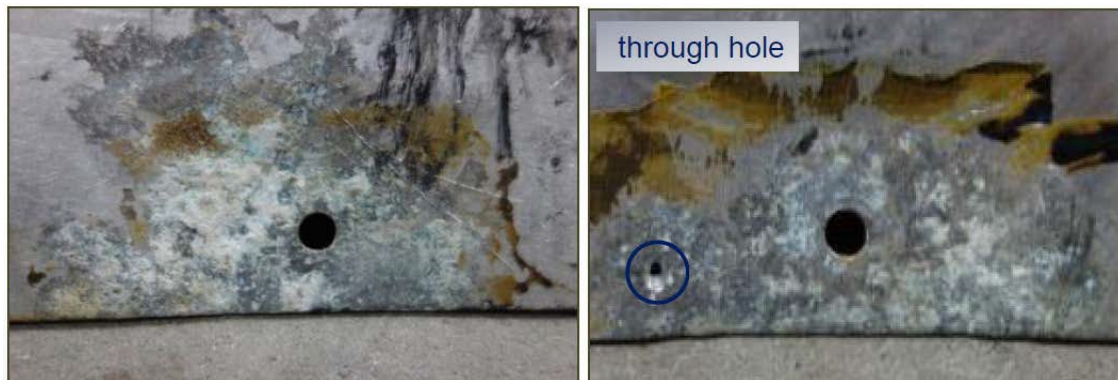
Figure 15 shows the same mode of corrosion as found on all of the panels, pitting attack, exacerbated by being entrapped under the deicer boot and the lack of a corrosion inhibitive primer. The corrosion is identified by visual inspection where the rubber deicer boot lifts due to the corrosion product. Remaining adhesive for the deicer boot can be seen in the figure as brown material.

Figure 15: Expanded view of corrosion around fastener holes.

A cold spray repair using an aluminum blend of powder, Al-Trans Chrome® was used to elicit the repair. The repair process is shown in Figure 6 where the corrosion product is removed, the panel thickness and fastener hole measured, then if within acceptable tolerances proceeded to be blended out, filled with the cold spray material, ground down to the original dimension, primed and then apply the deicer boot. This cold spray repair allows for the quick repair of an asset that is in demand by performing the repair and returning the asset back to the squadron in less than a week for a fraction of the cost of a new leading edge. The repair and modification to the coating stack-up is in line with other aircraft that use a primer and do not exhibit corrosion on the leading edge that incorporates a deicer boot.
