Sensing of Structural Damage with OBR Based Fibre-Optic Networks

Kaspar Lasn
Erik Sæter
Andreas T. Echtermeyer

Norwegian University of Science and Technology (NTNU)
Department of Mechanical and Industrial Engineering (MTP)
Composites and Polymers
Richard Birkelands vei 2B, 7491 Trondheim
NORWAY

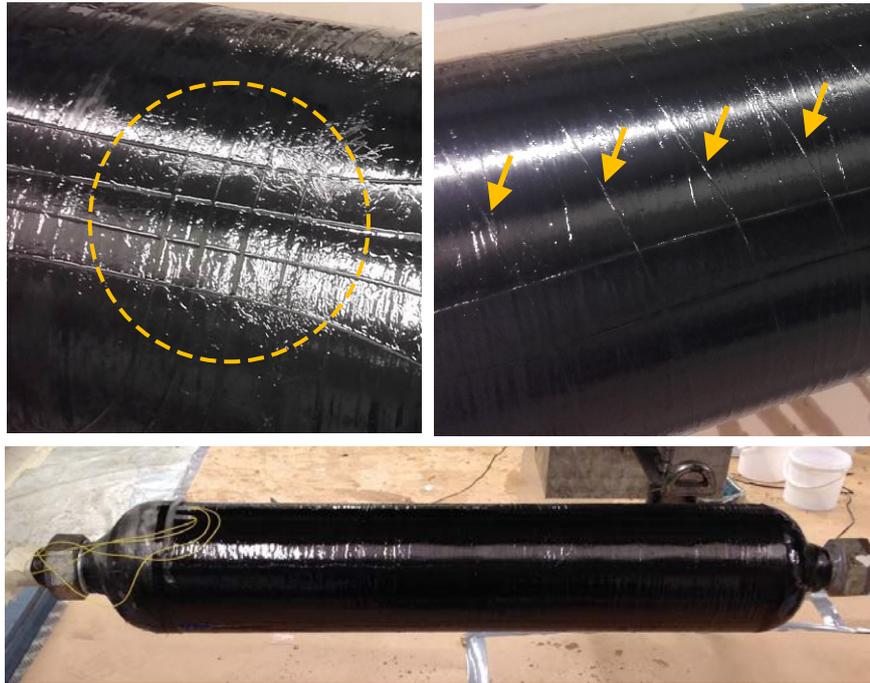
Figure 1: Embedding optical fibres during the manufacturing of carbon fibre COPVs [5].

Current work employs a novel distributed strain sensing system utilizing optical backscatter reflectometry (OBR) based on the principle of Rayleigh backscattering [4]. Regular telecommunications grade optical fibres were embedded into the composite layup i.e. wound between carbon fibre layers as seen in Fig. 1. The cylinders were struck with controlled impacts and the backscattered light from optical fibres was analysed to visualize the position and the severity of damage. The following study demonstrates how the interrogation of an embedded network of optical fibres provides high-resolution strain measurements covering the entire surface of the structure. OBR based optical fibre networks are shown to be a promising method for structural health monitoring of composite cylinders.

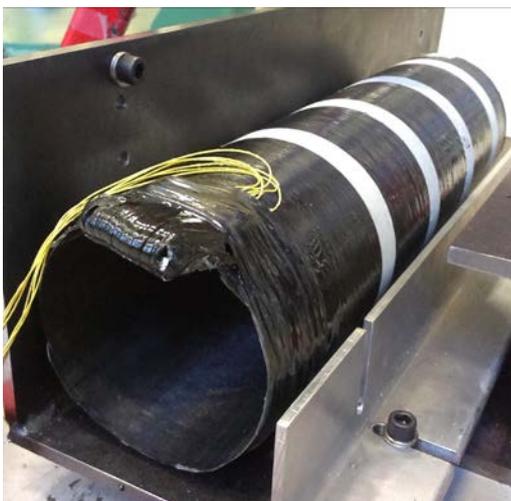
a) Instrumented composite cylinder.

Figure 5: The automated identification of three impacts on one tube.

In another experiment, a steel $\phi = 20$ mm hemispherical impactor was devised to struck three impacts – two with 20 J energy, and one with 10 J energy – to controlled locations on one composite cylinder. The specimen is shown in Fig. 5(a) and the eventual impacts could not be seen by visual inspection. An operator was then tasked to determine the locations of impact damage using the OBR method without any other previous information i.e. to perform a blind evaluation. The cylinder had been equipped with a system of six optical fibres, embedded inside the composite cylinder wall, close to its internal and external surfaces. Before proceeding with impacts, the operator also recorded the reference state i.e. backscattered signals from the healthy (un-impacted) cylinder.
