Non-Destructive Measurement Methods (Neutron-, X-ray Radiography, Vibration Diagnostics and Ultrasound) in the Inspection of Helicopter Rotor Blades

M. Balaskó¹, G. Endrőczy², Gy. Tarnai³, I. Veres⁴, Gy. Molnár⁴, E. Sváb⁵

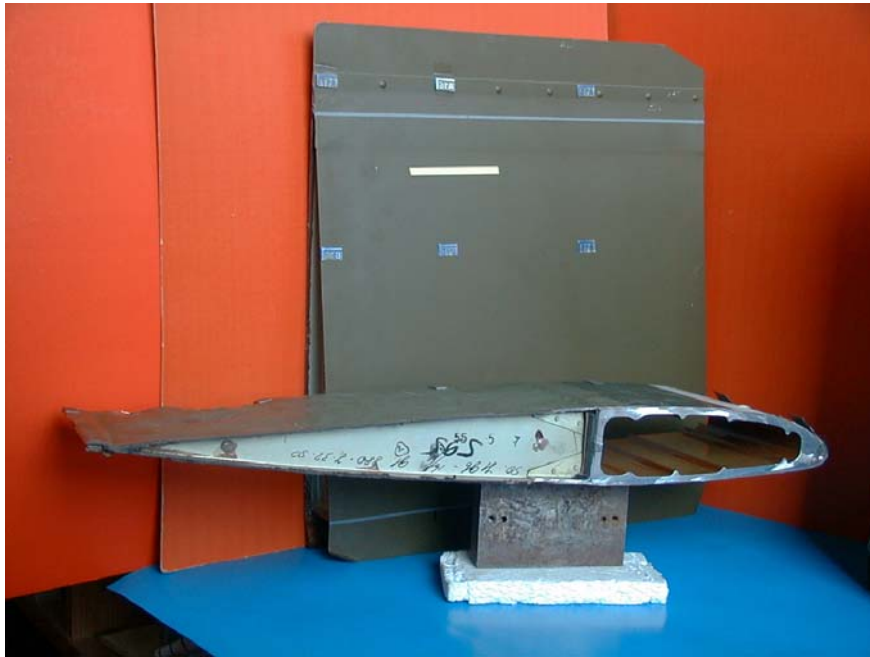
Figure 6: A lying special sample for ultrasonic test.

For the UT measurements a special object was produced (see Fig. 6.). Its XR picture (40 kV;2,5 mA) is shown in the Fig.14. It contains of some holes (diameter is 0,4mm) and some crack imitation (0,4 X 10 mm²) in the material of aluminum alloy spa with the 6FE type wire picture quality indicator on the D44 exposed picture field. In the tests to detect the cracks of main spar's section we used the principle of ultrasonic physics that the significant part of energy, using the appropriate inspection technology, rebounds in echo form from the cracks. The test would be successful when the echoes descending from the cracks simulation in sections, clearly, are detected and can be located.
