Technical Findings, Lessons Learned, and Recommendations Resulting from the Helios Prototype Vehicle Mishap

ABSTRACT

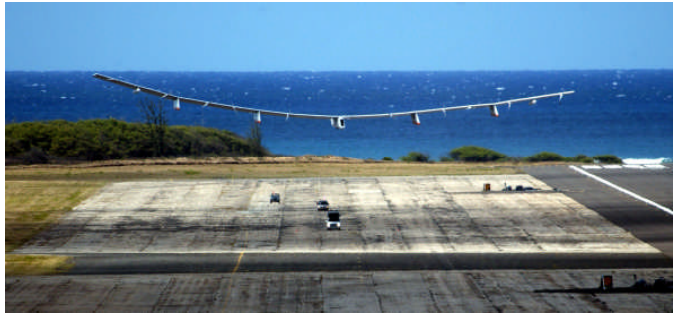
On June 26, 2003 at 10:06am local time, HP03-2 vehicle took off from the PMRF under the guidance of the Mobil Pilot (MP) located in the front vehicle shown in Figure 4. At that time the wind conditions were within an acceptable envelope, and consisted of a wind shadow over and offshore from PMRF, bounded to the north, south, and above by zones of wind shear and turbulence separating this region from the ambient easterly trade-wind flow.

Figure 4: HP03-2 on takeoff
