Structural Out-of-Autoclave Repair of Aircraft Fuselages via Adhesive Bonding

Dr. Patryk Burka, Frank Fischbach

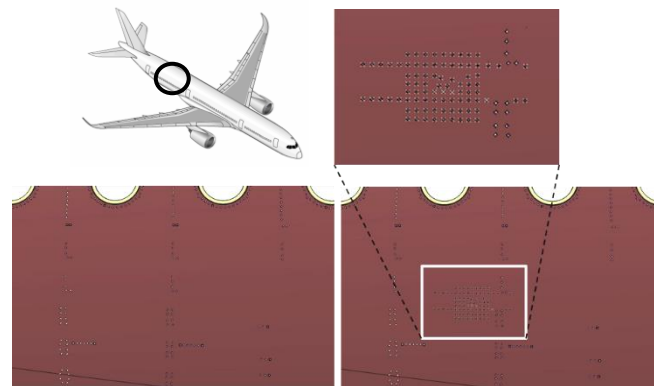
Figure 2-1: Damage position, drawing without repair (left) and with repair via riveting (right) including a magnification of the area.

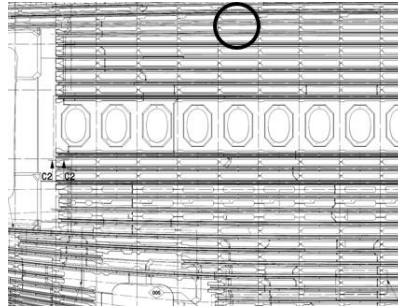
Figure 3-1. Excerpt of the left side shell of section 16/18 including the defined repair area.

The area that was cut out from the panel to demonstrate a penetration was sized 120 mm in circumferential and 150 mm in flight direction. To be able to conduct the repair two stringers had to be removed from the panel's inside surface which is conducted by cutting out and manual grinding. The grinding operation is conducted until reaching the bond line which is shown in Figure 3-2.

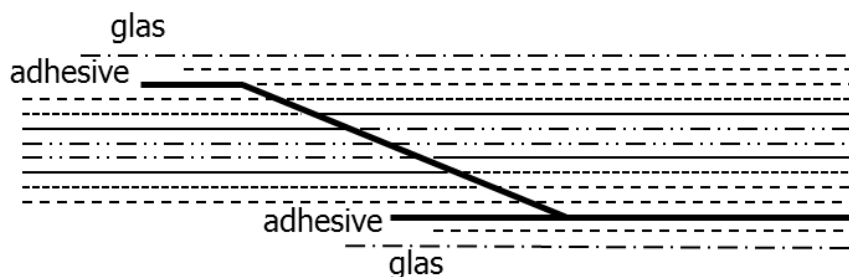
Figure 3-3. Representative sketch of a substrate's lay up and its repair patch including filler and cover plies as well as the adhesive film and glass plies.

To keep the repair area within a better handling size, the minimum overlap length and thus a slope ratio of 55:1 was defined. Additionally, two coverplies with a $+45^\circ$ orientation and an overlap length of 12 mm on each repair side had to be applied. Repair patch and adhesive film materials qualified and suitable in terms of thickness and mechanical properties were used. Altogether, 17 repair layers were used containing the entire original fibre stacking and additionally two coverplies, one on each side, as well as one filler ply to match the

penetration, and finally one glass ply on each side to cover the repair and adhesive film fully.

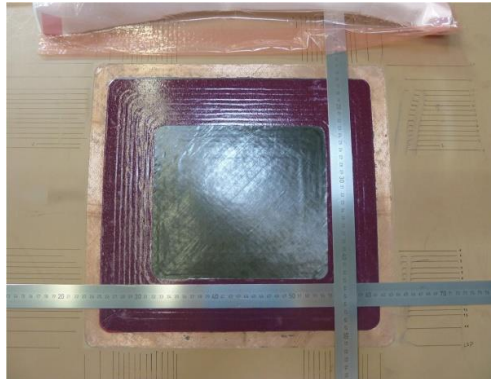
Figure 3-5. Repair patch after several repair plies have been laid up on the repair area.

Following the adhesive film repair plies according to repair design are laid up on the repair area being debulked at certain intervals. The debulking steps are performed at a certain vacuum pressure and time and aim for air removal from the repair patch. After the last ply was laid up a final debulking step is conducted. Figure 3-5 shows the repair area after lay-up of several repair plies.

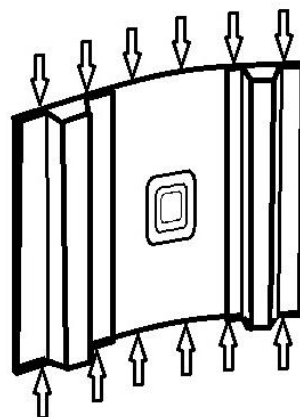
Figure 4-1. Schematical drawing of test panel with repair patch in the middle.

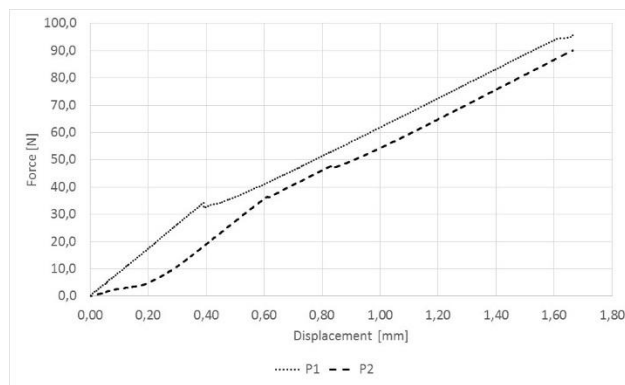
Figure 4-2. Force with respect to cross head displacement for panels P1 (intact) and P2 (repaired).

The recorded differences at the beginning are due to setting effects which are negligible. Once these are overcome (at about 0,2 mm for P2) both panels show a linear increase in compression force with respect to displacement. A first buckling is recorded at about 35 kN which is in line with numerical analysis data. The tests were terminated at 90 kN to validate numerical data and adjust strain gauges. Optical strain measurements were conducted for each test panel and compared to each other (Aramis). An example of these comparisons is shown in Figure 4-3 at a compression force of 85 kN.

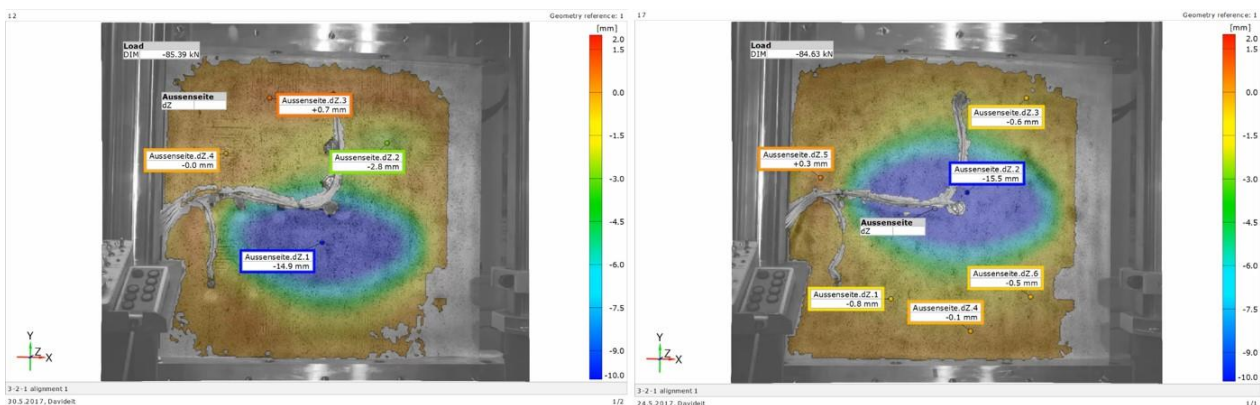
Figure 4-3. Plots of optical strain measurement for panel P1 and P2.

The optical strain measurements indicate a similar behaviour between the intact and the repaired panel. Data analysis and interpretation as well as numerical validation is ongoing and results are expected in the near future.
