## **AVT-339 Research Workshop on Robotics and laser/plasma – paint interaction in paint removal**

# **Nd:YAG laser de-painting and its effects on military aircraft surfaces**

**Henning Baron  
Airbus Defence and Space GmbH  
Germany**

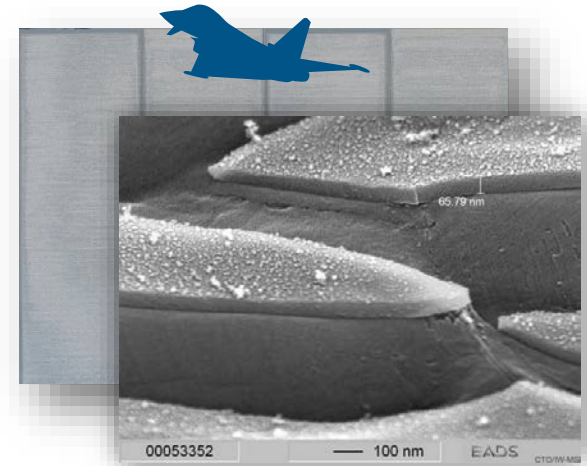
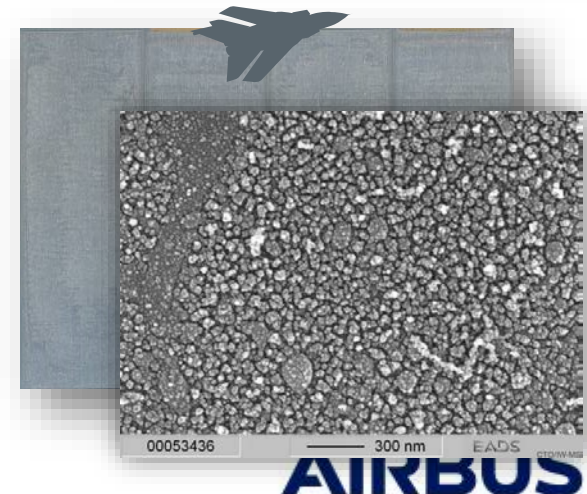
## Examination of newly generated oxide layer

- Both aluminium alloy specimen types showed the generation of a compact oxide layer on the Al surface.
- SEM analysis of these layers revealed thicknesses between 10 and 100 nm.
- In order to characterize the oxide layers as a potential pre-treatment for re-painting, Airbus performed further examinations, i.e.:
  - Adhesion of subsequent paint coatings,
  - Corrosion protection of bare Al surface,
  - Corrosion protection of painted Al surface.
- For this purpose clean unpainted Al specimens were treated with the same laser parameters.

- Examinations of these oxide layers showed detrimental behavior with regard to adhesion of subsequent paint layers and corrosion protection.
- ➔ Therefore Airbus Defence and Space took the decision that the laser de-painting process may not be applied for the removal of an entire coating system from an aluminium surface. Instead, the top-coat on an Al component shall be selectively de-painted until the primer surface is reached.
