Implementation of a New Inlet Protection System into HEMS¹ Fleet

EC-135P2+ helicopters operated by the LPR are highly exposed to environmental particles entering the engine during HEMS missions. The organisation adopted a comprehensive set of measures to predict and limit the impact of dust ingestion including gas path analysis, health and usage monitoring, and visual inspections. Finally, helicopters had modified inlets to install air filtration system which minimises the number of particles ingested by the engine. CFD simulation has been performed to check whether the upgrade has an impact on helicopter aerodynamics. The consequence of using filters is to extend the lifetime of engines, reduce operating costs and the number of maintenance tasks.

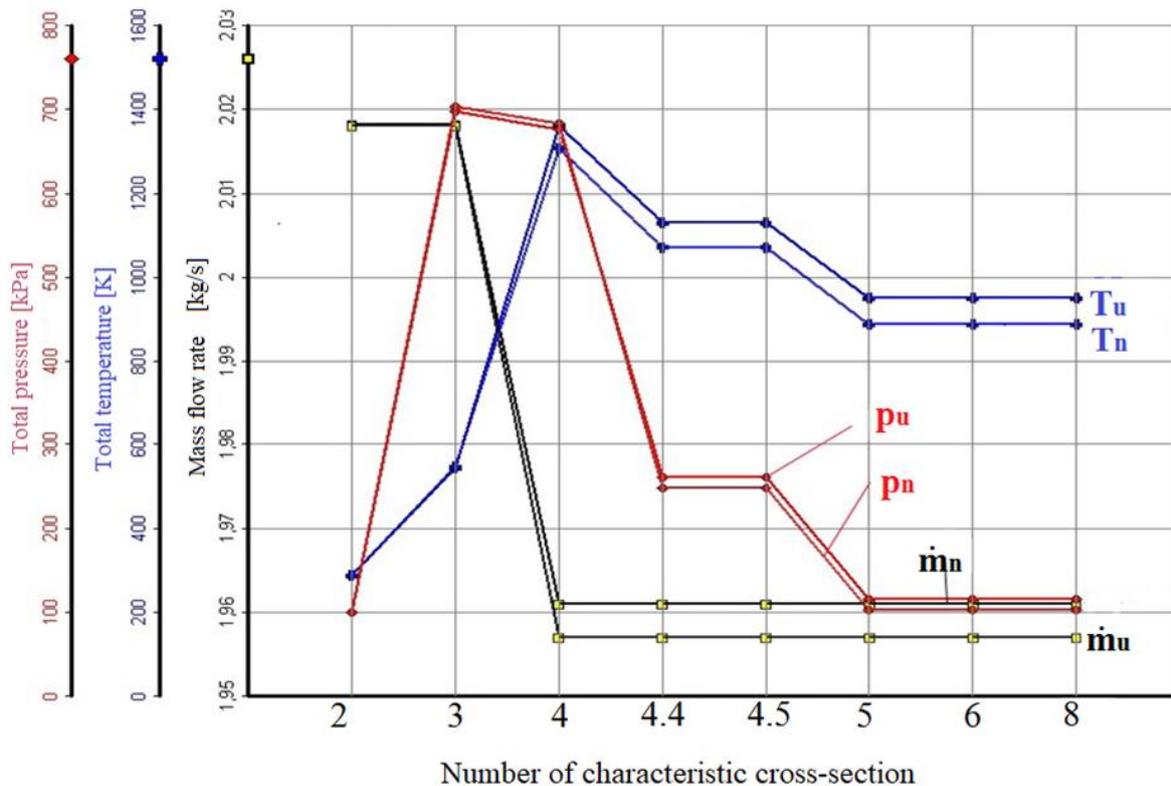
Figure 4. Distributions of total pressure, total temperature, and mass flow rate of air for the new ("n") and degraded ("u") engines [22]

It was observed that in each of the investigated cross-sections, the parameters for the degraded engine changed in relation to the new engine. The most noticeable change of values occurred in the engine hot section, i.e. from the outlet of the combustion chamber (cross-section 4) to the exhaust (cross-section 7). In the example under consideration, the engine was required to be overhauled after less than 500TFH which was mainly caused by the decrease of the efficiency of compressors and the efficiency of the generator and power turbine. Taking into consideration that between cross-sections 2-3 (engine inlet - diffuser) the changes in parameters' value are small ($\Delta T \approx 3$ K, $\Delta P \approx 7$ Pa), in the cross-section from 4 to 8 (i.e. from the outlet of the combustion chamber to the exhaust) these changes are more significant ($\Delta T \approx 50$ K, $\Delta P = 6 \div 19$ Pa).

The degraded compressor is less efficient due to the failures of the impeller and stator. This means that a smaller amount of air is produced by the same rotational speed. To constantly deliver the required torque through the drive shaft, the EEC system controlling the engine increases the quantity of fuel supplied to the engine. The effect of this is an increased temperature in the combustion chamber and the increased pressure of exhaust gases, due to which the kinetic energy of exhaust gases is increased. The power turbine generates higher torque, which, drives the rotor of the compressor through the shaft and thanks to this, the compressor, by increasing its rotational speed, provides the amount of air essential for the proper operation of the engine. On the other hand, the increased gas temperature contributes to the reduced lifetime of turbines. Temperature margin ΔT_{OT} measured during GPC, which initially equalled approx. 50°C , decreases even to 0 due to the dirt and erosion.

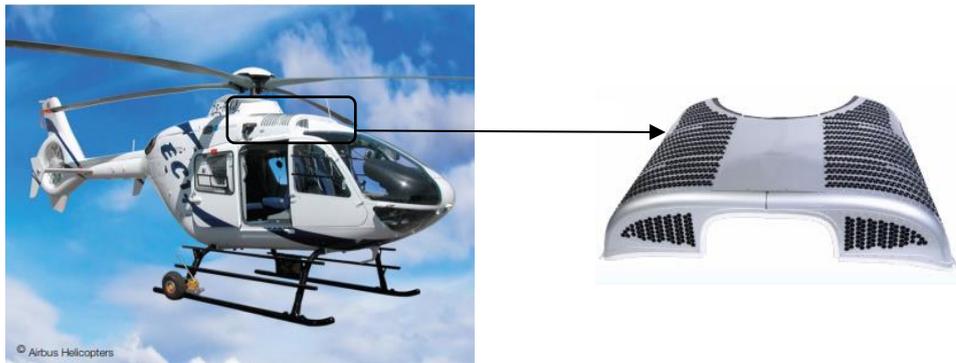
This type of inlet protection drew moderate interest in Europe. One of the operators using this solution, is ADAC. The main disadvantage is the necessity to turn on the system fans to work correctly. They take a lot of helicopter power. The pilots, who fly with this system, frequently switch off the fans during take-off/landing to have more power in the case of a heavy payload. Thus, when the protection is necessary, the filtration is scarce. Additionally, the location of the system results in many leakages through the shield and the swash plate (Figure 14). Sealing leakages is problematic and arduous. Although failures do not often occur, it is indispensable to replace the nozzles.

Figure 14. EC135 helicopter with PUREair system

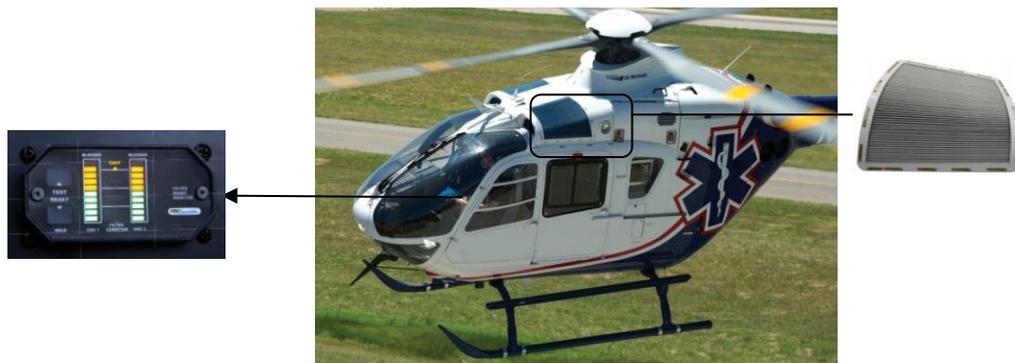
The system by FDC/aerofilters (now Aerometals) combines some advantages of PUREair and AHD IBF (figure 15). It consists of filters of air-ducts, control panel, bypasses, new ducts of oil cooling system and sealing system of the main rotor. The FDC system has similar problems with deformation of filters as the AHS IBF system. The price is still an advantage. The biggest drawback of this system is the lack of the possibility to carry out further modifications of the helicopter from the P2 to P3 version.

Figure 15. EC135 with FDC/aerofilters system

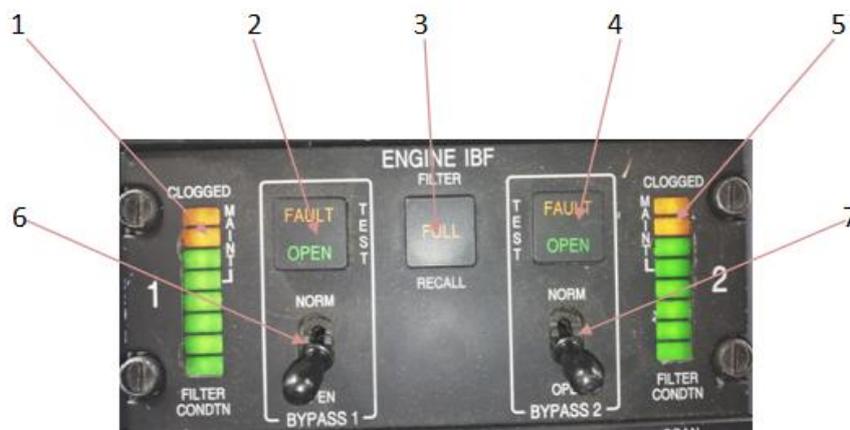
Figure 17. IBF control panel

IBF system requires maintenance as every system, but the occurring defects are not difficult to remove. The most common malfunctions include:

- Failures of servo-motors of bypasses' doors – Fighting in humid conditions contribute to blocking the servo-motors and inability to open/close doors, which is detected during the pre-flight test and indicated on the control panel;
- Failures of electrical transmitters – blocking them is also indicated as the lack of correct performance of pre-flight test;
- Failures of transmitters changing the read pressure into the appropriate electrical signal have an impact on the incorrect operation of the whole system and incorrect readings on the control panel.

In the event that excessive filter clogging is indicated, it is replaced with a filter which was previously cleaned and oiled. Filter cleaning consists in physical shaking out the loose deposits, moistening it with a proper cleaning medium, cleaning under running water and drying at the room temperature (increasing the temperature to approx. 600 C substantially shortens the drying process). The useful life of a filter depends on its technical condition, but it should be no longer than seven years. There is no rule stating how long a given filter can be installed on a helicopter. It depends on its technical condition. Sometimes, there are filters, which, without being cleaned, can fulfil their functions for 50-80h. However, the low resistance of filter to humidity or rain can trigger a need for cleaning after the first flight. The dust accumulated in the filter swells in connection with water, simultaneously reducing the flow capacity of the filter. Due to this, every 15 days, during maintenance works, the filter is disassembled and cleaned by shaking it out or gently dusting.
