## Development of New Repair Technologies for Out-of-Autoclave Aircraft Composite Components

*The main objective of this work was to develop analytical tools and protocols for the design of composite bonded repair for primary aerospace structures manufactured with out-of-autoclave processing. An innovative bondline breathing strategy considerably reduced bondline porosity in a wide range of processing conditions. A robust wet patch impregnation method led to low porosity and improved mechanical properties in the repair patch. The optimized prepreg and wet patch methods developed in this work were applied to a demonstrator repair part, an Airbus A320 elevator composed of thin-skinned sandwich panels. 2D and 3D models were developed to analyze scarf and stepped repaired monolithic and sandwich composite joint under tensile loading. From an optimization perspective the search for an optimum shape of the repair patch was carried out. When a stiffener is present the adhesive shear stress state is affected depending on various geometric parameters such as: position to the repair, stiffener pitch, cut-out size, size vs pitch ratio. In order to validate the numerical results, a simpler an

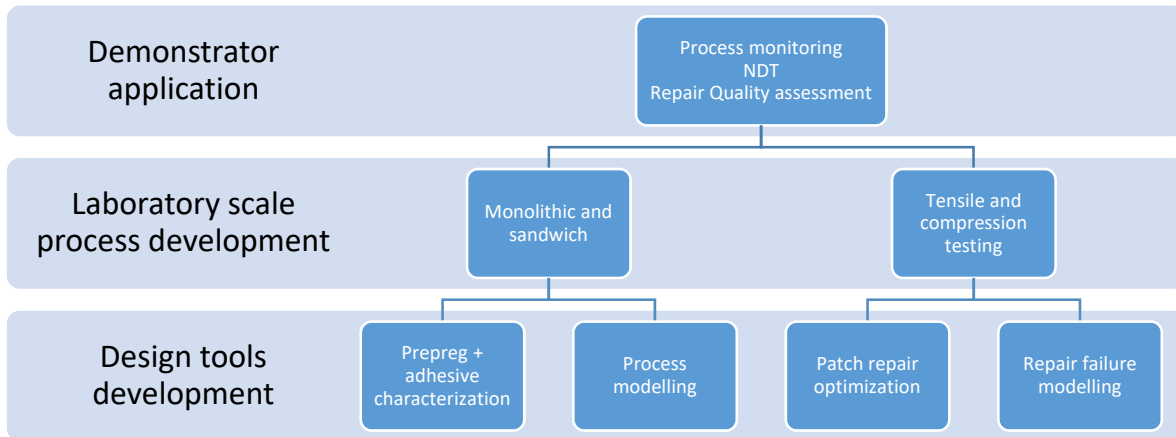
Figure 1-1: Task organization for the development of robust quality repair processes.

Figure 1 illustrates the approach used to develop robust processing protocols. Material characterization involved the development of thermochemical and rheological models of the resins and adhesives used in this research. Laboratory scale controlled experiments were used to optimize a breathable adhesive film and fibre preform impregnation method for the prepreg and wet patch respectively. Finally, the repair protocols were tested on a ~14-year-old aircraft component where the repair process was monitored and the quality of the repairs was assessed by non-destructive and destructive tests.

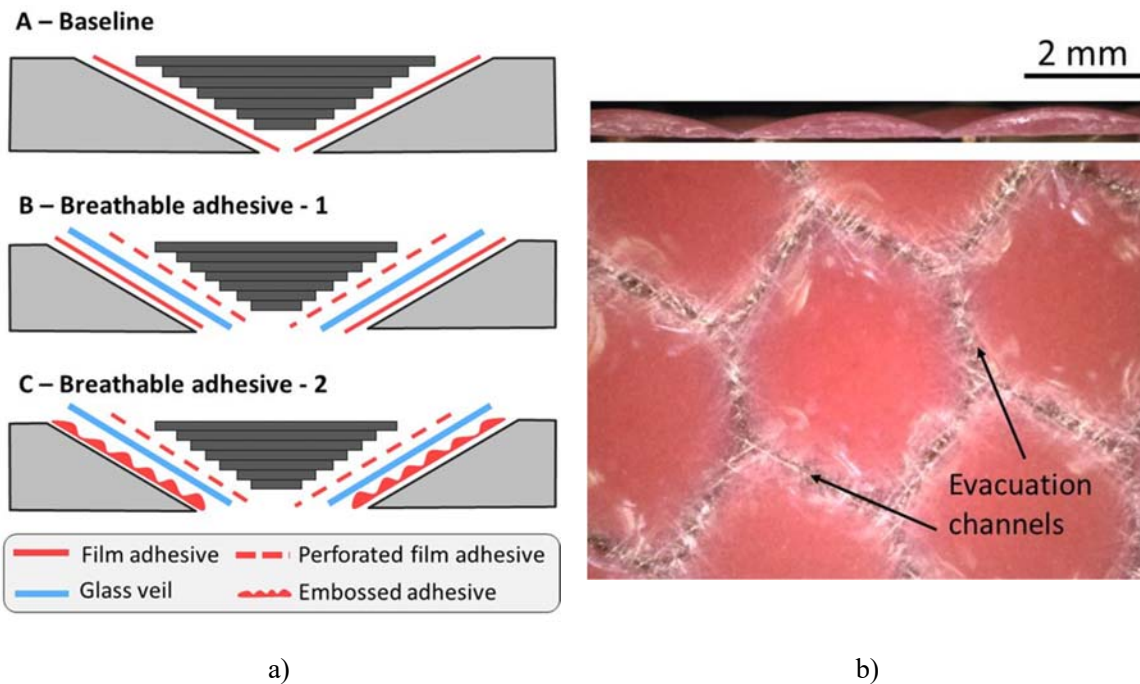
Figure 3-1: a) Schematics of repair air evacuation strategies: baseline (A), non-woven dry glass veil interleaved between a perforated and baseline adhesive film (B), and another breathable adhesive strategy in which an adhesive film is embossed (C). b) Close-up photographs of the embossed adhesive film: cross-sectional view (top) and in-plane view (bottom). Air evacuation channels are created by hexagonal core cell imprints, revealing the non-woven polyester carrier in the film channels.

An adhesive film texturing process was developed to provide in-plane air evacuation capabilities, and produce high quality Vacuum Bag Only (VBO) bonded scarf repairs (Figure 3-1). This technological solution, also called embossing, consists of creating pathways for air to be extracted during the pre-cure room temperature vacuum hold. Using digital X-ray radiography, the solution was confirmed to eliminate entrapped air in the bondline. Internal patch porosity was also found to significantly decrease when a textured adhesive film was used, providing in-plane ply air evacuation. Thermal analysis showed that the embossing treatment had a limited effect on the thermal properties on the adhesive, but in-situ observations indicated that the air evacuation channels were sensitive to ambient temperature and compaction pressure, possibly limiting the effective air evacuation time. This

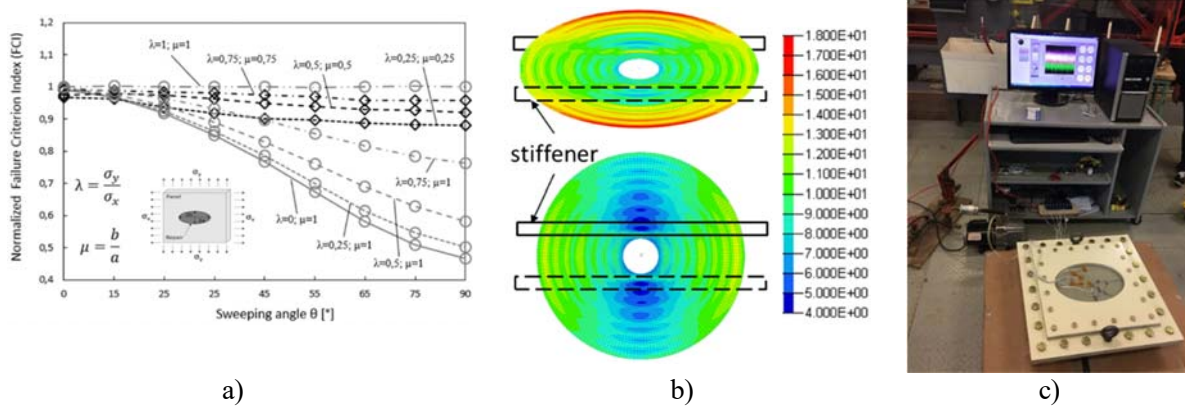
Figure 4-2 a) Optimum repair under biaxial loading, b) Stiffener effect on adhesively scarf repair, c) Biaxial loading testing rig.

New literature studies and late 2014 FAA new regulation pointed out the importance of repair cutout as well as the remaining strength needed after a failed repair. A procedure of optimization of the patch repair shape was conducted with parametric analytical models (Figure 4-2a,b). The 2D and the 3D finite element studies emphasized the non-uniform stress distribution within the bond surface. From an optimization perspective, the search for an optimum repair patch shape was performed. It was also shown that under uniaxial and biaxial loading a non-circular patch can reduce the stress concentrations with up to 40% less material removal.

In order to validate the numerical results, a simple and innovative test fixture was developed to replace a biaxial testing rig (Figure 4-2c). An instrumented rig was designed where out-of-plane loading was applied by hydrostatic pressure on of the repaired panel with various clamping boundary conditions. Circular and elliptical repairs were performed on monolithic quasi-isotropic composite plates. The repairs were instrumented in order to confirm the uniformity of the stresses. The testing rig also measures the ultimate load of the repair patch and analyses the failure modes. It was found that the stress distribution in the bonded region should be as uniform as possible in order to avoid the peaks that can initiate failure. Furthermore, the rig design enable the investigation of the patch repair performance under cycling loading.

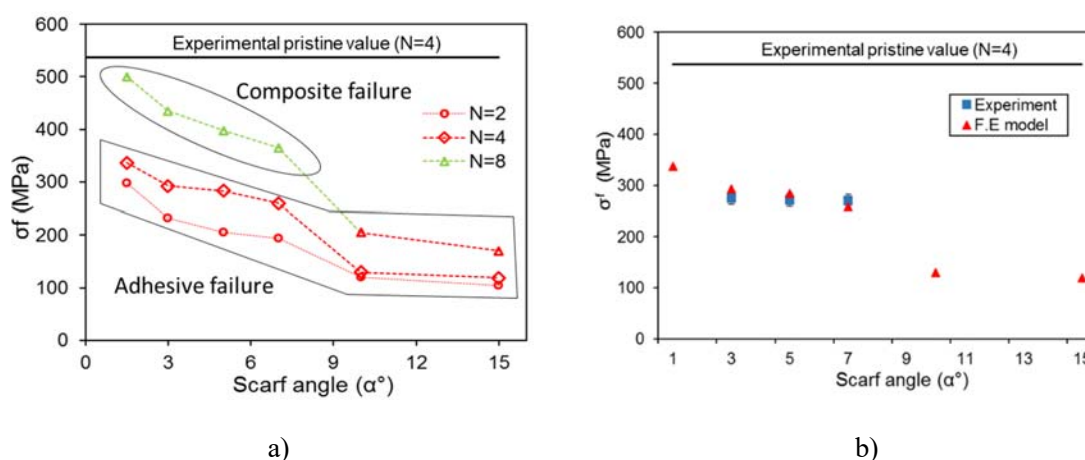
Figure 4-3: a) Effect of scarf angle and number of plies on patch repair strength of repaired sandwich panels. b) Validation of repaired sandwich panel modelling.

Using ABAQUS finite element software, a two-dimensional (2D) model was developed to analyze scarf-step repairs in sandwich composite panel under tensile loading. The adhesive film was modelled between the parent and the patch and was considered as an isotropic elastic-plastic material. A shear failure criterion was used for the adhesive. The composite material was considered as linear elastic. A simple maximum strain fibre criterion was used to predict failure of the composite. The geometrical design parameters investigated are the scarf angle ( $\alpha$ ), the number of plies (N) and the overlap length of the overply ( $L_o$ ). The influence of these parameters on the shear and peel stress distributions along the bondline of the stepped-scarf joint was investigated. The strength of the repaired sandwich panel was also predicted and compared with the one of the pristine panel (Figure 4-3a).

The model predictions were validated by experimental work (Figure 4-3b). Repairs were performed using the baseline configuration but with three different scarf angles ( $3^\circ$ ,  $5^\circ$  and  $7^\circ$ ) and tested in tension at RTD. Moreover, sandwich specimens were repaired using the baseline configuration but with the addition of a (+45/-45) over-ply with an overlap length equal to 10 mm and tested in tension at RTD. Correlation between experimental and finite element results was very good.

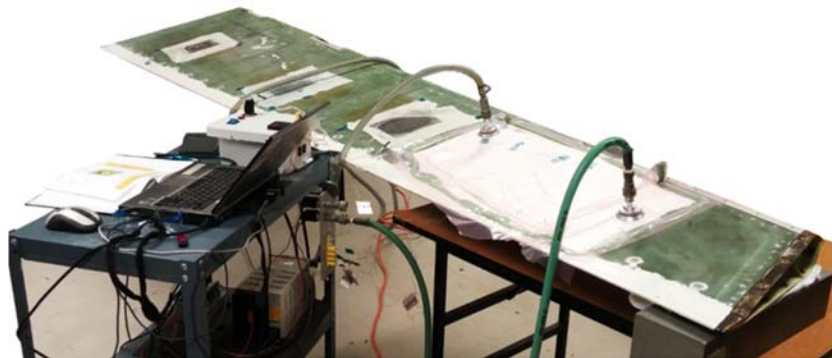
a)

**Figure 5-1: Demonstrator repair setup.**

At the lab scale, the impregnation technique was the second most important factor to both void content and fibre volume fraction. Only the two optimal methods, the vacuum and random blob impregnation techniques, were applied to the demonstrator (Figure 5-1). For the demonstrator this factor proved less important than the DVD process, with the random blob method leading to a slight improvement in void content compared to the vacuum impregnation technique. The DVD factor had only a 10 % contribution to void content. However, this was likely
