## Automated Infusion Repair on Rotor Blades – Improving Quality Standards

**Dipl.-Ing. Markus Zellhuber**

Airbus Helicopters Deutschland GmbH  
Industriestr. 4  
86609 Donauwörth  
GERMANY

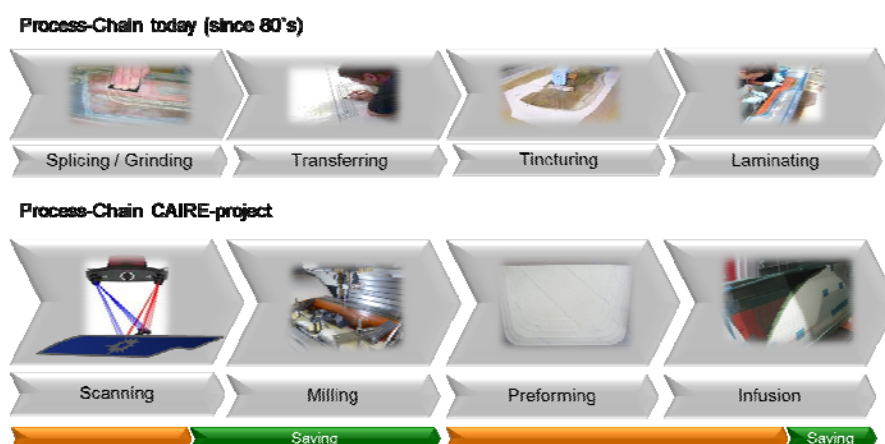
Figure 1-2: Comparison of repair process-chain.

However, only the process steps of splicing, surface preparation, laminating and curing, which are marked in red in Figure 1-1, are important for the improvement of the bonding, which is why they should be further considered in detail. On the basis of the results of the research projects Rapid Repair, CAIRE (Composite Adaptable Inspection and Repairs) and FACTOR (Future Advanced Composite Bonding and bonded Repair), the process chain illustrated in Figure 1-2 shall gradually replace the current repair process.

In order to exclude human influences as far as possible during the splicing of the repair area, the new process is based on an automated milling. The previous manual impregnation and laminating of the repair plies should be replaced by a dry preform, impregnated via an infusion process. Both methods offer the possibility to generate reproducible results, within certain tolerances, by definition of the process parameters.

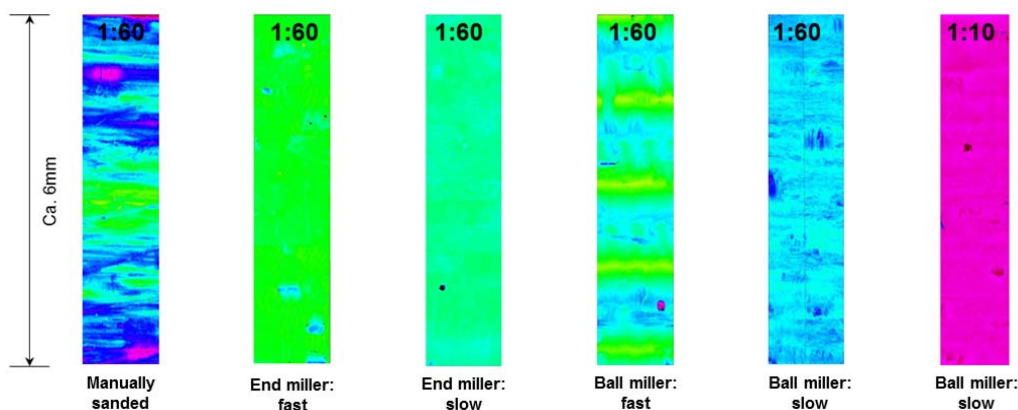
**Figure 2-8: Alicona measurements.**

The surfaces were then optically measured by means of the focus variance microscopy. The process described below as an Alicona measurement (Alicona = Name of manufacturer) has the great advantage (depending on the resolution) of giving surface roughness values, as well as a percentage increase in the effective surface due to roughness. These values were thought to be potentially significant values for the strength of an adhesive bond. All Alicona measurements were also carried out by the consortium partner Airbus Defense & Space. Since very large amounts of data are generated during an Alicona measurement, the measuring procedure is very time-consuming and the entire sample could not be measured. Instead of the entire sample, approximately 6 mm long and approximately 2 mm wide strips, transversely to the milling direction were measured. The fact that the Alicona measurements of the surfaces with a splicing ratio of 1:60 are transferable on surfaces with a splicing ratio of 1:10 was demonstrated by means of a verification measurement. The results of all measurements are shown in Figure 2-8.

In the Alicona measurements, it became clear that the fast machining parameters with the ball miller achieved the highest roughness values. In a "medium" roughness range of the series the fast milling parameters with the end miller and the manually grinded surfaces can be found. The slow milling parameters provided the "smoothest" surfaces of the sample program with both milling tools. Therefore, the surface

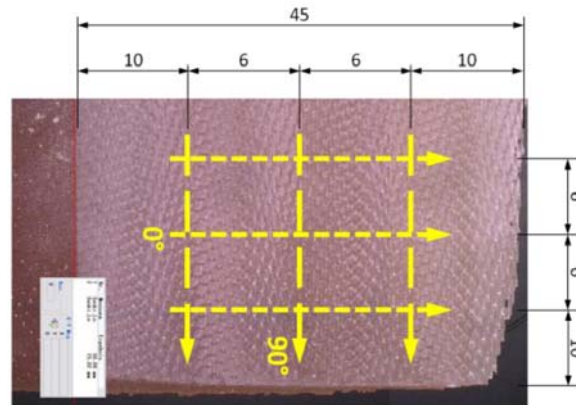
Figure 2-9: Measurement scheme for tactile roughness values.

magnifications for these parameter are relatively small. The tactile roughness measurements of the samples were carried out in the form of a classical sampling pattern. In order to obtain an preferably representative image of the surface, three measurements were taken in and across the milling direction. This scheme is shown in Figure 2-9.

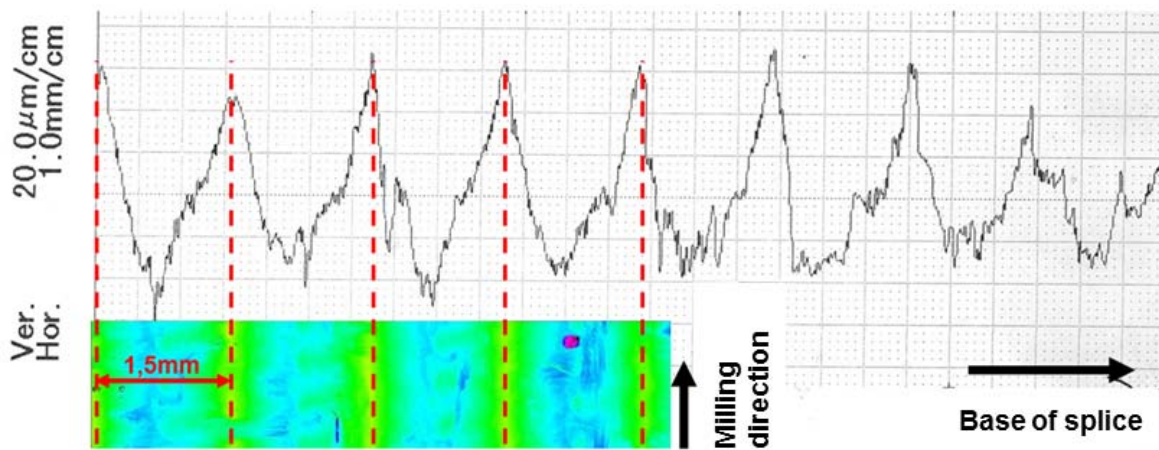
Figure 2-10: Alicona measurement compared to tactile roughness measurement.

The mean value of the individual measurements was used to evaluate the roughness measurement. The overall picture of the measurements was able to confirm the tendency from the Alicona measurements, even when the maximum values did not fit exactly in the absolute dimension. In addition to the pure roughness values, the profiles of the individual surfaces were also characterized. In this way, clear "patterns" of the milling tools could be recognized on the surface. As a particularly clear example, Figure 2-10 shows the processing parameters of the fast ball milling cutter.

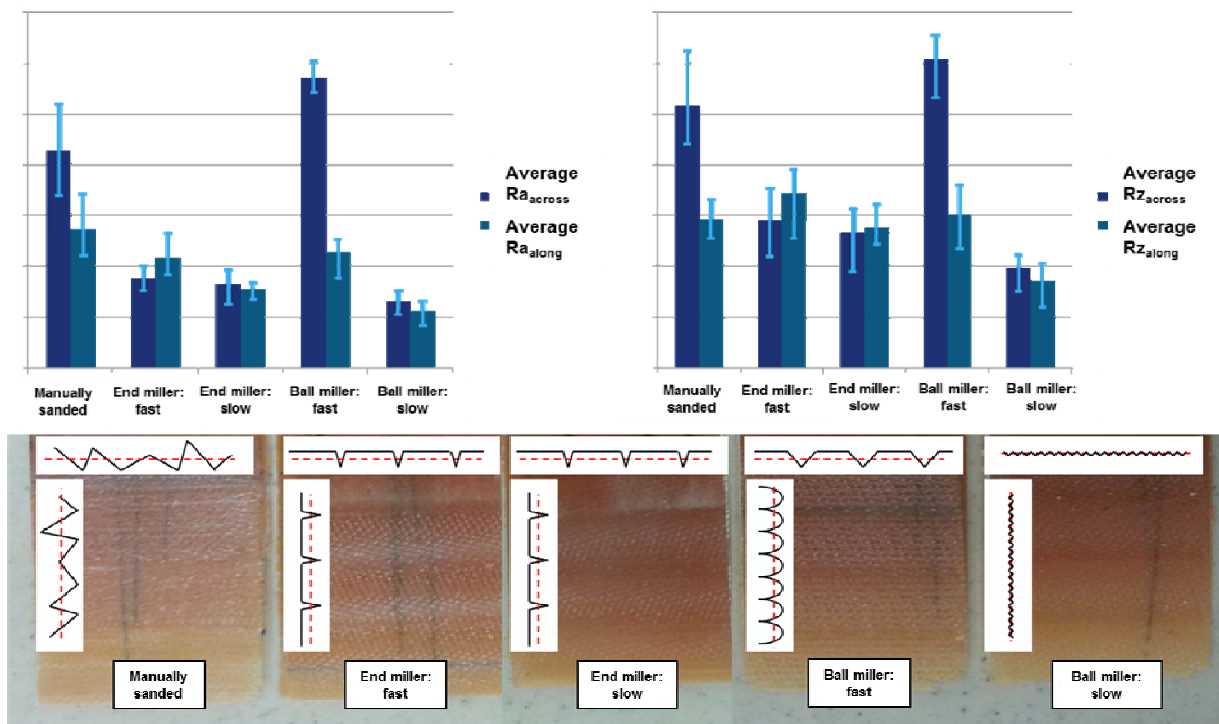
Figure 2-11: Results of tactile roughness measurements.

The characteristic patterns and associated mean values of the roughness measurements are plotted in Figure 2-11.

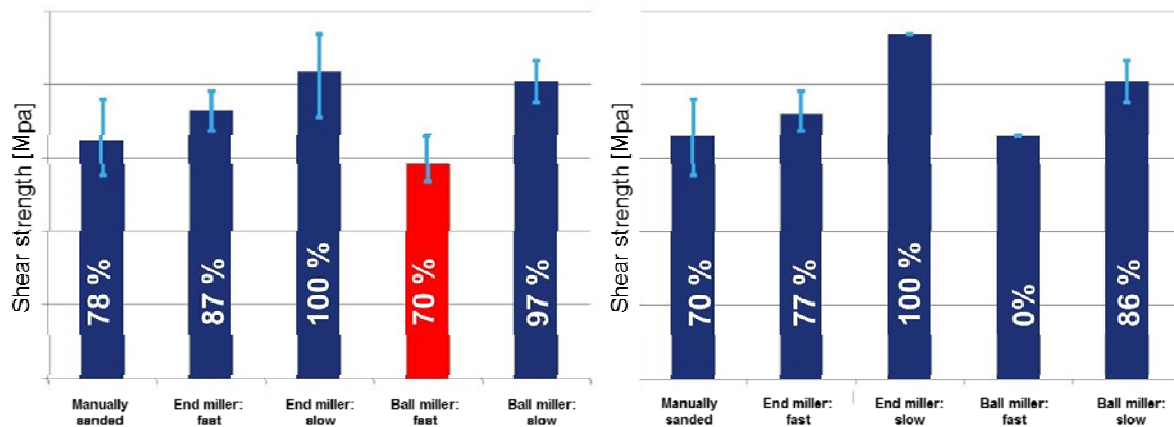
**Figure 2-14: Shear strength results of spliced tensile specimen 1:10.**

The evaluation of the sample series with regard to the achieved shear strengths can be seen in Figure 2-14. On the left side of Figure 2-14 every specimen is taken into account, on the right side only the ones with a correct failure mode are considered. Since no single specimen of the parameter set "ball miller fast" showed a correct failure mode, no shear strength value can be calculated (marked red and set to 0% for the diagram with the correct failure modes). As mentioned above, only one specimen showed a correct failure mode for the parameter set "end miller slow", that's why no scatter is shown in Figure 2-14 for these specimens.

The machining parameters "end miller slow" and "ball miller slow" were chosen as "best" parameter sets due to their failure type. However, the distinction between the other values was difficult because, given a splicing ratio of 1:10 and a sample thickness of 1 mm, only a very small bonding surface is available. This leads inevitably to the fact that already small measurement errors during the determination of the bonding surface lead to large deviations in the absolute values of the shear strength. As expected, the strength results of the 1:60 spliced tensile specimens could not show any differences between the tested parameters, which is why they are not presented separately. This result suggests that a difference in the strength of both methods can not be determined when using a splicing ratio of 1:60 (standard for rotor blade repair).

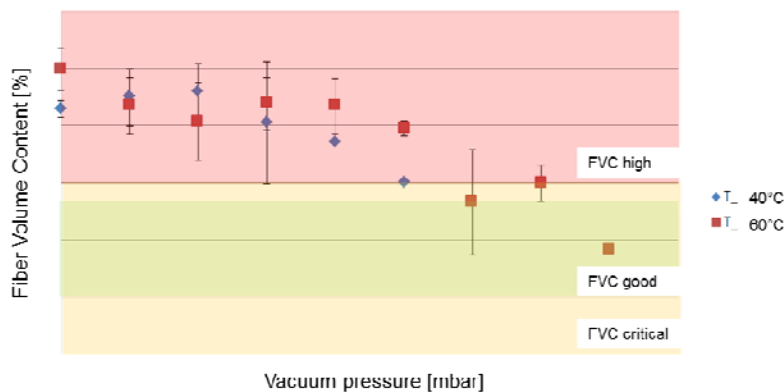
Figure 2-15: Fiber volume content over vacuum pressure.

To determine the optimal infusion pressure, the laminate properties of the prepared sample plates were examined with regard to their fiber volume content and their porosity. The target value was a fiber volume content slightly below 50%, as well as a porosity of less than 3%. These values are particularly favorable for the durability of the rotor blade skin and thus for the service life of the repair.

Figure 2-15 shows the fiber volume content over the infusion pressure, while Figure 2-16 shows the porosity. The fiber volume content was determined by means of the laminate mass and / or by ashing and later confirmed by a micrograph picture. The porosity was determined by the optical evaluation of the micrographs. In the analysis of the diagrams, it was noticeable that a relatively high infusion pressure is necessary to reach the acceptable fiber volume content below 50%. The porosity of the samples showed exactly the opposite. An acceptable porosity content below 3% could only be achieved at a very low infusion pressure. Due to this contrary behaviour of fiber volume content and porosity it was not possible to find any process parameters that would meet the requirements and target values in the first iteration step. In order to improve the results, a further process variant was used to examine how the good properties of the high and low infusion pressures can be combined. Since the lowest porosity in the previous experiments could be achieved at 0 mbar, full vacuum pressure was also established for the infusion pressure of these tests, but the process was extended by another pressure step with a significantly reduced pressure. By these final additional measures the optimal process parameters could be determined. The following micrographs clearly show the effects of the process parameters on the resulting laminate:

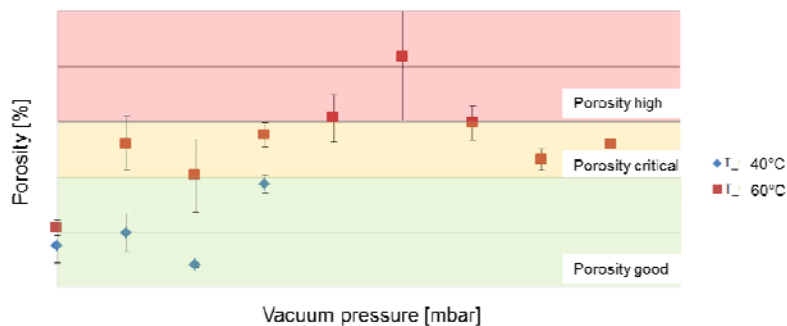
Figure 2-16: Porosity content over vacuum pressure.
