Improving Reliability of Bonded Composite Repair with Advanced Pretreatment and Surface Inspection Technologies

Uwe Lommatzsch*, Kai Brune, Olaf Hesebeck

Fraunhofer Institute for Manufacturing Technology and Applied Materials Research IFAM,
Wiener Str. 12, D-28359 Bremen
GERMANY

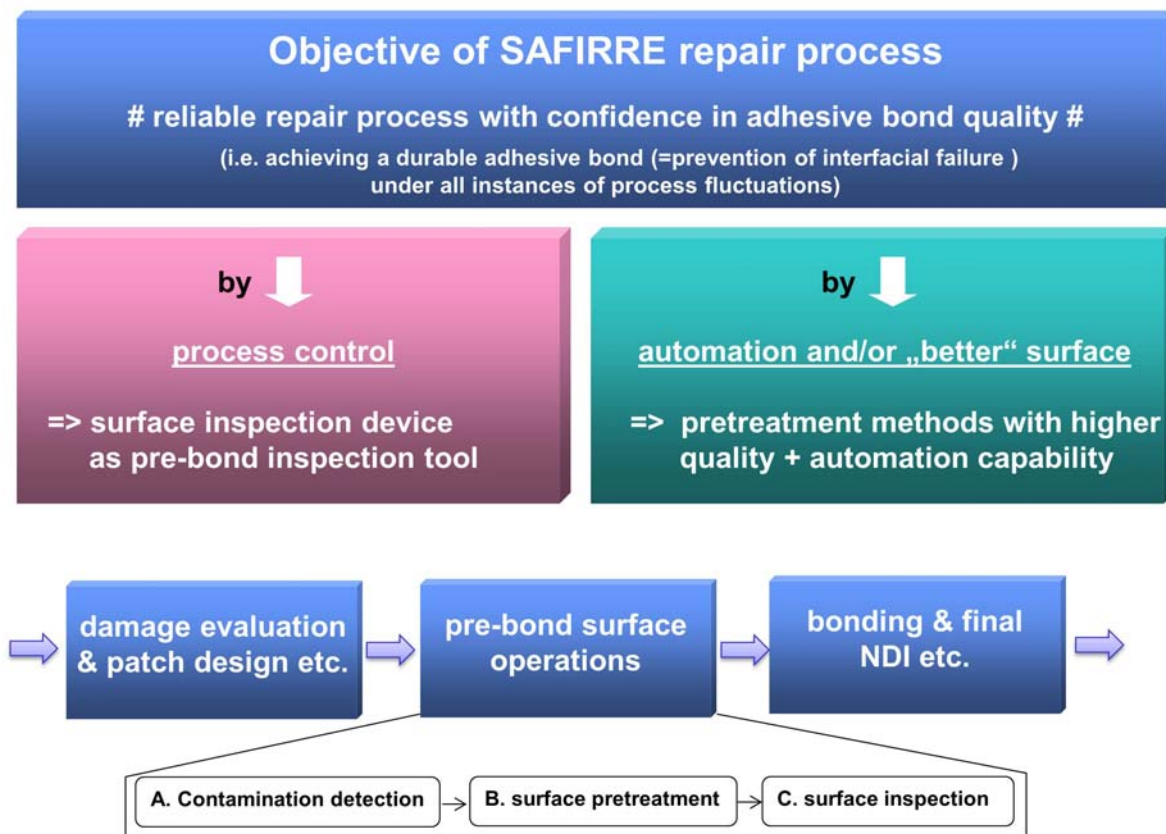
Figure 1-1: SAFIRRE approach for bonded repair of composite aircrafts with focus on surface quality

Assuming that the surface to be bonded to is highly significant in achieving a robust repair process, we propose to eliminate the likelihood of errors (=events affecting the durability of the joint adversely) related to the surface by using technologies for surface preparation/inspection with a high degree of automation and the potential for high-quality surface treatment. Besides automation and superior performance, process control to check and validate the surface properties is thought to be the second element for a robust repair process in addition. Therefore we propose a repair process that relies on the combination of surface pretreatment/cleaning methods with surface pre-bond inspection methods. We termed this approach safe, integrated, and reliable repair process, abbreviated as SAFIRRE. Figure 1-1 outlines this two-key-element approach.

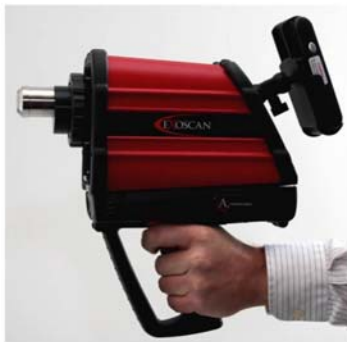
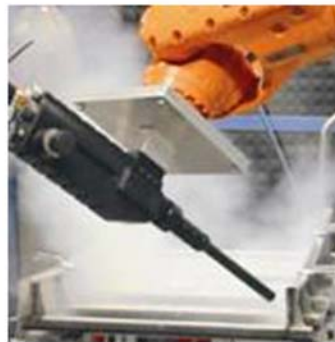
Figure 1-2: Examples for surface inspection and treatment technologies. (left): mobile FT-IR instrument; (right): automated CO₂ snow cleaning

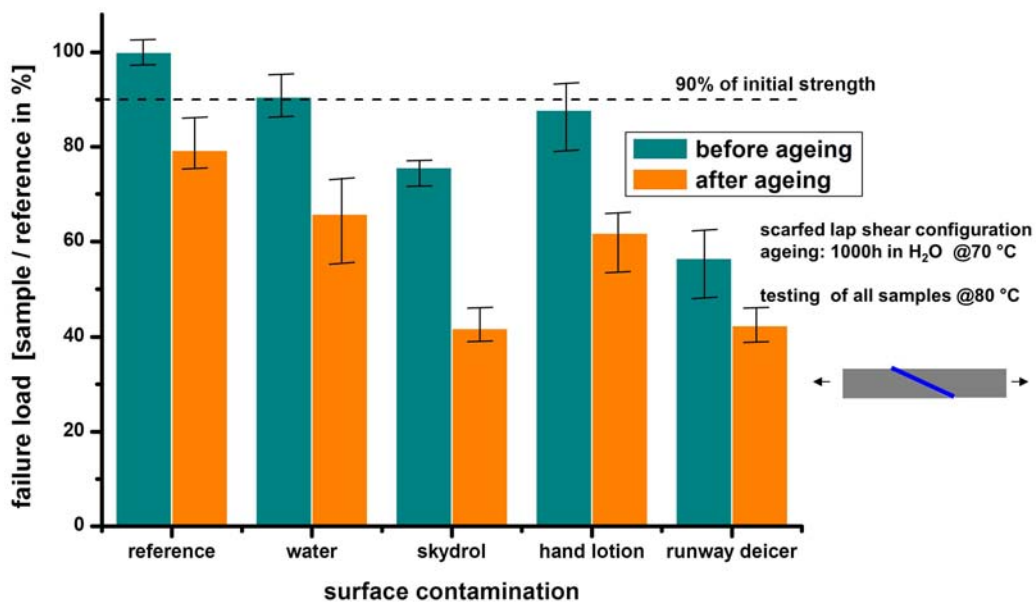
Figure 3-1: Bond strength after bonding to differently contaminated surfaces. The graph also shows the influence of ageing the bonded specimens before testing. The samples with deicer show an adhesive failure mode. All other samples have a complex failure mode with a cohesive failure mode partially within the adhesive layer and the laminate. The ageing seems to affect the failure mode only slightly.

Fig. 3-1 presents the change of bond strength when differently contaminated surfaces are bonded in comparison to a non-contaminated reference surface. Due to the above mentioned challenges we refrain from quantifying the amount of contamination. Contamination by water, hydraulic fluid, and deicer has been achieved by dipping the specimens for a defined time in the respective liquid. Hand lotion was applied manually by a brush.

In these experiments contaminations due to a runway deicer had the most prominent effect on bond strength. As expected ageing strongly influences the bond strength. So choosing the right testing&ageing conditions is also of major importance in the assessment of the effect of contamination on bond durability.

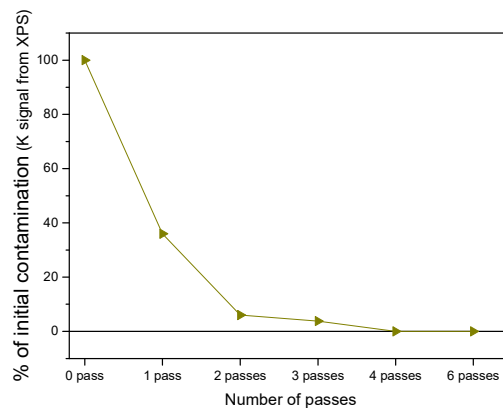
Figure 3-3: Semi-quantitative level of de-icer contamination on a CFRP surface as a number of treatment passes using a CO₂ snow system. As analytical marker the K peak derived from a XPS analysis is used.

For the selection of the appropriate surface pretreatment methods it is necessary to evaluate their effectiveness for contamination removal. Again, here the major challenge is the analytical assessment of the contamination before and after pretreatment. Fig. 3-3 presents the removal of de-icer contamination from a surface using a CO₂ snow system with a fully automated robotic system. It can be seen that more than 1 pass with the CO₂ treatment is necessary to remove the de-icer (or at least the K ions which are major component of the de-icer). To establish a reliable pretreatment, process data as those are mandatory to assure a clean surface has generated. In addition, in principle, such experiments have to be performed for all levels and types of contaminations. A way to reduce the number of experiments might be to use a chemistry-based approach for clustering contaminations according to their chemical behavior and influence on bond strength and durability. In terms of repair cost and adaptation to curved aircraft surface it is also necessary to have efficient automation tools that allow for such pretreatment processes without manual interference.

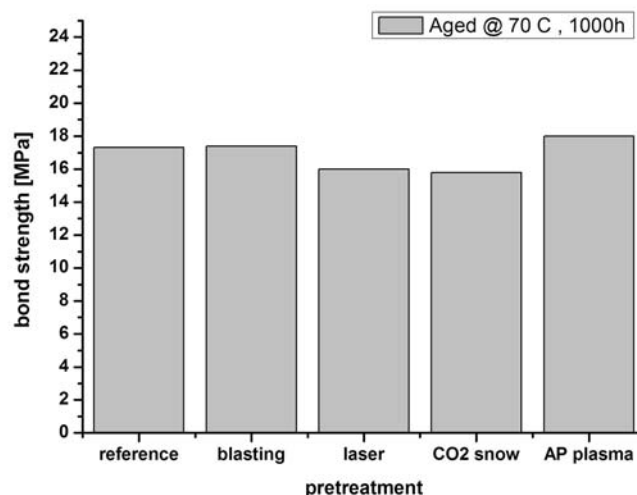
Figure 3-5: Bond strength after ageing (1000h @ 70 °C) of bonded CFRP samples having received different surface pretreatments. Lap shear testing was performed at room temperature and measured bond strength values vary by approx. ±2 MPa for each set.

It is interesting to see how these different surfaces affect the bond strength. Fig. 3-5 displays the lap shear strength of non-contaminated CFRP surfaces having received the individual surface pretreatments. Due to the nature of the testing procedure we observe for all samples a cohesive failure mode within the laminate. The surprisingly moderate influence of the surface state (topology and chemistry) on the bond strength can be very likely related to the nature of the used adhesive film. The adhesive seems to be capable to build up similar adhesion forces to all surfaces. Research how adhesive chemistry and surface properties are affecting bond durability is still needed to reduce the number of experiment to fully validate such an approach. In addition, predictions on the bond durability using different ageing protocols is very difficult.
