Integrated Logistic Support Approach of Wear-Related Problems

Nicolas CHRETIEN (Author) and Frederic ABSI (Co-author)

Paper presented at the RTO AVT Specialists' Meeting on "The Control and Reduction of Wear in Military Platforms", held in Williamsburg, USA, 7-9 June 2003, and published in RTO-MP-AVT-109.

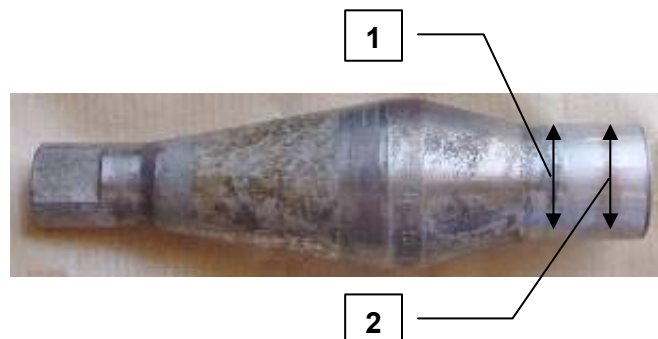
Fig. 4 Alphajet engine/fuselage interconnecting trunnion

For example, during a periodic visit, traces of wear were found on Alphajet engine/fuselage interconnecting components (trunnions). A dimensional control was performed to establish the loss in material. The first measurement (mark 1 on Fig. 4) was out of tolerance (24.960 mm for 24.970 mm admissible). A second measurement (mark 2 on Fig. 4) was performed to check the extent of the worn area. This measurement was inside tolerances (24.980 for 24.970 mm admissible). However, as one of the measurements was out of tolerance, and since this element is highly critical for the aircraft, the trunnions were replaced. A systematic dimensional check of these elements during periodic visits was also added to the Alphajet maintenance plan.

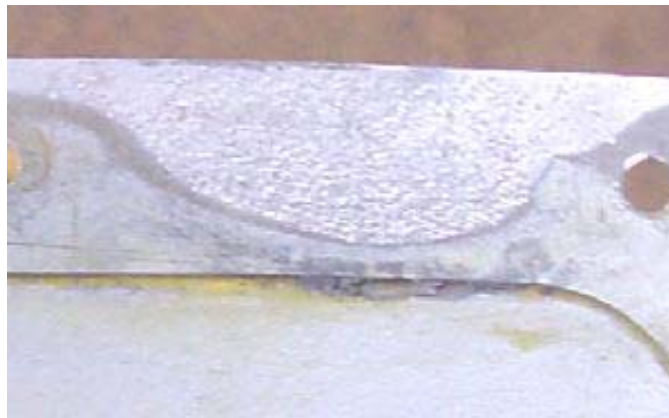
Fig. 5 Fretting of contact area between Alphajet fuselage and tail cone

- Fretting occurs frequently between contacting surfaces such as wing/fuselage fairing or fuselage/tail cone and wing/slats ties. Fig. 5 shows an example of contact area fretting between fuselage and tail cone on an Alphajet. In these cases, repairs consist mainly in renewal of the area protection (paint and putty, if necessary) or use of Teflon adhesive.

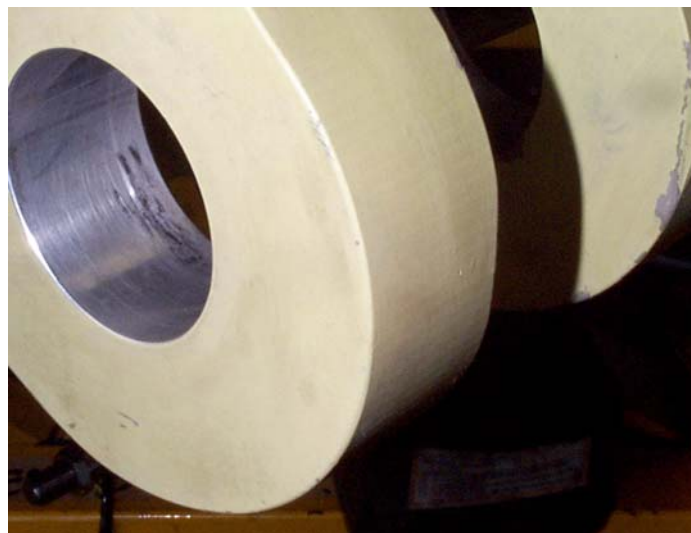
Fig. 7 Fretting wear on Mirage 2000 wing/fuselage main attachment fitting

- Wear in stiff assemblies or hinges can appear through ovalization or fretting on inner surface of a loaded reaming. A common repair solution is oversize dimension drilling of the damaged reaming. This allows to recover a flawless surface condition and prevent fatigue cracks growth without perceptibly altering the structural behaviour of the mechanical assembly. An example of fretting wear is shown (Fig. 7) on wing/fuselage main attachment fittings of a Mirage 2000. The inside diameter was extended from $\phi = 52mm$ to $\phi' = 53,2mm$.

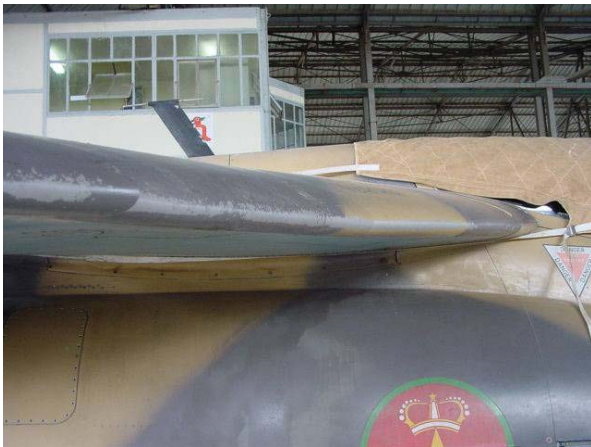
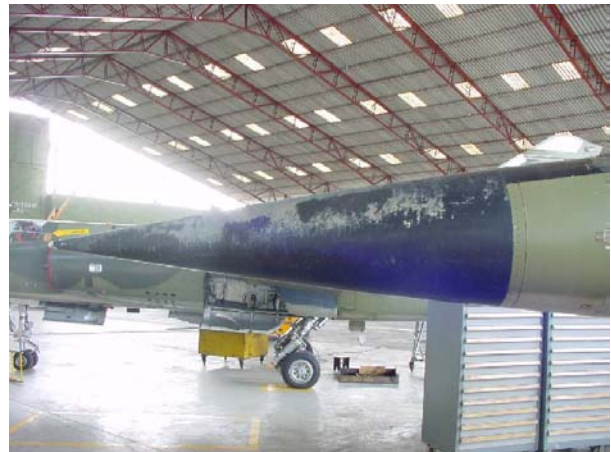
Fig. 8 Alphenet wing leading edge erosion (left) and Mirage F1 nose cone erosion (right)

For example, the experience of aerodynamical or contact erosion on older aircrafts (Fig. 8) allowed to integrate the choice of specific anti-erosion products into the Rafale protection plan definition, such as :
