Andrzej Szczepankowski, Janusz Szymczak, Radosław Przysowa

ABSTRACT

The Effect of a Dusty Environment Upon Performance and Operating Parameters of Aircraft Gas Turbine Engines

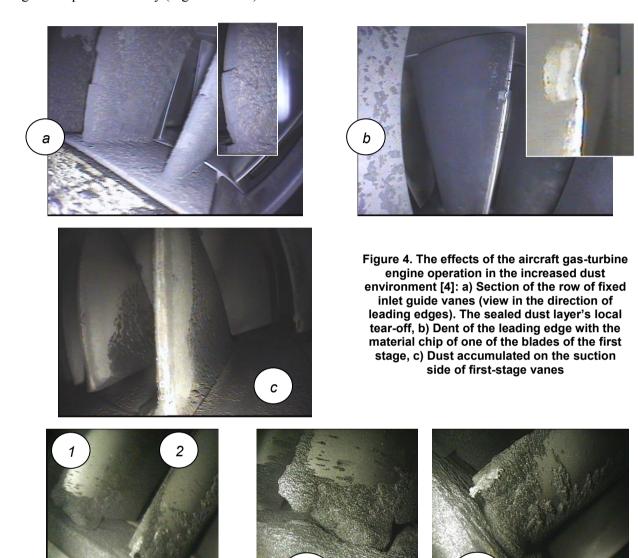
Figure 5. The effects of the aircraft gas-turbine engine operation in the increased dust environment [4]: a) Section of the first stage compressor's adjustable vanes (view in the direction of the surface of leading edges and tops). The sealed dust layer's local tear-off.

a₁ and a₂) two vanes of the first stage compressor adjacent in the row

However, ingested dust particles not only change the shape of profiles of the surrounded blades, they also settle in the compressor's inlet part, disrupting its operation, making it very difficult for the aircraft gas turbine engine to operate correctly (Figure 4 and 5).

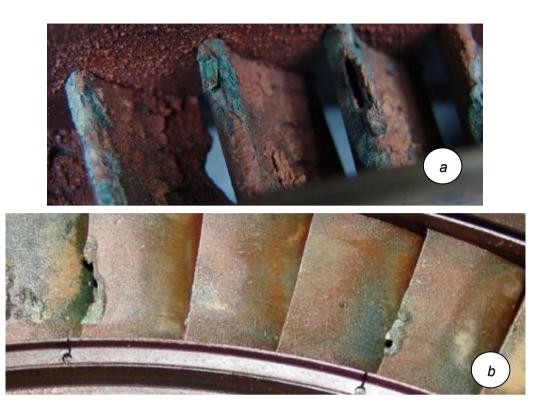
Figure 12. The removed first stage of the turbine stator (of gas generator) [5]. View in the direction of edges: a – leading, b – trailing

The effects of this type of operation were illustrated in Figure $8 \div 12$.

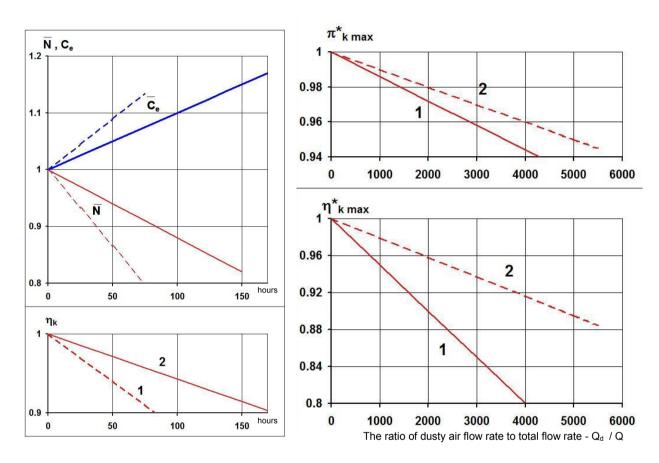
Figure 19. The change in N power, Ce fuel consumption and ηk efficiency of the engine with the axial - 1 or centrifugal - 2 compressor [6]

Comparative studies [6] show that the pressure ratio of axial and centrifugal compressors, which operate in the same pollution accumulation conditions, much faster decreases in the first one, at the same time, reducing its efficiency (Figure 19-20).
